## Informational Bulletin

## ENHANCED VAPOR RECOVERY

### Minimizing Wintertime In-Station Diagnostic System Overpressure Alarms

December 4, 2017

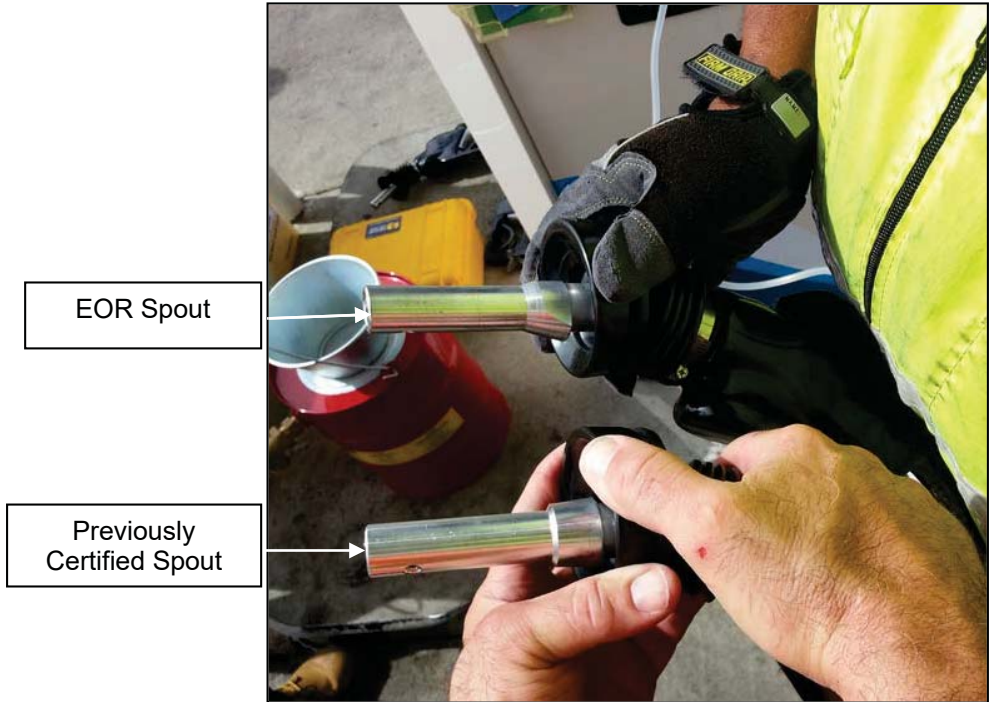
In response to these findings in 2015, Franklin Fueling Systems (FFS), manufacturer of the assist system, made design enhancements to the spout assembly of the assist nozzle. These improvements enable a better seal between the nozzle's vapor collection boot and the vehicle fill pipe, thereby reducing excess air ingestion. The new spout assembly, referred to as Enhanced ORVR-Vehicle Recognition (EOR), is depicted in Figures 1 and 2 and can be field retrofitted onto existing nozzle bodies. During the winter of 2016/2017, CARB staff evaluated the performance of the EOR spout assembly at eight GDFs, each with

**Figure 1: EOR and Previously Certified Spout Assembly (horizontal view)**

1. Replace existing assist nozzles with the new (factory assembled) nozzles equipped with the EOR spout assembly according to Section 2 of the CARB Approved Installation, Operation and Maintenance Manual (IOM) for the assist system. The new EOR nozzles are anticipated to be available from FFS in January 2018.

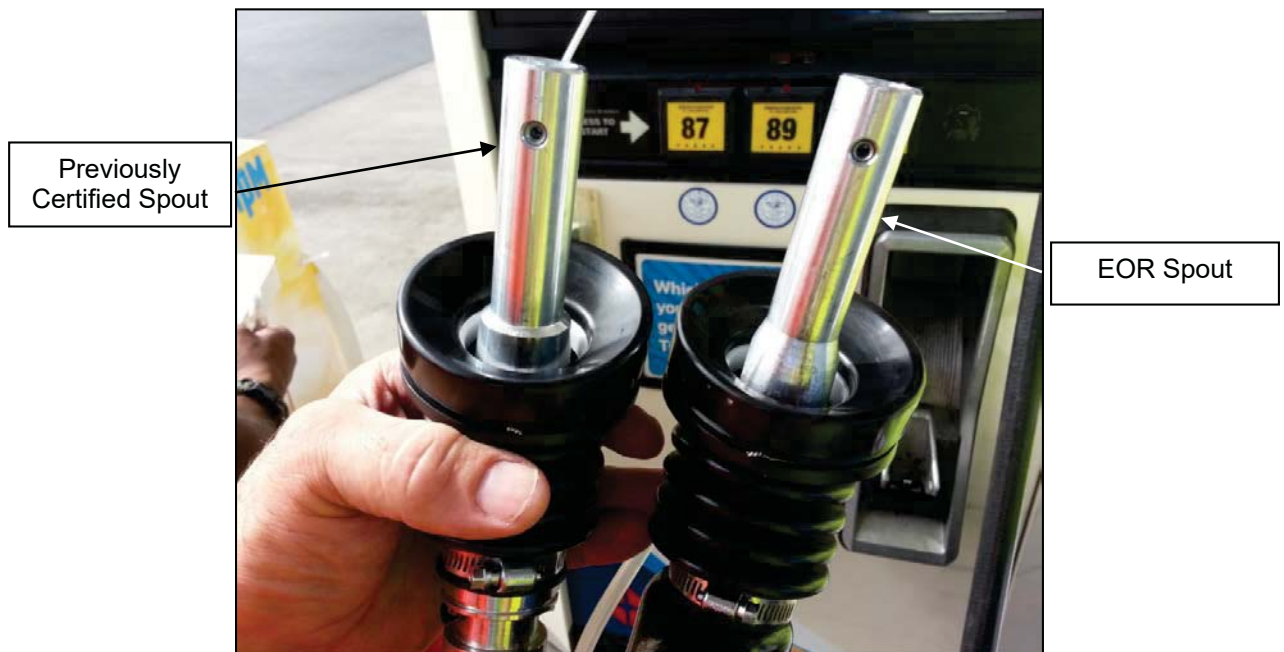
**Figure 2: EOR and Previously Certified Spout Assembly (vertical view)**
