Subject: 2026 Carbon Media Vessel Evaluation Report – Supplemental Report, Chiquita Canyon Landfill

**LABORATORY NUMBER: 260190A**

**Subject: H2S Tank Failure**

## **ENGINEERING ANALYSIS**

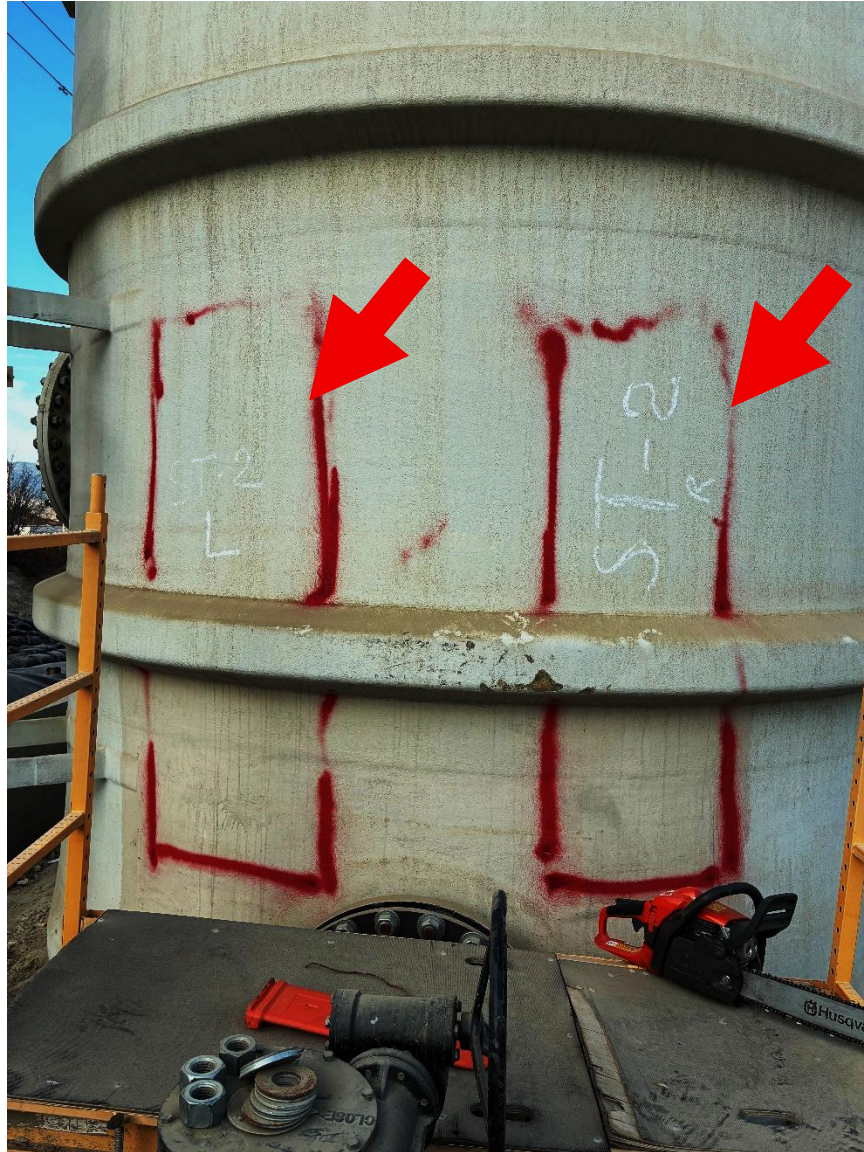
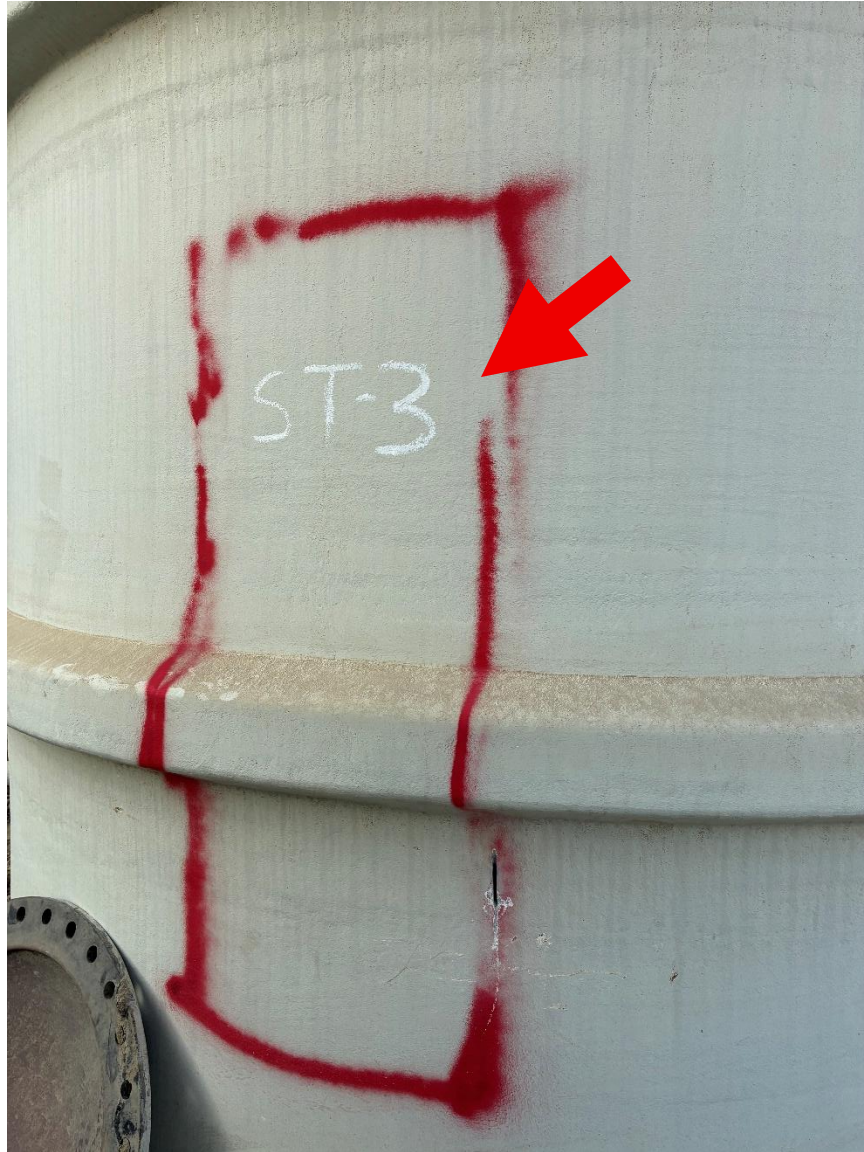
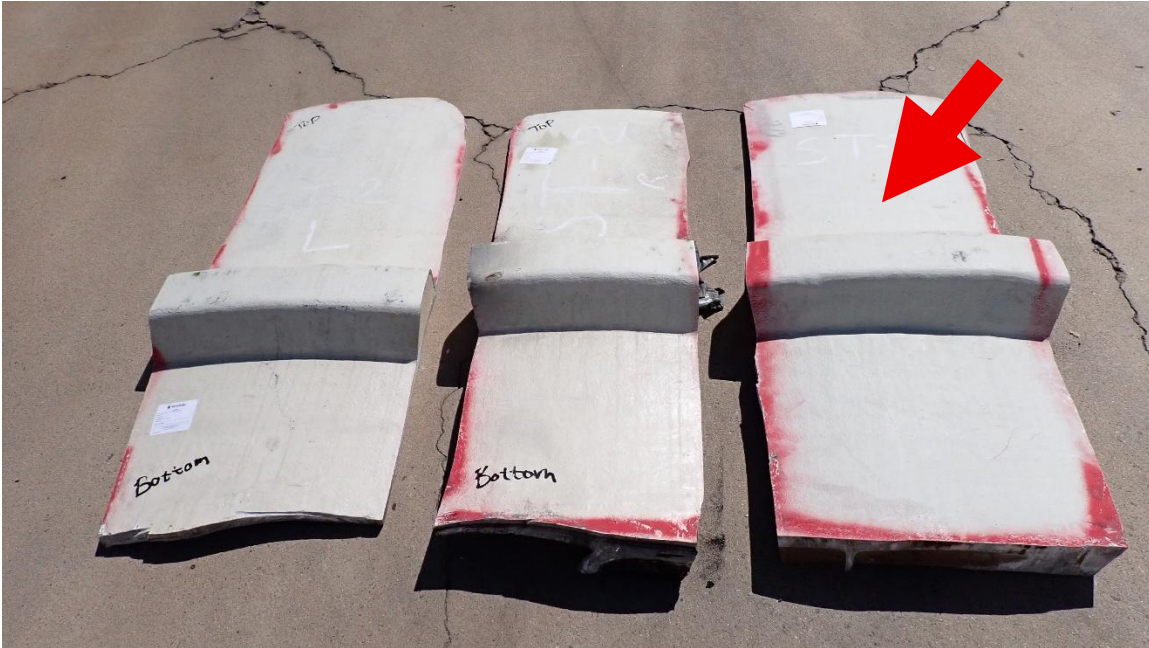
One section of tank 3 and two sections of tank 2 were sectioned and submitted for evaluation, as shown in Figures 1, 2 and 3. The sections were labeled ST 3, ST 2L and ST 2R, as shown in Figures 4, 5 and 6. There were black residues on the inner surface of the all the tank sections, as shown in Figure 7. Samples of the black residues were removed from each tank section for further evaluation, as shown in Figure 8.

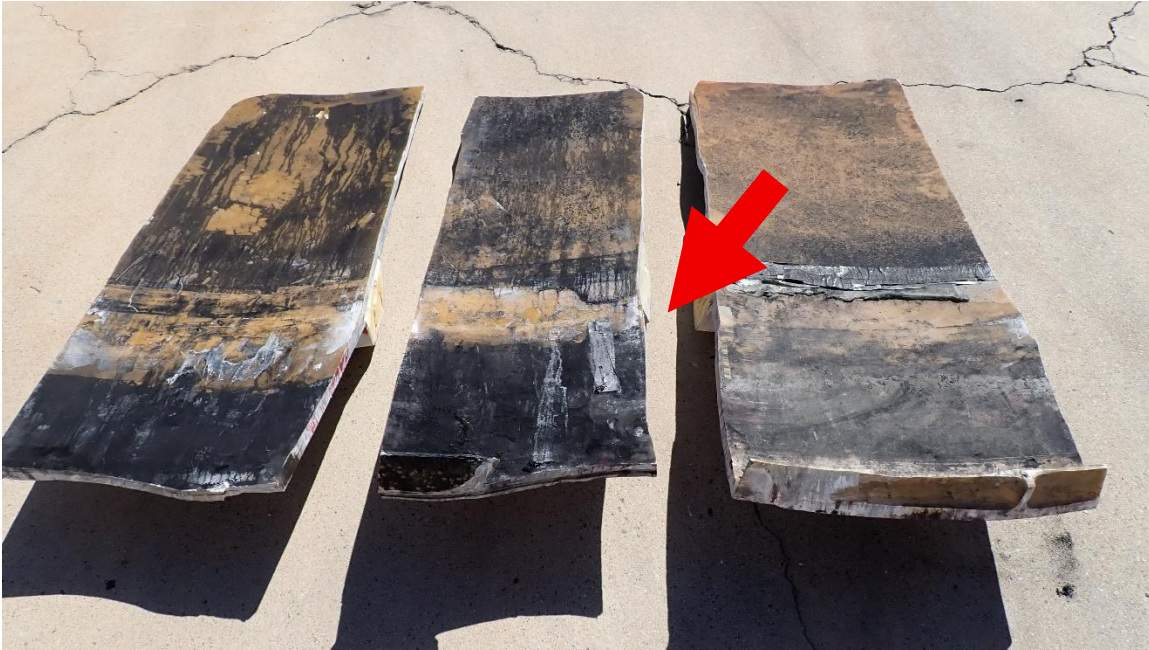
Figure 7

The residues on the inner surface of the tank had carbon and sulfur concentrations, which would be expected in a H<sub>2</sub>S tank where sulfur is being converted from H<sub>2</sub>S to sulfur.

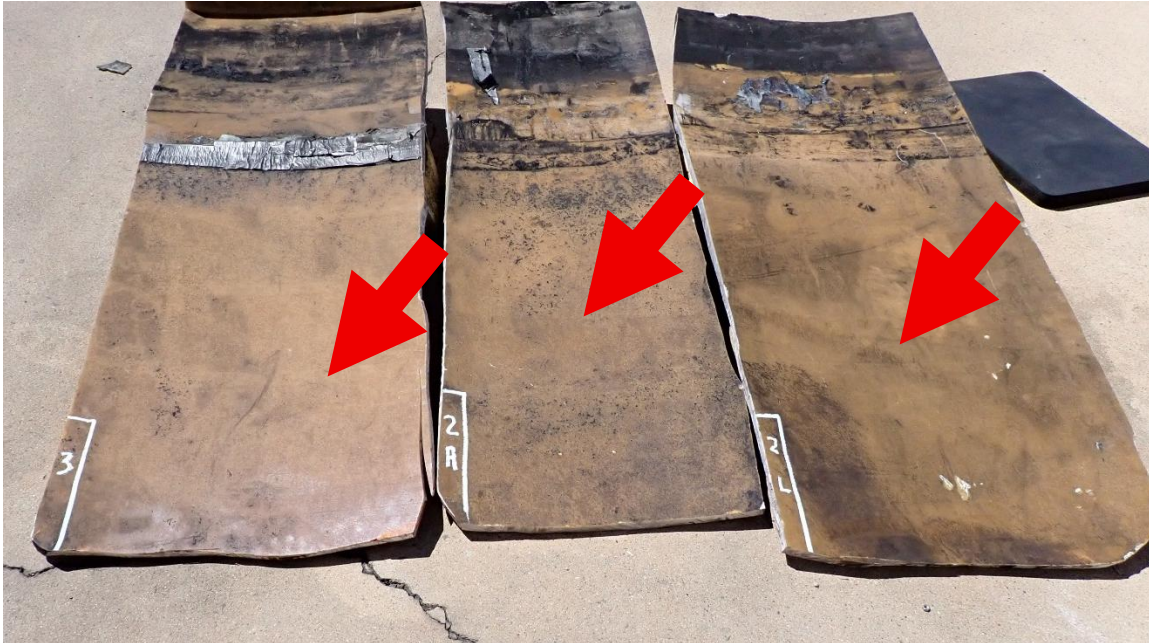
Figure 9

The inner surface of the tanks were power washed. The polymer surface of the inner surface of the tank section were brown in color, as shown in Figure 9. A piece of each tank section was removed and polished for evaluation, as shown in Figures 10 through 16. The tank thicknesses varied from 0.978 to 1.035 inches as follows:

The brown coloration on the inner surface of the tank suggests oxidation from elevated temperatures. The OIT tests confirmed that. No chemical degradation was noted to the tank material.

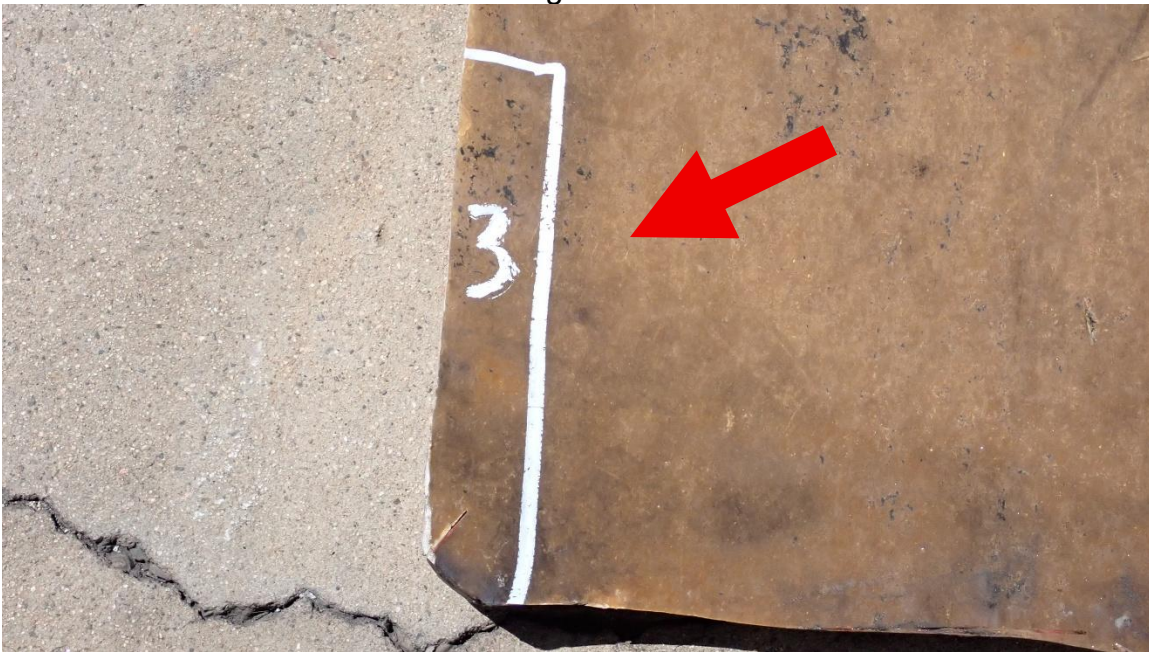
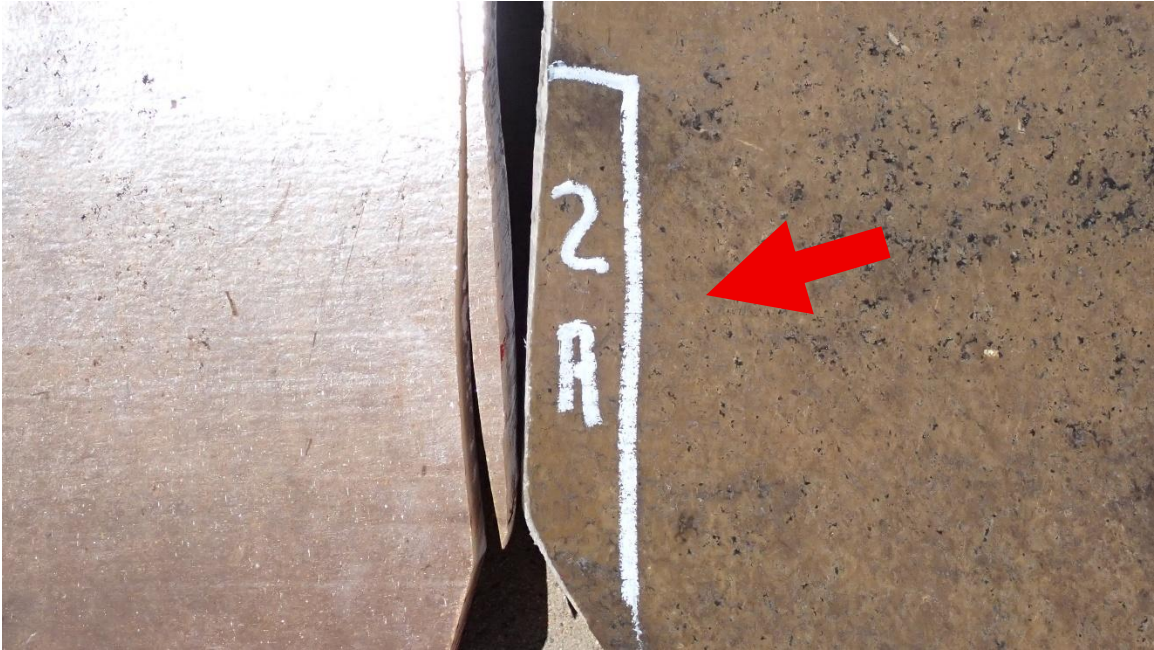
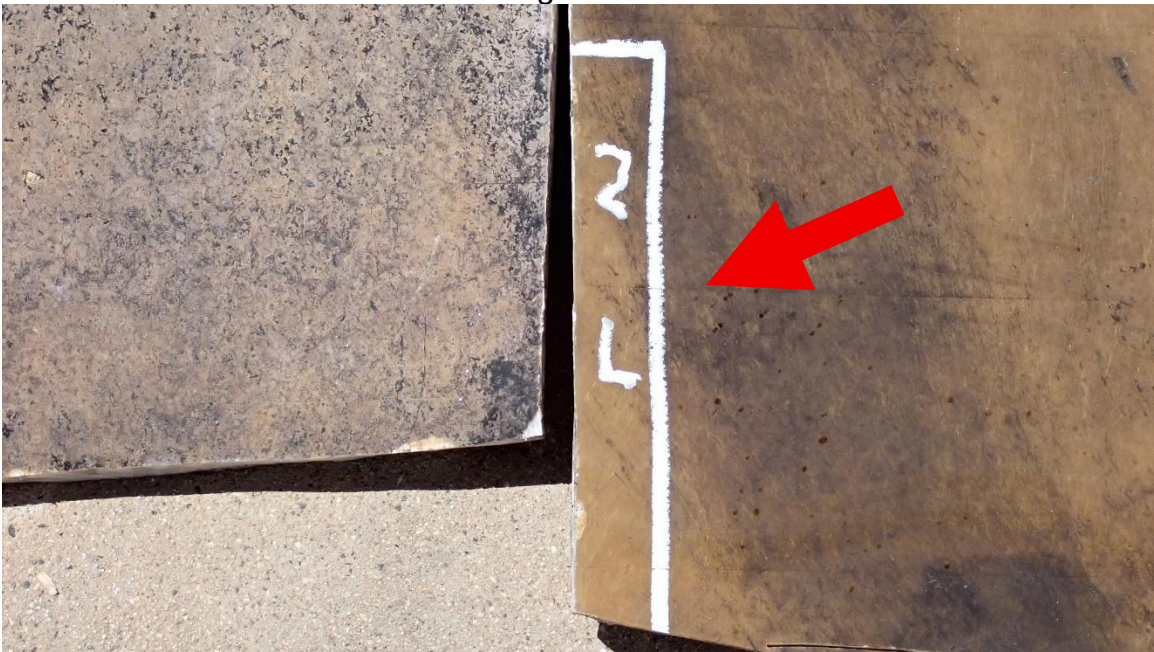
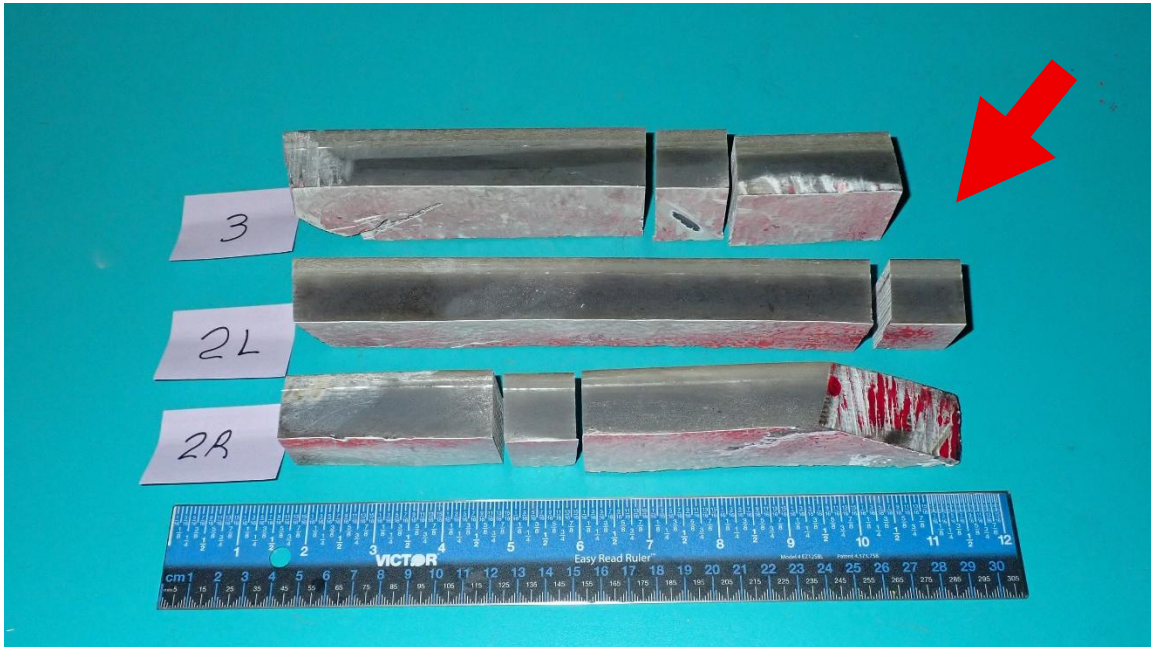
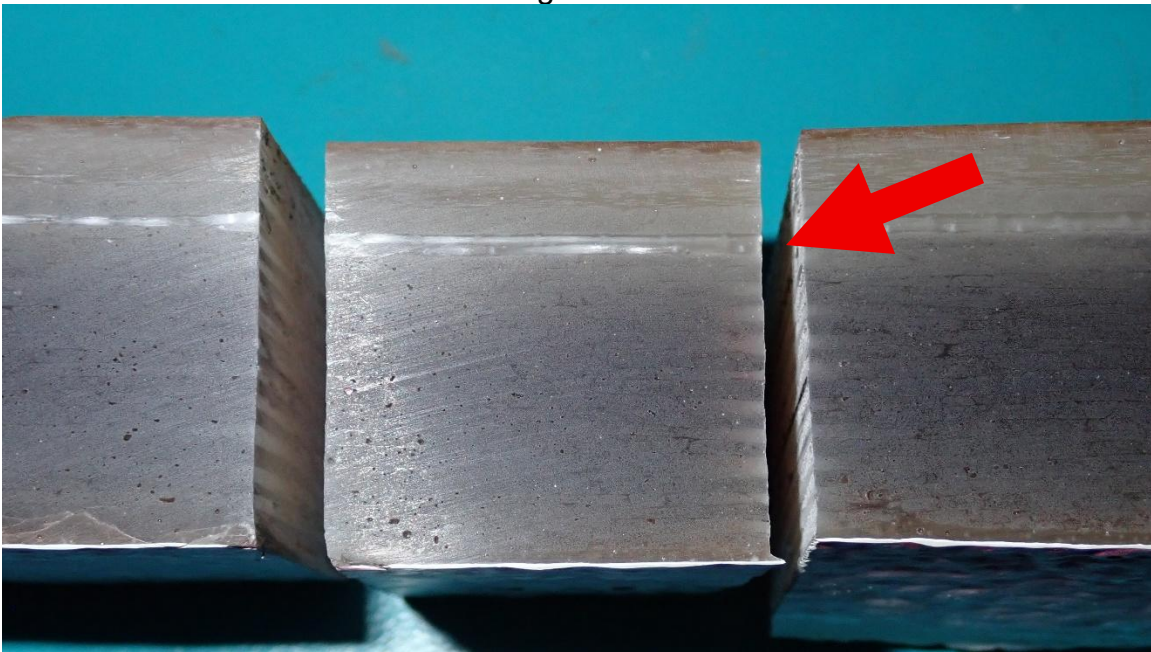
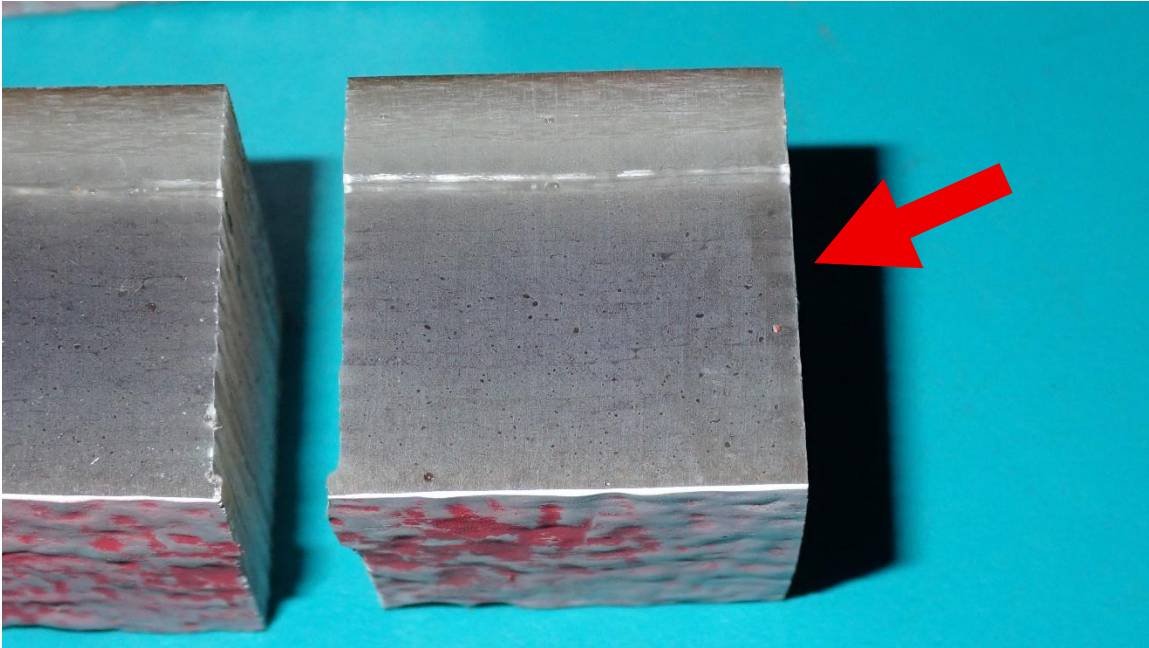
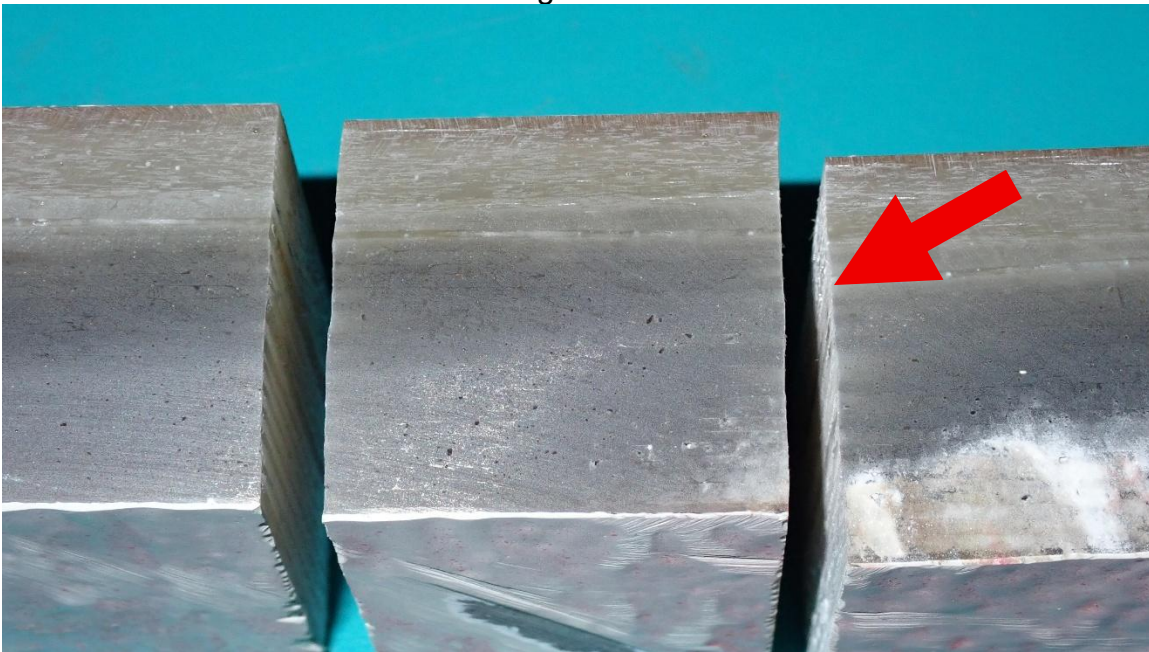
- Tank 2L: 0.988 inches
- Tank 2R: 0.978 inches
- Tank 3: 1.035 inches

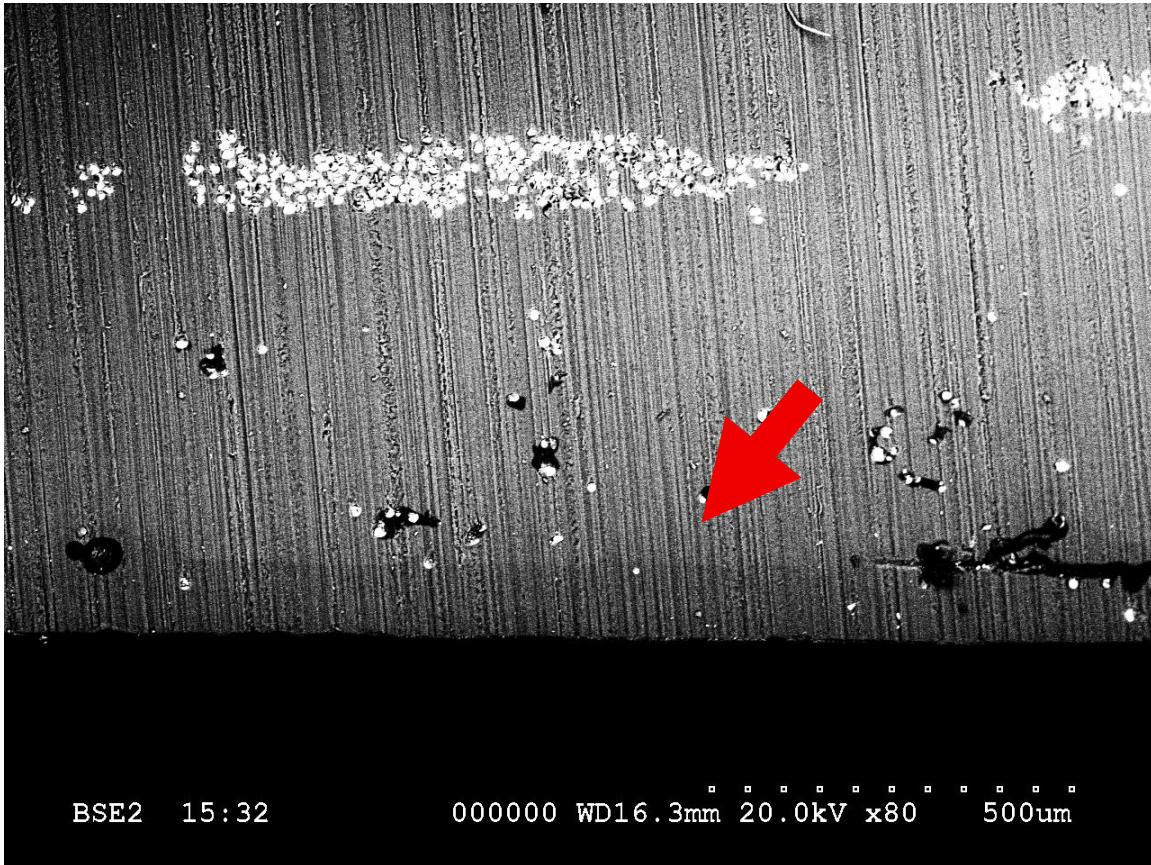
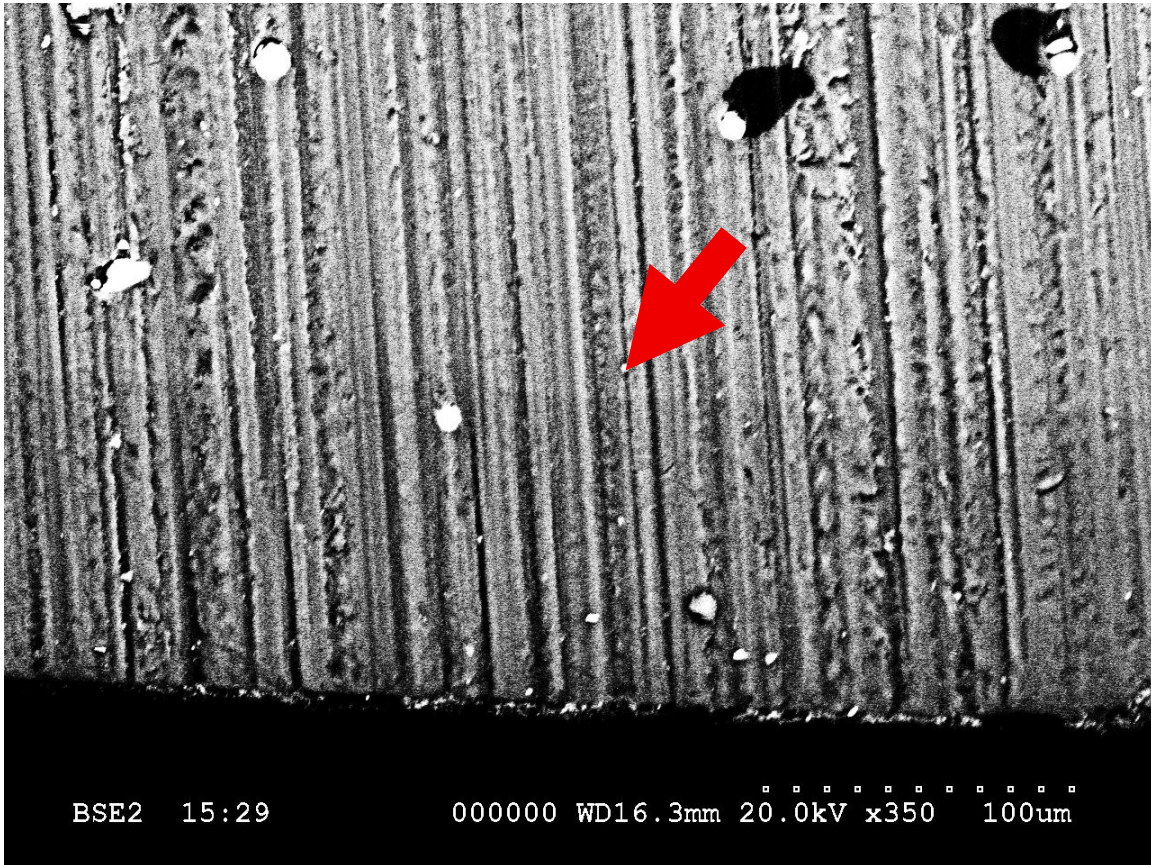
Scanning electron microscopy (SEM) analysis of tank 2L revealed a layer of degradation approximately 100 um deep, as shown in Figures 17 and 18. There was good adhesion of the laminate layers to each other and of the fibers to the matrix, as shown in Figures 19 , 20 and 21.

It was reported that the tanks had been misidentified. The sample identified as tank 3 was actually tank 2 (the failed tank) and the two samples identified as tank 2 were actually from tank 3. A review of SEM images revealed that tank 2 (the failed tank) had about twice the depth of oxidation as the tank 3 consistent with either being exposed to higher temperatures/longer times or both. The fiber glass layers of both tanks had good adhesion to the substrate with no obvious defects except some porosity which would be expected.

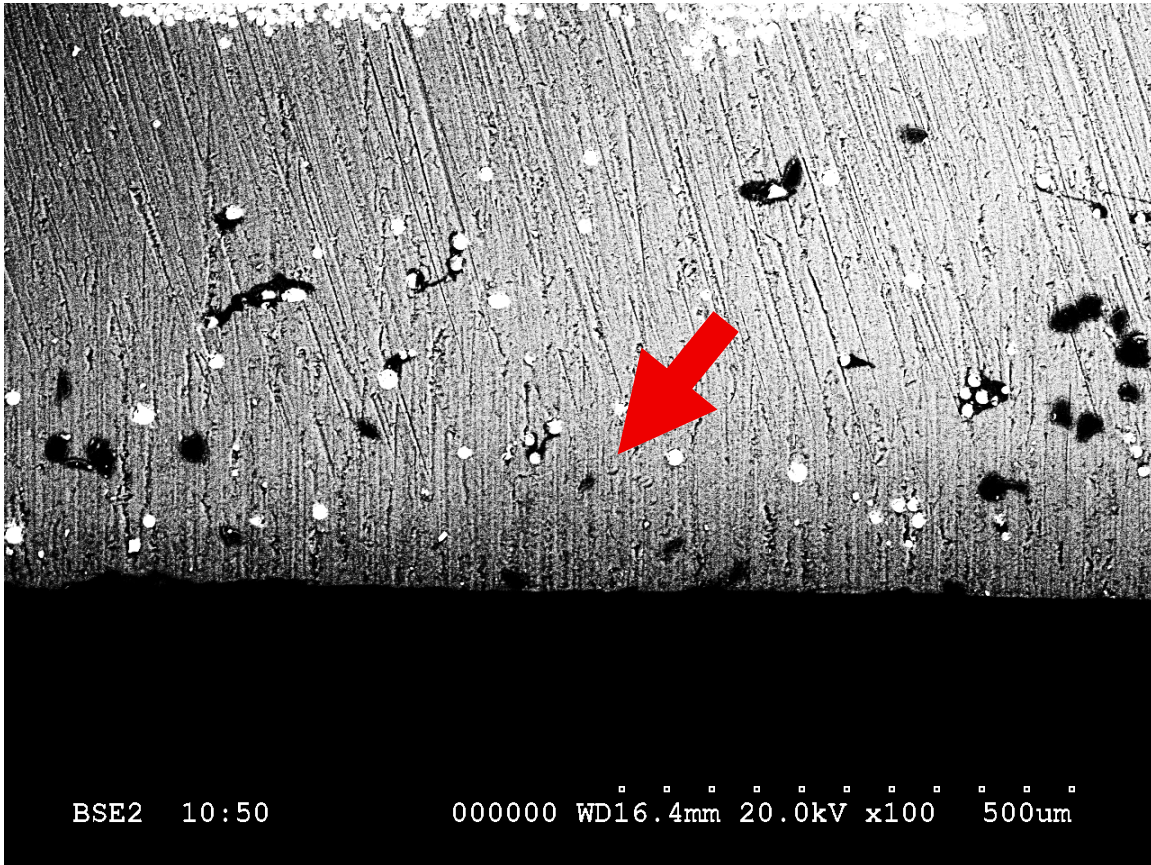
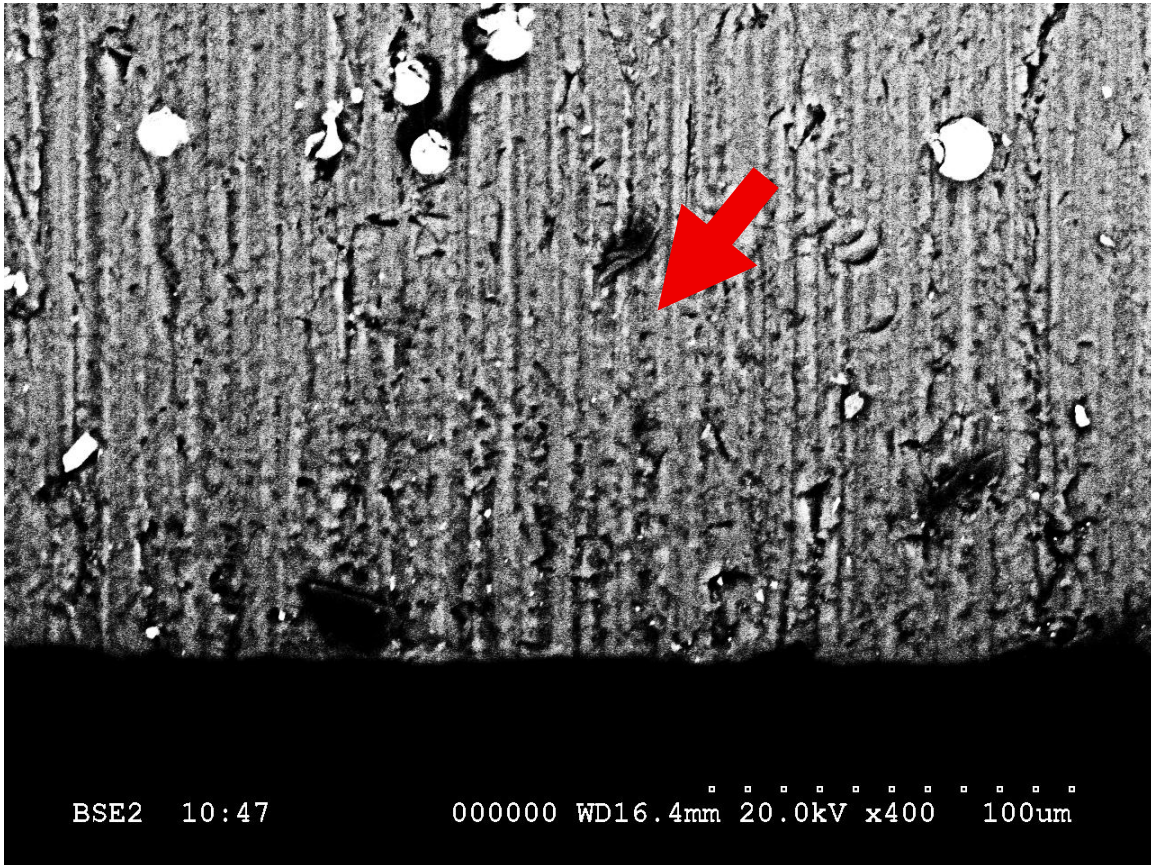
SEM analysis of tank 2R revealed a layer of degradation approximately 70 um deep, as shown in Figures 22 and 23. There was good adhesion of the laminate layers to each other and of the fibers to the matrix, as shown in Figures 24, 25 and 26.

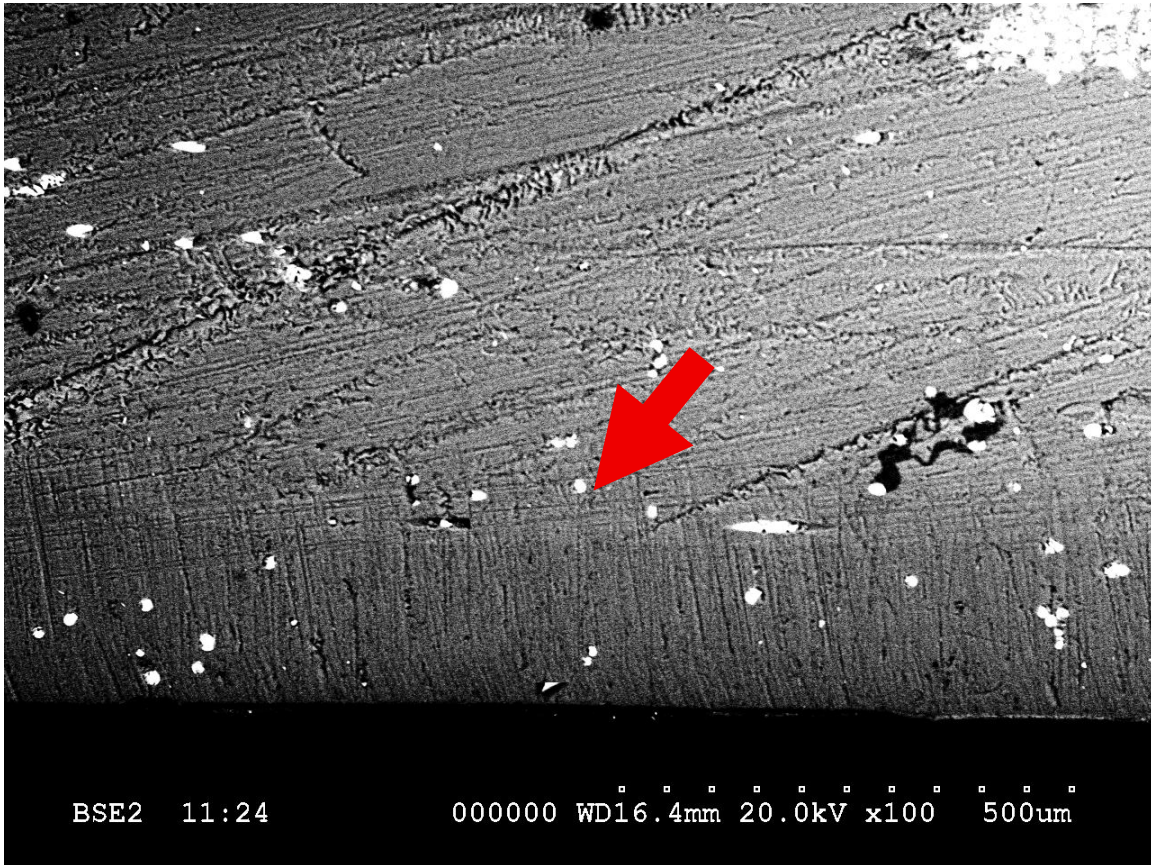
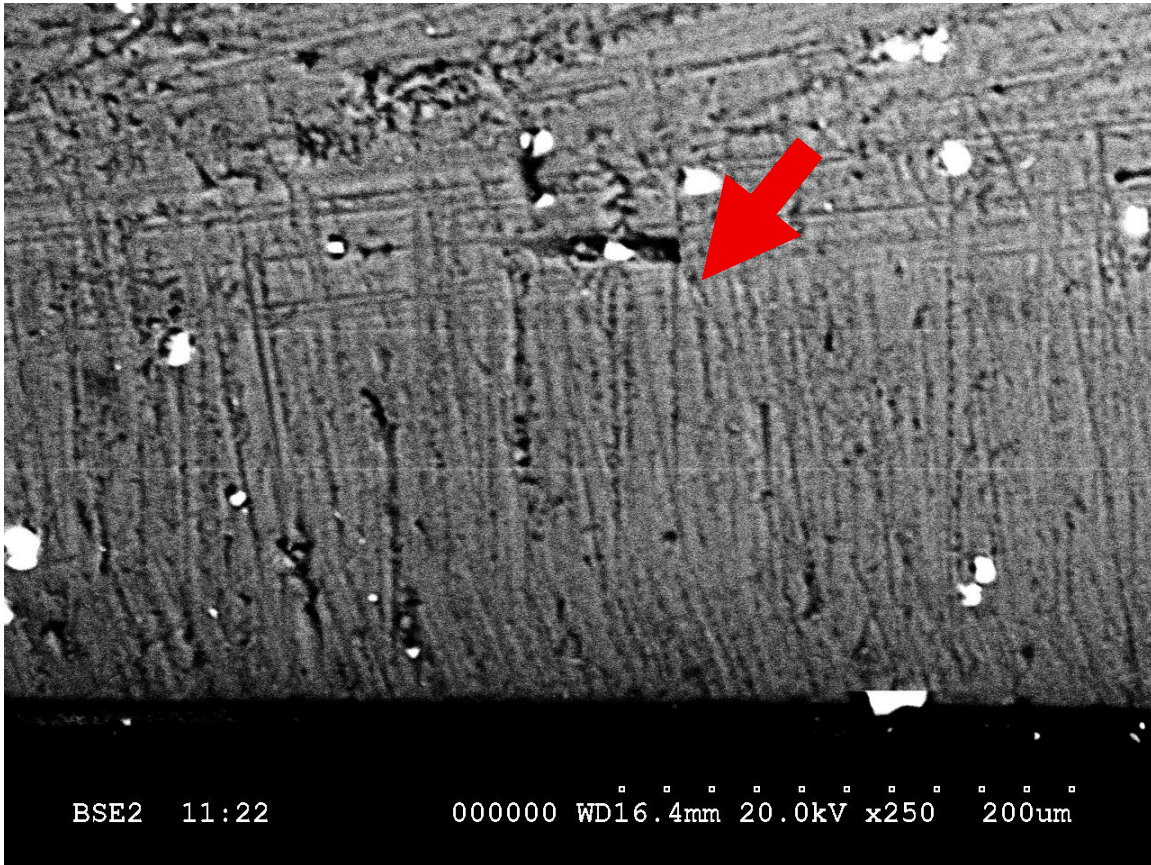
SEM analysis of tank 3 revealed a layer of degradation approximately 200 um deep, as shown in Figures 27 and 28. There was good adhesion of the laminate layers to each other and of the fibers to the matrix, as shown in Figures 29, 30 and 31. The glass fibers were approximately 10 -14 um in all the samples.

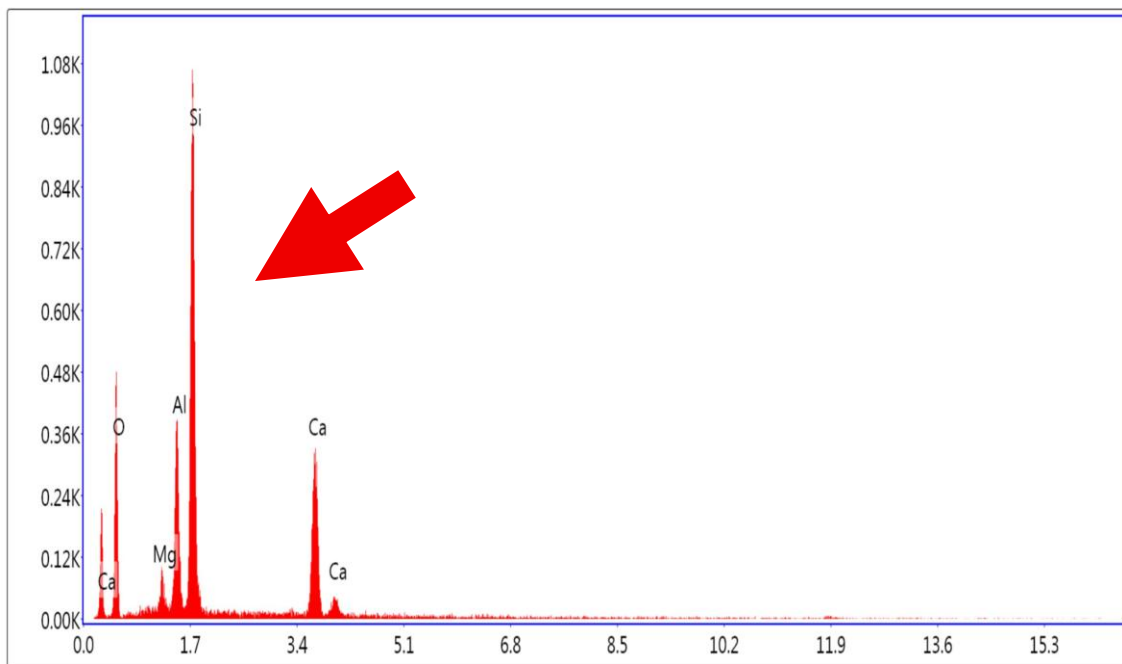
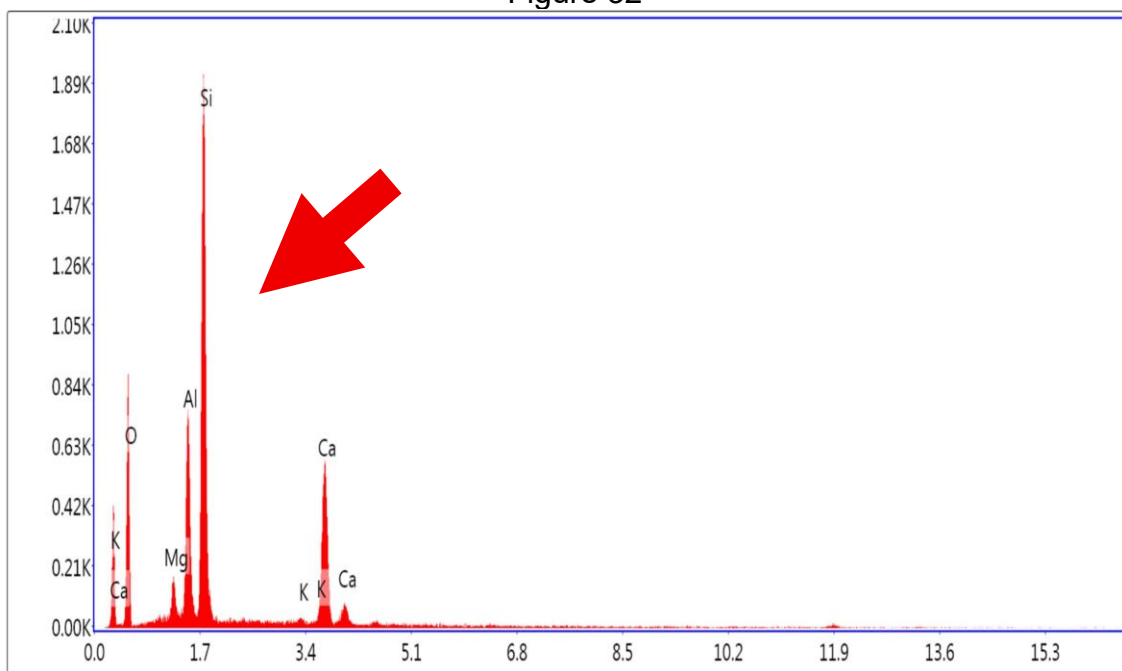
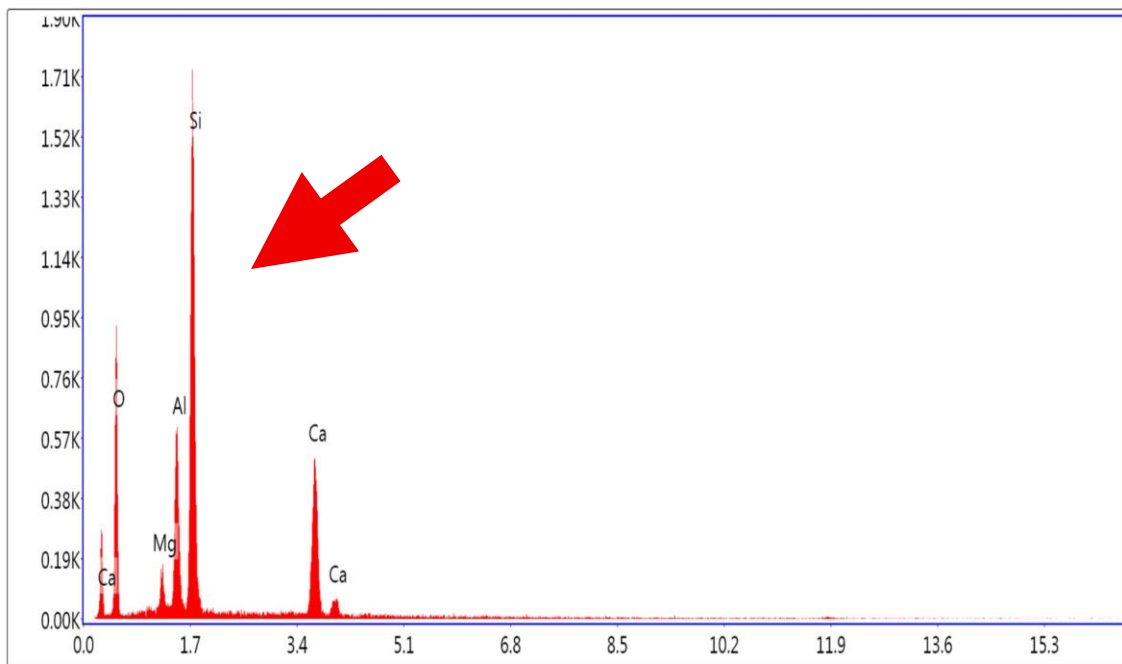
Energy dispersive x-ray spectroscopy (EDS) confirmed the fibers from each tank section were primarily silicon consistent with being glass fibers, as shown in Figures 32, 33 and 34. EDS analysis of the black residues from each tank sample

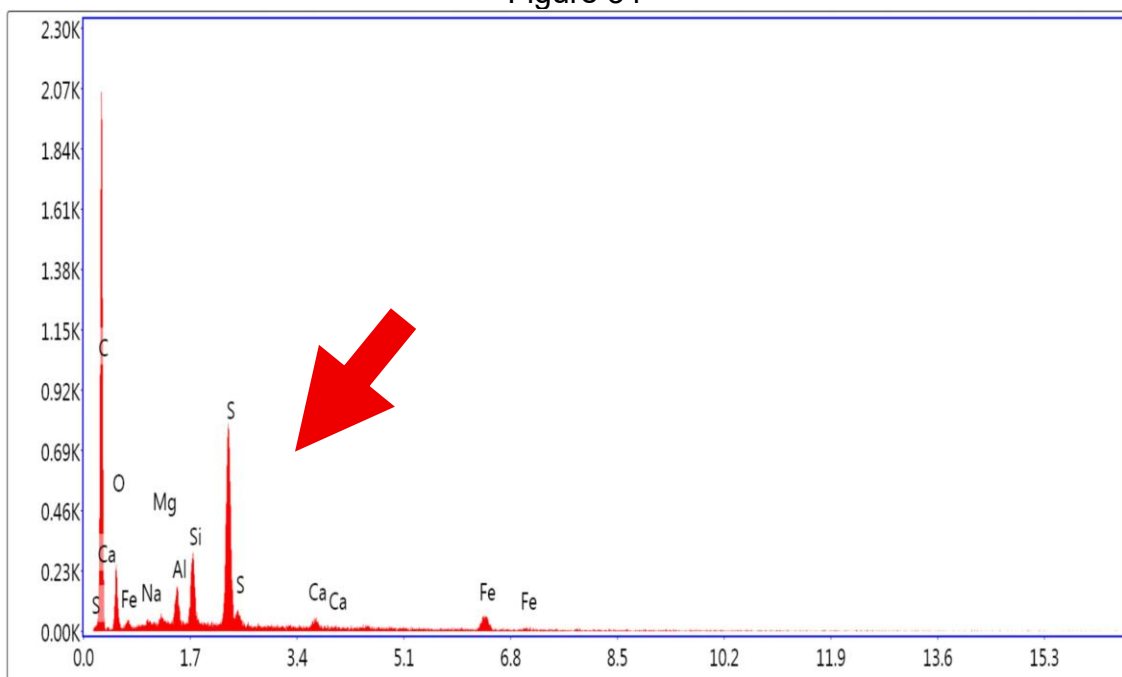
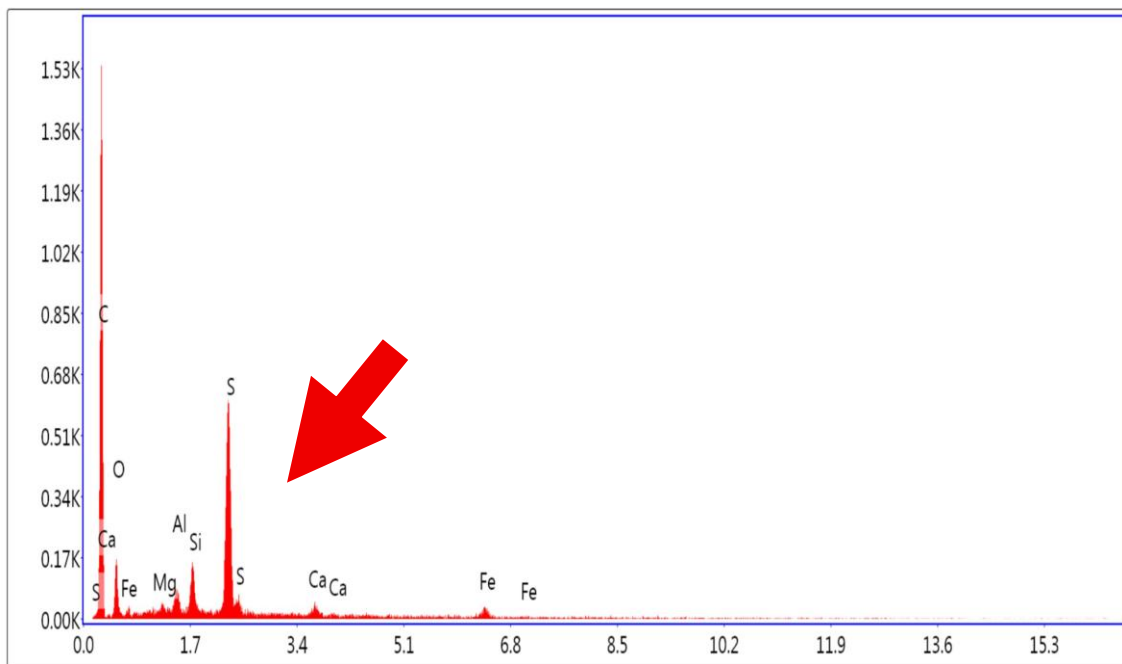
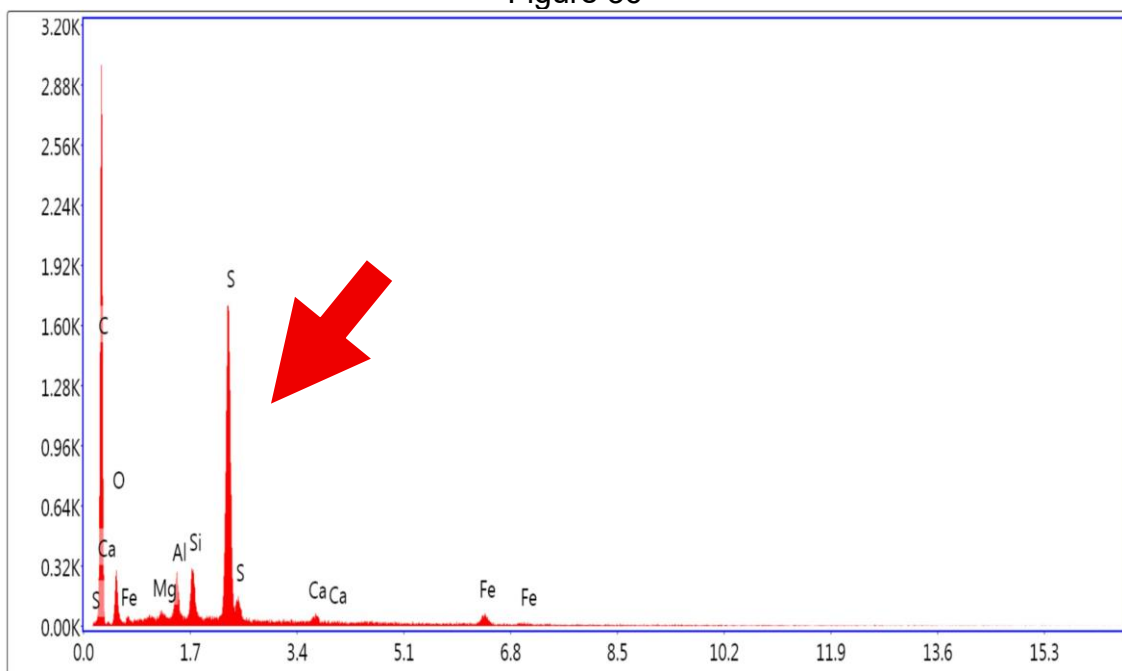
revealed high concentrations of carbon and sulfur, as shown in Figures 35, 36 and 37.
