December 29, 2025

POST-EXCEEDANCE AIR MONITORING INVESTIGATION MS-04, DECEMBER 22-23, 2025 – STIPULATED ORDER FOR ABATEMENT CONDITION NO. 34(d)

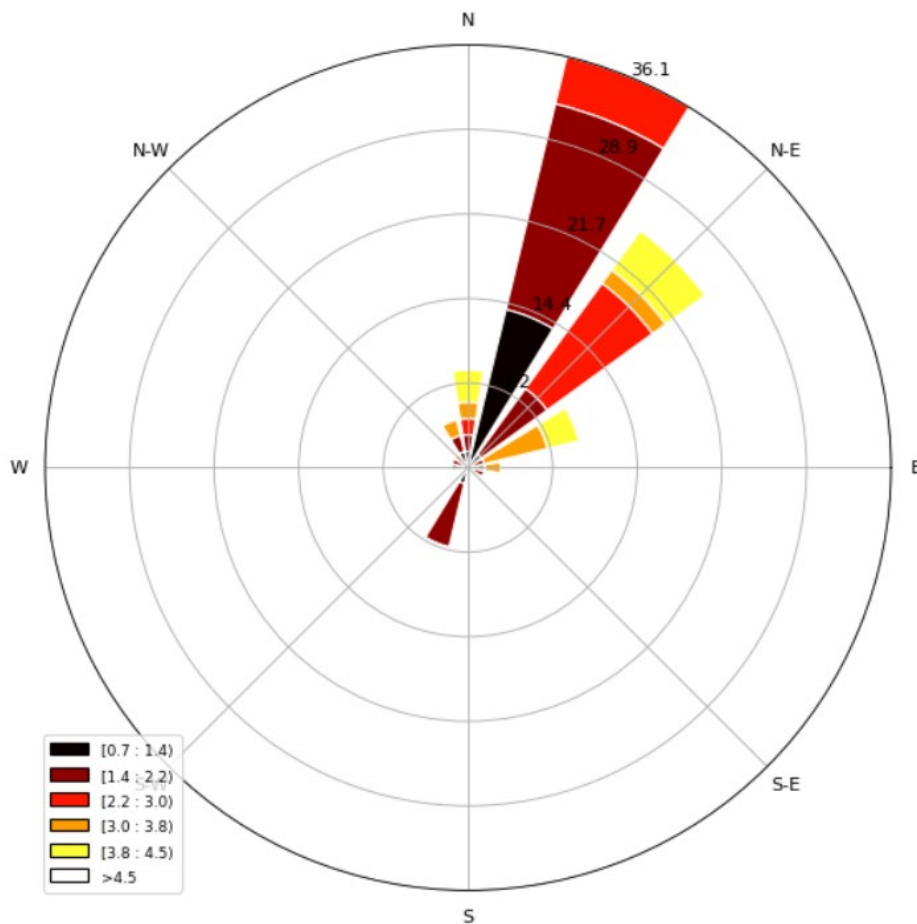
Figure 2. Wind Rose for MS-04, December 22-23, 2025, 8 PM through 4 AM

Wind data suggests that the air monitoring unit was not directly downwind from the Landfill during the time prior to and during the exceedance event although wind speeds were generally very low, indicating limited air mixing and dispersion likely occurred.

As shown in **Figure 2** above, winds were generally observed to be coming from the northwest and north-northwest. As such, additional data review was conducted at MS-07, located south-west of MS-04. Analysis indicates no strong trend observed at MS-07 during the time of the REL exceedance. This suggests that the measured constituents were mainly located near MS-04, which is the nearest station to the reaction area.

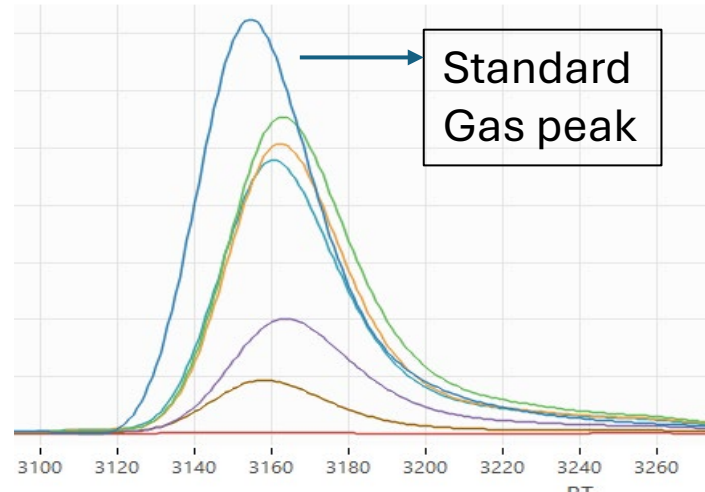
Dec 22 , MS04 – Benzene reading

Sampling Start Time	Benzene
12/22/2025 20:00	0.47 ppb
12/22/2025 21:00	11.14 ppb
12/22/2025 22:00	9.67 ppb
12/22/2025 23:00	4.23 ppb
12/23/2025 0:00	1.64 ppb
Calibration time	Calibration
12/23/2025 4:00	9.41 ppb

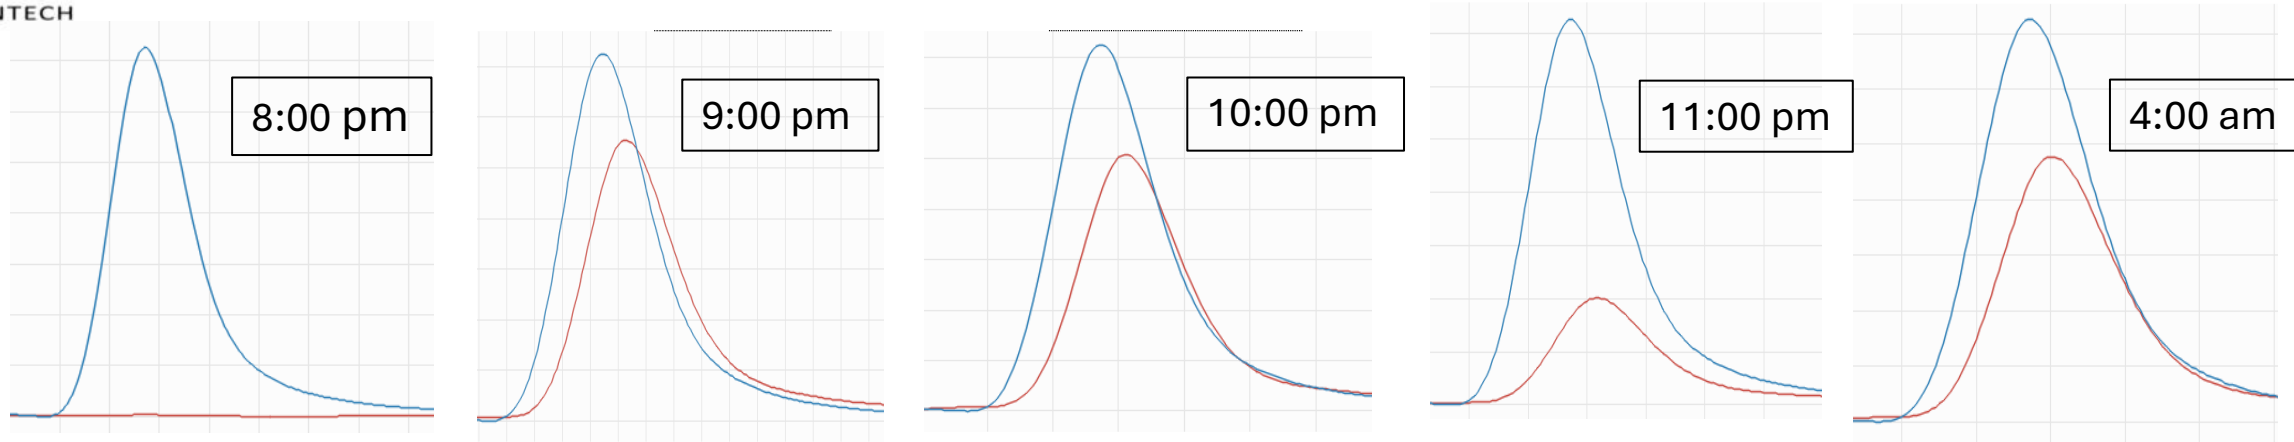
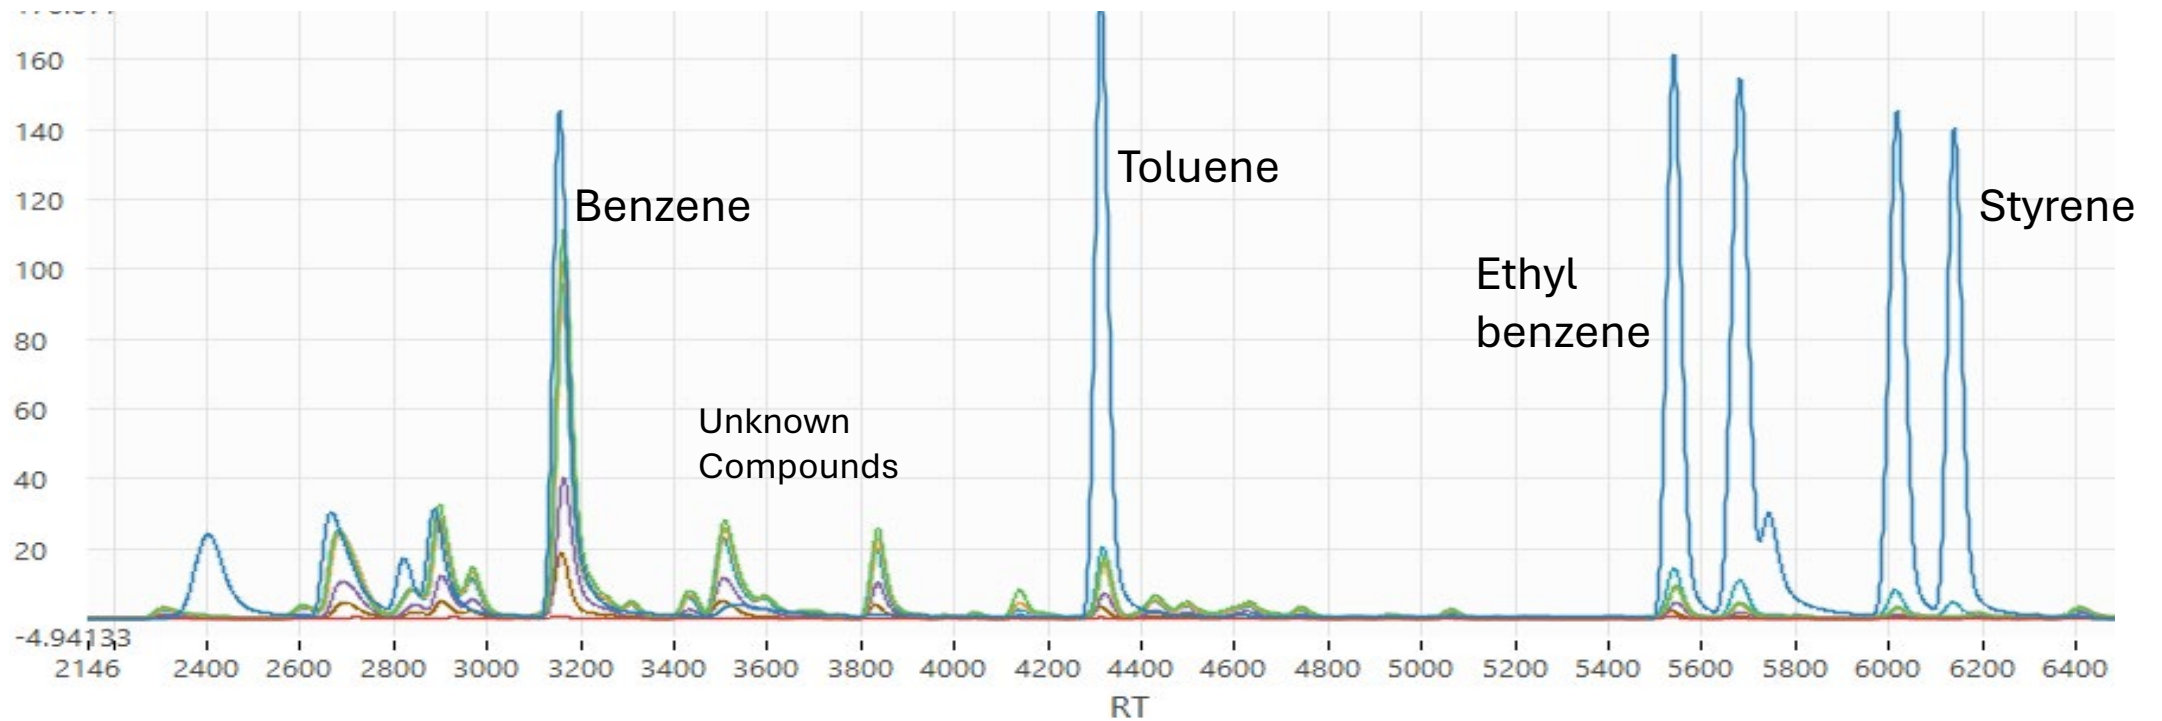
MS04 – Benzene Environmental sample signals

Hourly environmental benzene responses show strong correlation with recent calibration standards.

Chromatographic retention and peak characteristics are consistent with calibration benchmarks.

All benzene data recorded at MS04 are valid, reliable, and representative of environmental conditions, with no evidence of analytical or operational anomalies.
