Waste Connections - Chiquita Canyon Landfill  
Project: 2026 10 Week 43 Emission Study  
Job: Non-Compliance Emission Study  
Report Submitted Oct 21, 2026

## Emission Study Daily Peaks Verification Report

Waste Connections - Chiquita Canyon Landfill  
Project: 2026 10 Week 42 Emission Study  
Job: Non-Compliance Emission Study  
Report Submitted Oct 15, 2026

Waste Connections - Chiquita Canyon Landfill  
Project: 2026 10 Week 41 Emission Study  
Job: Non-Compliance Emission Study  
Report Submitted Oct 8, 2026

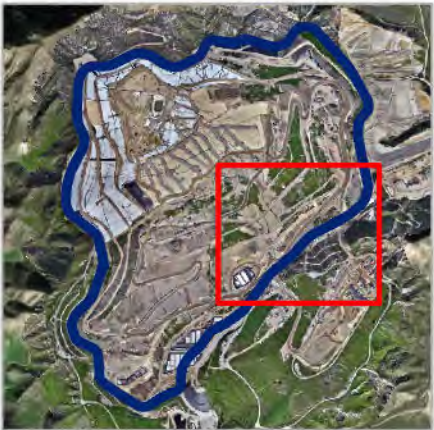
# Peak Verification Map

This map provides an overview of all increased meter readings of methane, or "Drone Flight Peaks", over the course of the inspection and the manual verification measurements taken at each peak.

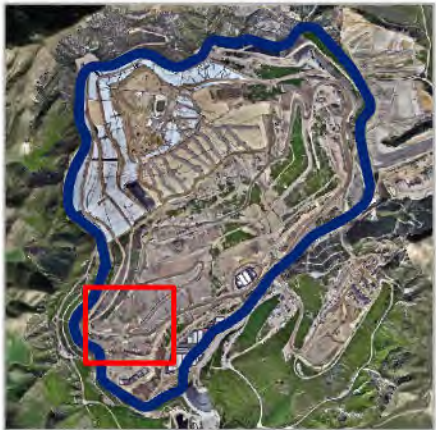
# Peak Verification Map

This map provides an overview of all increased meter readings of methane, or "Drone Flight Peaks", over the course of the inspection and the manual verification measurements taken at each peak.

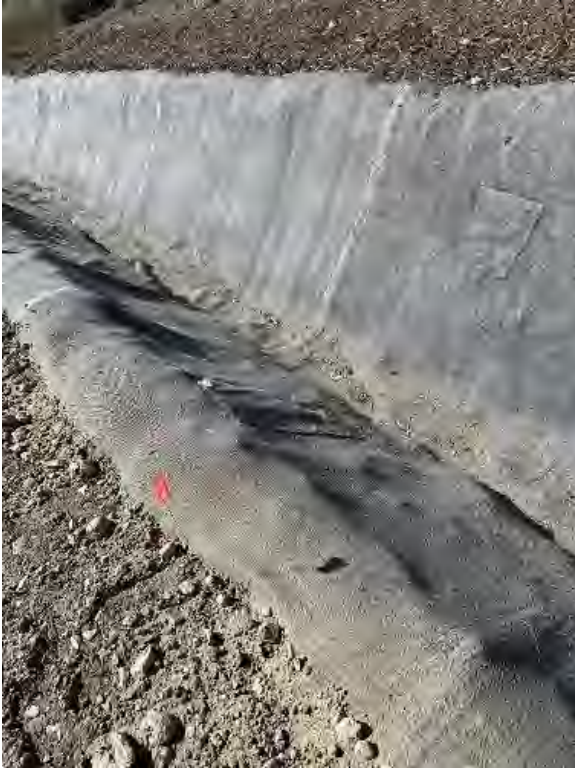
1. SnifferDRONE Verification

| LOCATION DETAILS | | | | | | INSPECTION RESULTS | | | | | | |
|---|---|---|---|---|---|---|---|---|---|---|---|---|
| 1 | 34.432480 | -118.643006 | 34.432476 | -118.643002 | Patch in trench | 10/20/2026 | 19:23 | 216 | 10/20/2026 | 19:45 | 1,000 | |

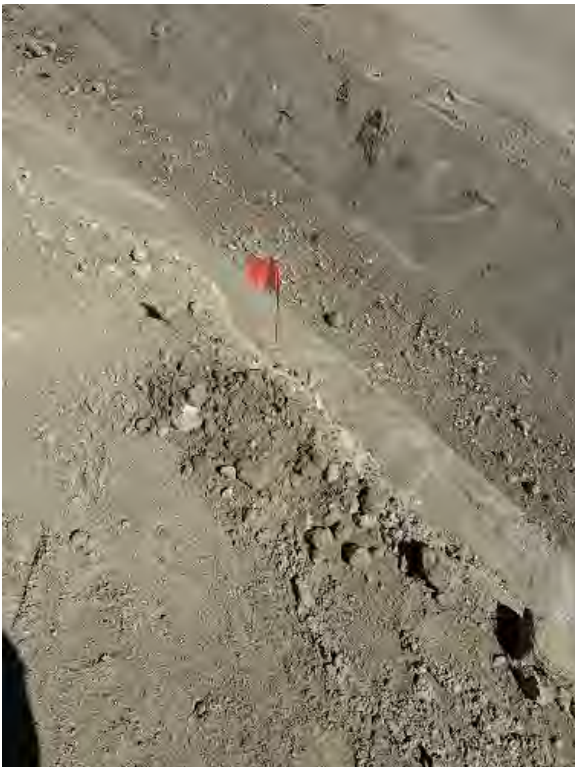
3. SnifferDRONE Verification

| LOCATION DETAILS | | | | | | INSPECTION RESULTS | | | | | | |
|---|---|---|---|---|---|---|---|---|---|---|---|---|
| 3 | 34.430387 | -118.644741 | 34.43043973 | -118.644736 | Trench | 10/20/2026 | 20:03 | 483 | 10/20/2026 | 20:32 | 1,000 | |

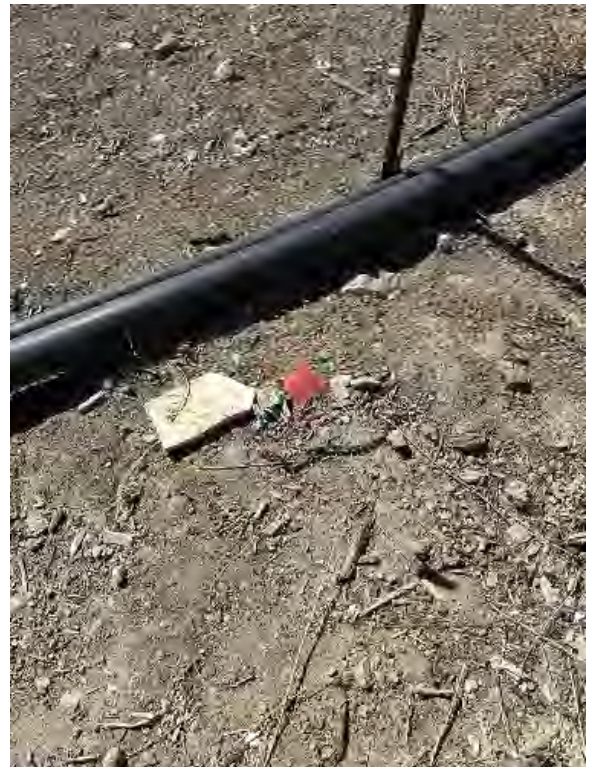
4. SnifferDRONE Verification

| LOCATION DETAILS | | | | | | INSPECTION RESULTS | | | | | | |
|---|---|---|---|---|---|---|---|---|---|---|---|---|
| 4 | 34.429228 | -118.649703 | 34.42912571 | -118.649745 | | 10/20/2026 | 17:44 | 284 | 10/20/2026 | 18:12 | 900 | |

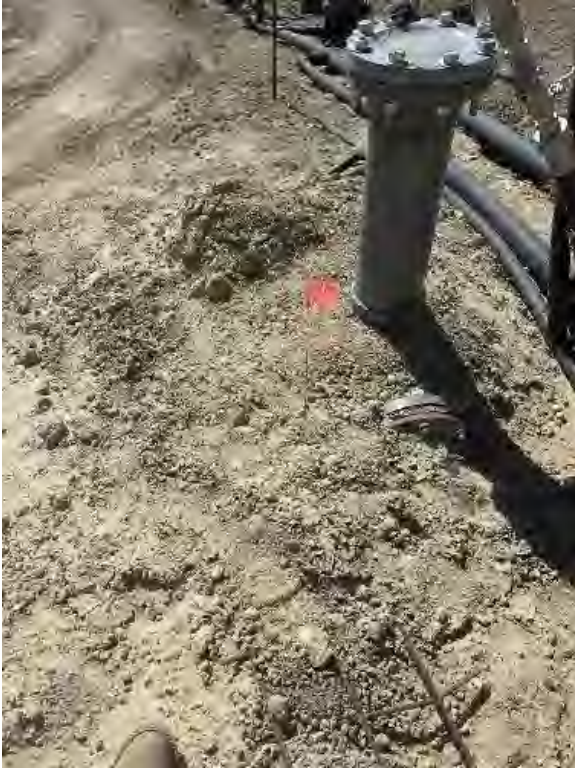
5. SnifferDRONE Verification

| LOCATION DETAILS | | | | | | INSPECTION RESULTS | | | | | | |
|---|---|---|---|---|---|---|---|---|---|---|---|---|
| 5 | 34.431355 | -118.644862 | 34.43132637 | -118.644765 | | 10/20/2026 | 20:07 | 1,311 | 10/20/2026 | 20:21 | 700 | |

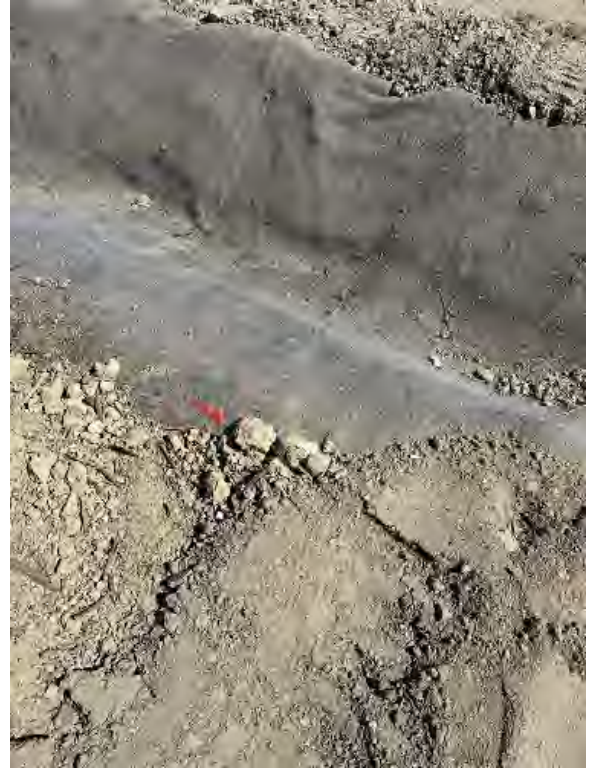
6. SnifferDRONE Verification Edge of tr...

| LOCATION DETAILS | | | | | | INSPECTION RESULTS | | | | | | |
|---|---|---|---|---|---|---|---|---|---|---|---|---|
| 6 | 34.431727 | -118.643728 | 34.43165528 | -118.643803 | Edge of trench | 10/20/2026 | 20:06 | 1,471 | 10/20/2026 | 20:38 | 600 | |

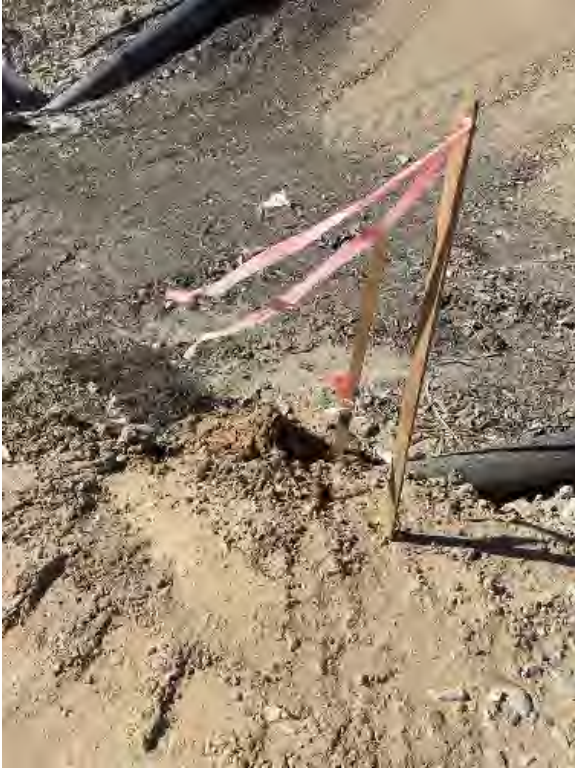
1. SnifferDRONE Verification

| LOCATION DETAILS | | | | | | INSPECTION RESULTS | | | | | | |
|---|---|---|---|---|---|---|---|---|---|---|---|---|
| 1 | 34.431694 | -118.643758 | 34.431582 | -118.644525 | | 10/14/2026 | 20:41 | 791 | 10/14/2026 | 21:06 | 7,000 | |

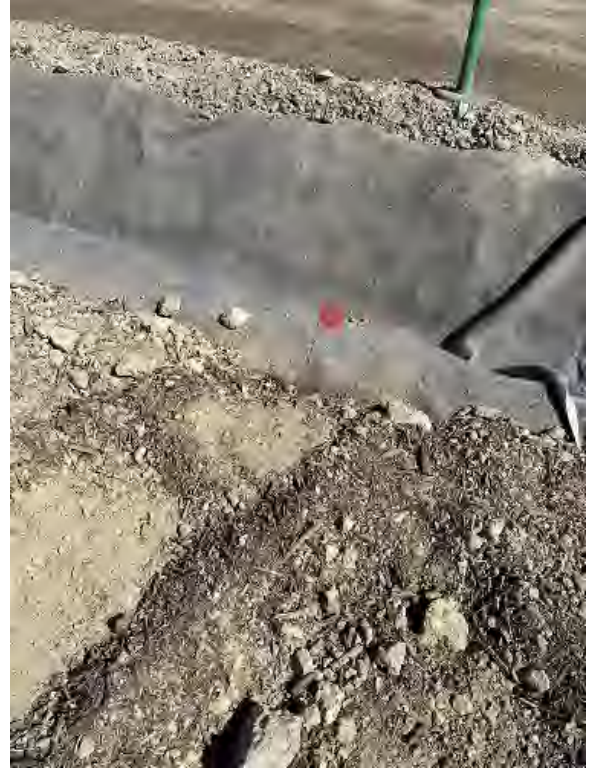
2. SnifferDRONE Verification

| LOCATION DETAILS | | | | | | INSPECTION RESULTS | | | | | | |
|---|---|---|---|---|---|---|---|---|---|---|---|---|
| 2 | 34.431514 | -118.644511 | 34.431636 | -118.643808 | | 10/14/2026 | 20:42 | 373 | 10/14/2026 | 21:22 | 1,000 | |

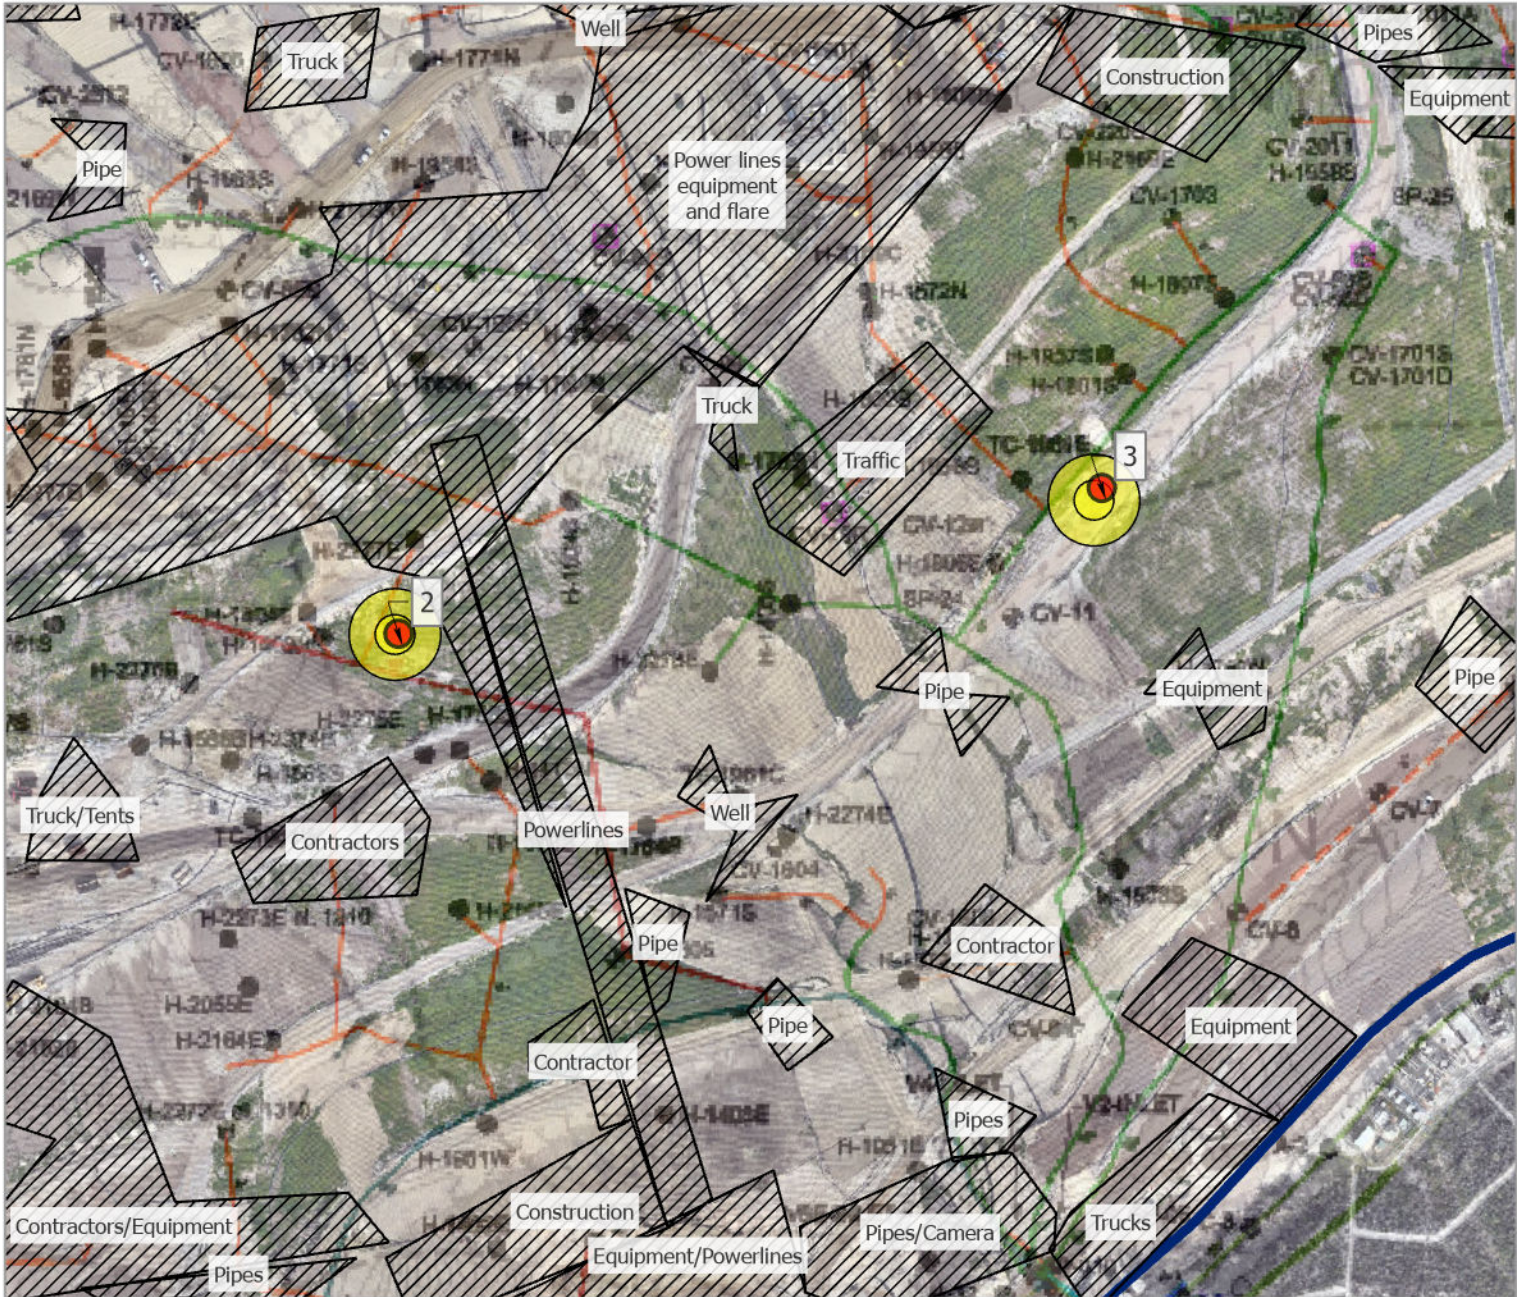
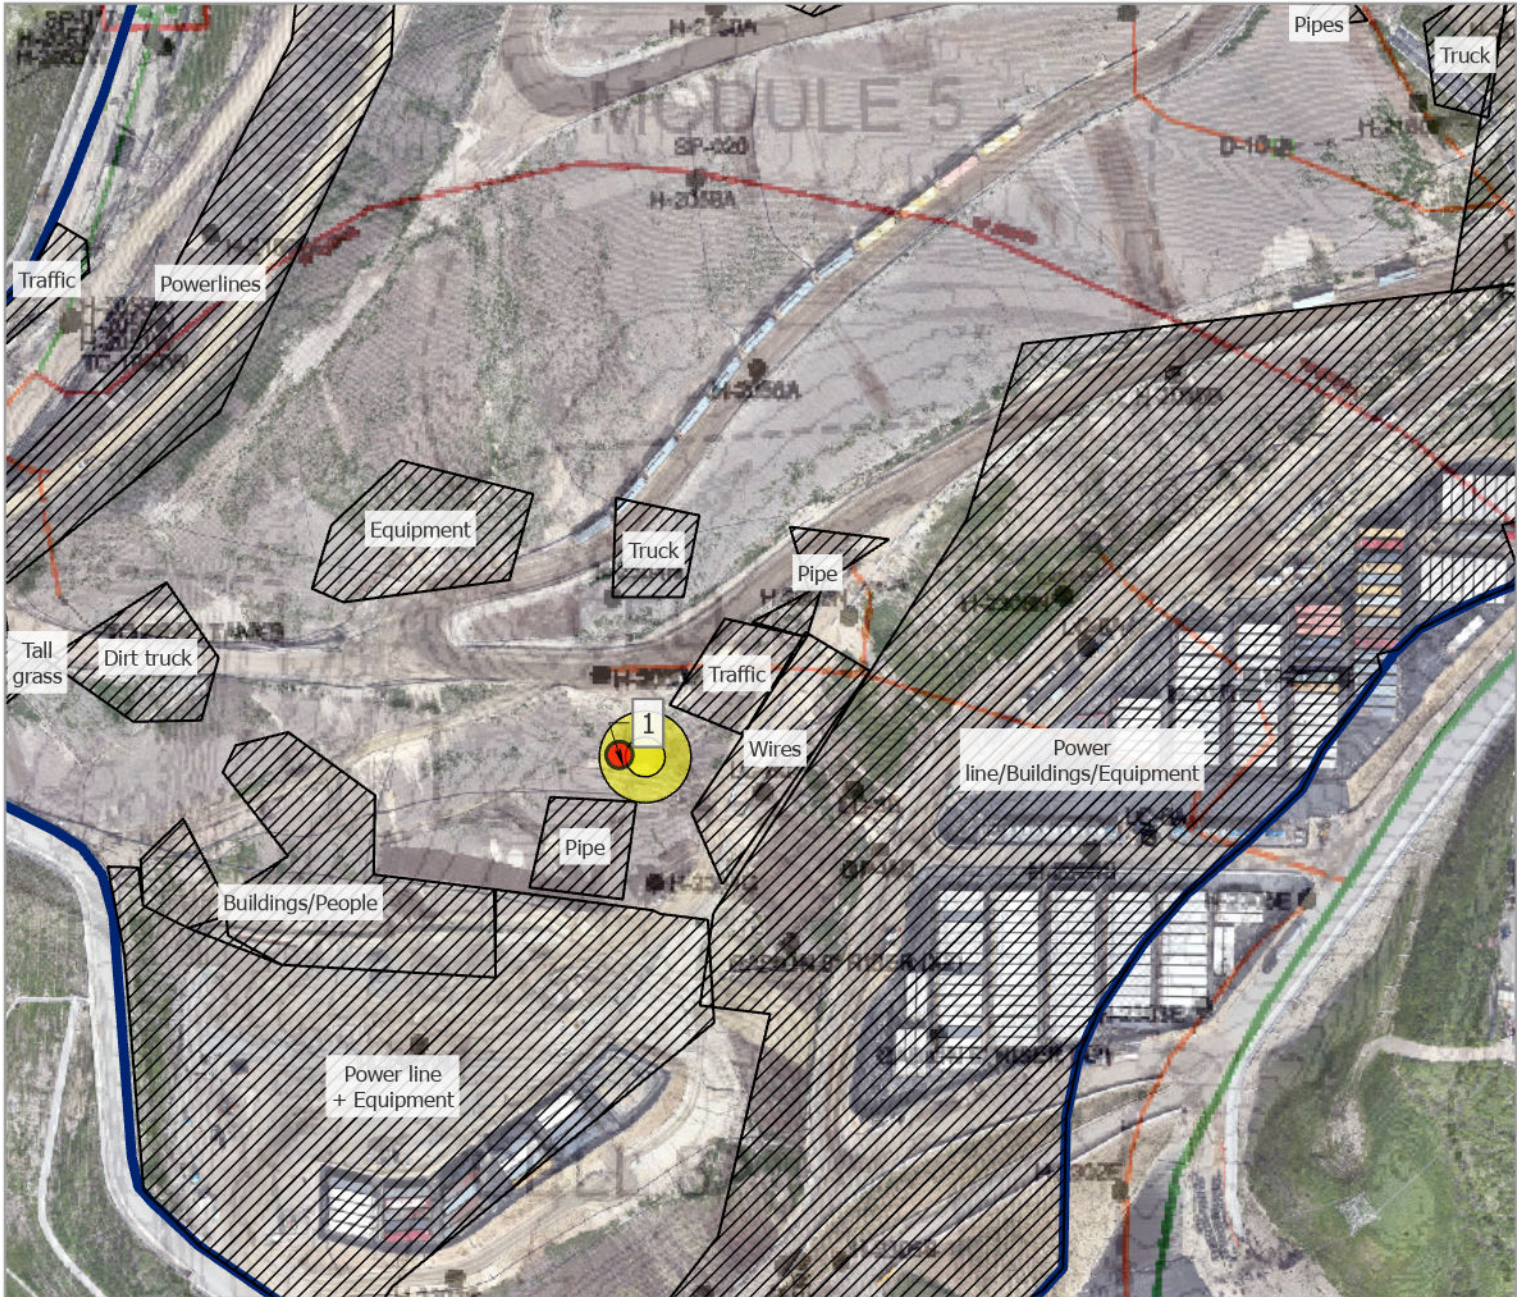
# Peak Verification Map

This map provides an overview of all increased meter readings of methane, or "Drone Flight Peaks", over the course of the inspection and the manual verification measurements taken at each peak.

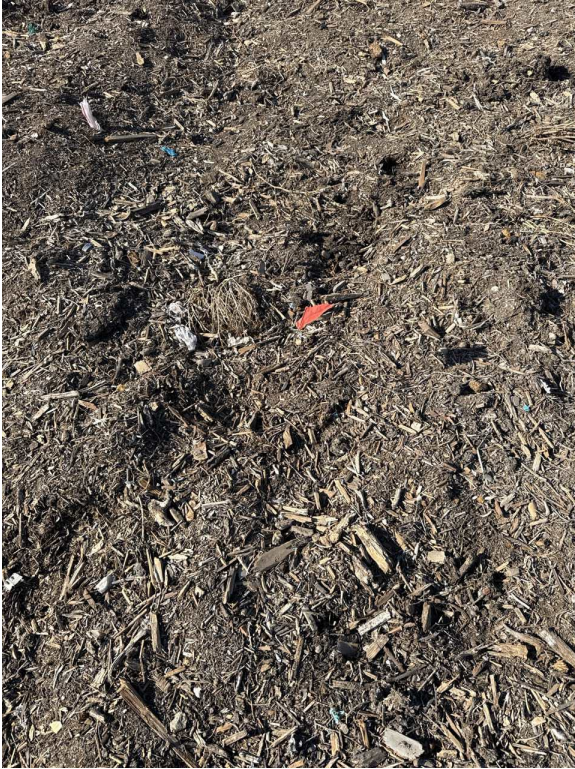
1. SnifferDRONE Verification

| LOCATION DETAILS | | | | | | INSPECTION RESULTS | | | | | | |
|---|---|---|---|---|---|---|---|---|---|---|---|---|
| 1 | 34.428575 | -118.649008 | 34.428579 | -118.649091 | | 10/7/2026 | 22:58 | 303 | 10/7/2026 | 23:13 | 2,000 | |

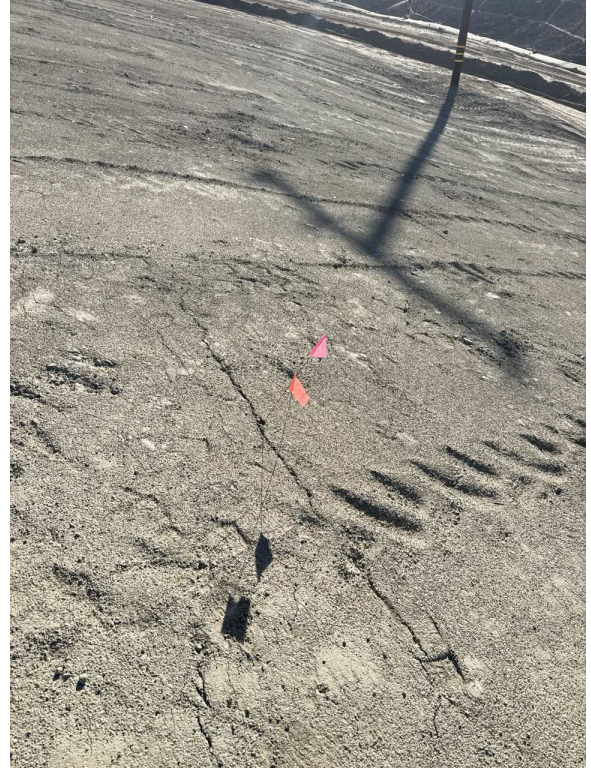
2. SnifferDRONE Verification

| LOCATION DETAILS | | | | | | INSPECTION RESULTS | | | | | | |
|---|---|---|---|---|---|---|---|---|---|---|---|---|
| 2 | 34.432820 | -118.646229 | 34.432822 | -118.646218 | | 10/7/2026 | 14:53 | 449 | 10/7/2026 | 16:00 | 1,000 | |

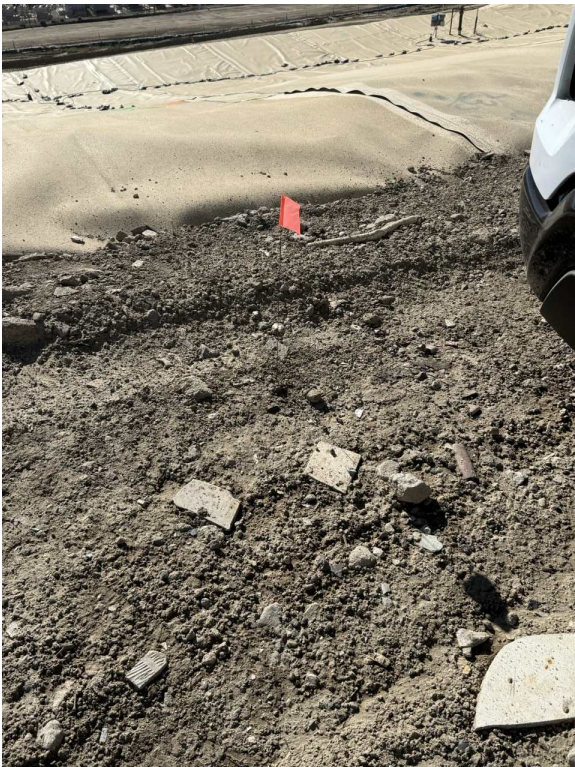
3. SnifferDRONE Verification

| LOCATION DETAILS | | | | | | INSPECTION RESULTS | | | | | | |
|---|---|---|---|---|---|---|---|---|---|---|---|---|
| 3 | 34.433209 | -118.643982 | 34.433242 | -118.643958 | | 10/7/2026 | 16:33 | 385 | 10/7/2026 | 17:12 | 1,000 | |

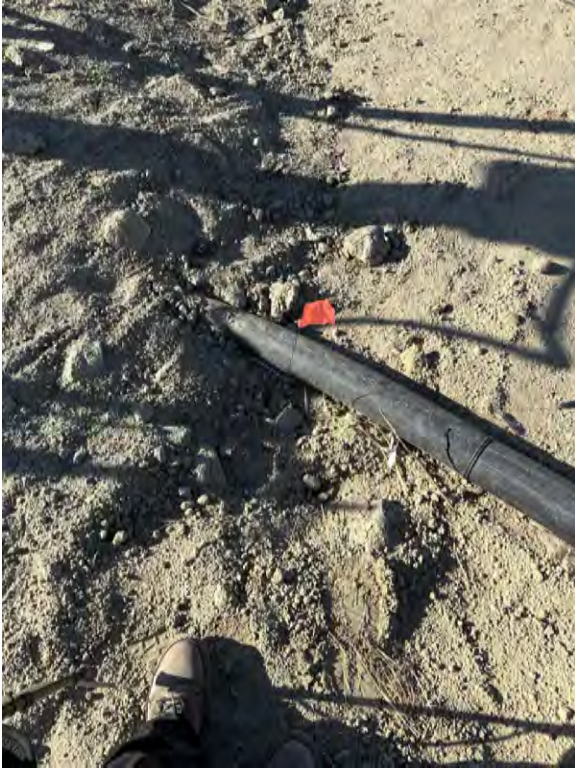
1. SnifferDRONE Verification

| LOCATION DETAILS | | | | | | INSPECTION RESULTS | | | | | | |
|---|---|---|---|---|---|---|---|---|---|---|---|---|
| 1 | 34.432708 | -118.646153 | 34.43260531 | -118.646176 | | 10/1/2026 | 15:07 | 644 | 10/1/2026 | 15:54 | 2,000 | |

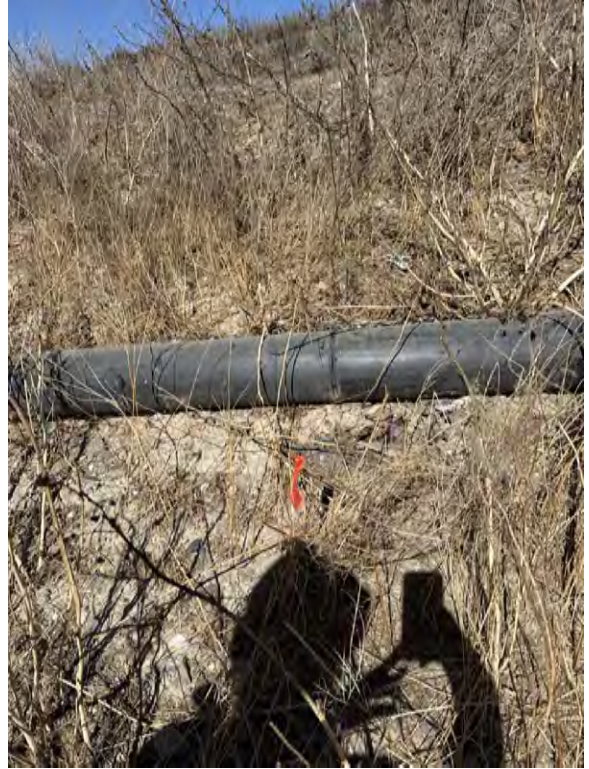
2. SnifferDRONE Verification

| LOCATION DETAILS | | | | | | INSPECTION RESULTS | | | | | | |
|---|---|---|---|---|---|---|---|---|---|---|---|---|
| 2 | 34.433045 | -118.641169 | 34.43299234 | -118.641168 | | 10/1/2026 | 17:03 | 777 | 10/1/2026 | 17:32 | 2,000 | |

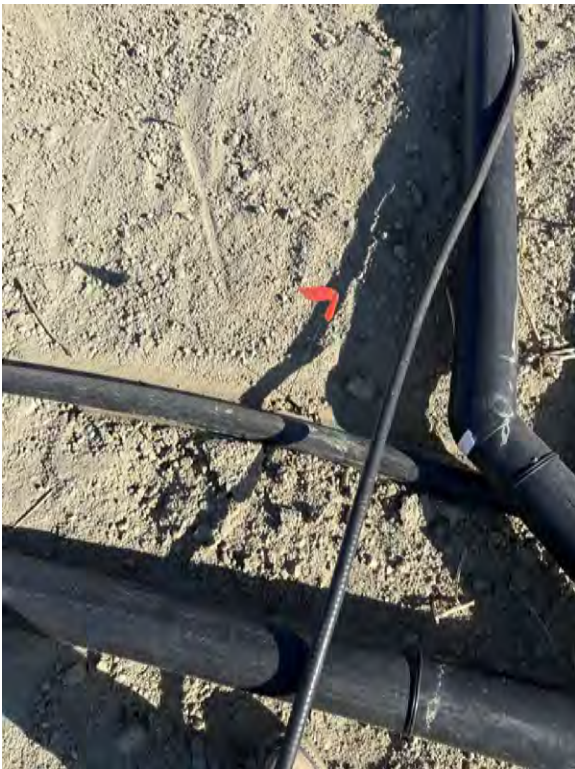
3. SnifferDRONE Verification

| LOCATION DETAILS | | | | | | INSPECTION RESULTS | | | | | | |
|---|---|---|---|---|---|---|---|---|---|---|---|---|
| 3 | 34.432828 | -118.647155 | 34.43283746 | -118.647273 | | 10/1/2026 | 15:05 | 331 | 10/1/2026 | 15:34 | 1,000 | |

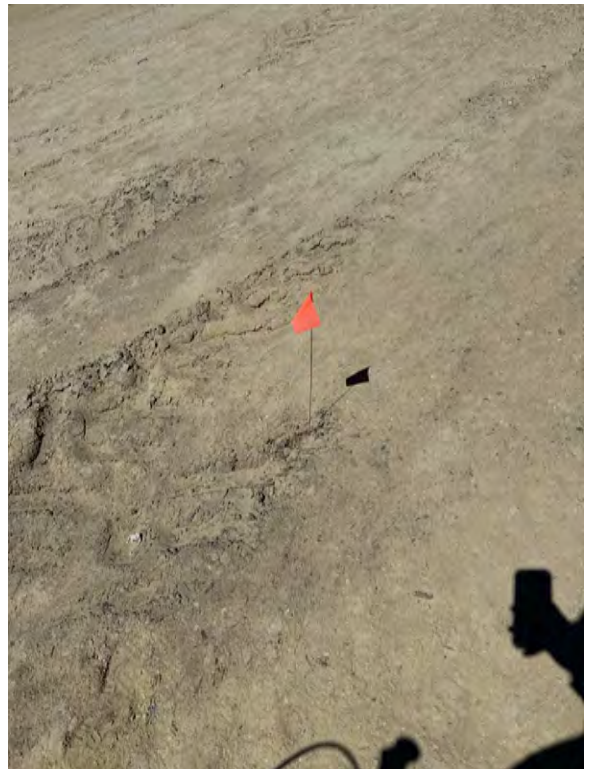
4. SnifferDRONE Verification

| LOCATION DETAILS | | | | | | INSPECTION RESULTS | | | | | | |
|---|---|---|---|---|---|---|---|---|---|---|---|---|
| 4 | 34.431677 | -118.644787 | 34.43164433 | -118.644736 | | 10/1/2026 | 18:11 | 256 | 10/1/2026 | 18:31 | 1,000 | |

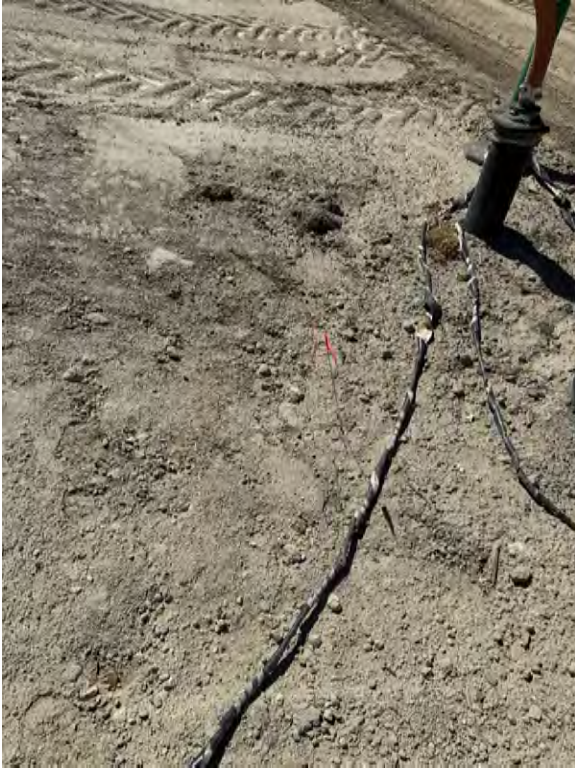
5. SnifferDRONE Verification

| LOCATION DETAILS | | | | | | INSPECTION RESULTS | | | | | | |
|---|---|---|---|---|---|---|---|---|---|---|---|---|
| 5 | 34.430027 | -118.650541 | 34.43009589 | -118.650497 | | 10/1/2026 | 20:36 | 205 | 10/1/2026 | 20:52 | 1,000 | |

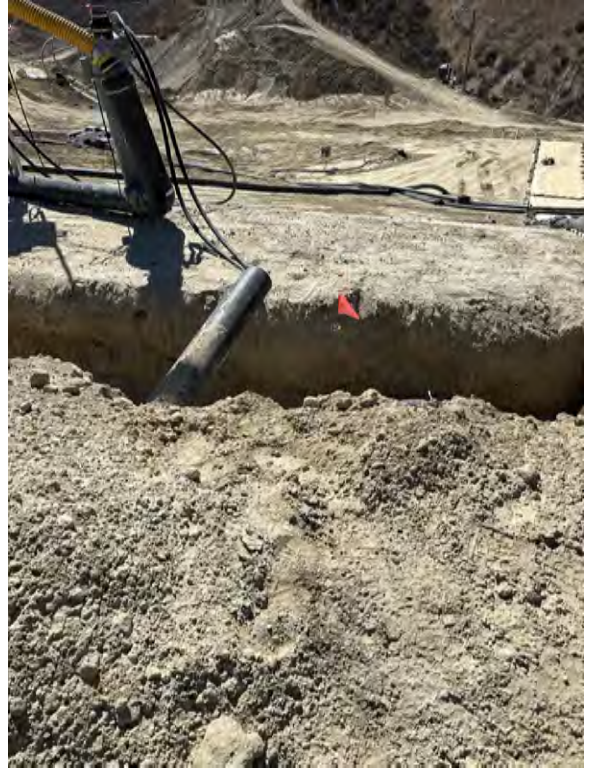
6. SnifferDRONE Verification

| LOCATION DETAILS | | | | | | INSPECTION RESULTS | | | | | | |
|---|---|---|---|---|---|---|---|---|---|---|---|---|
| 6 | 34.431555 | -118.650236 | 34.43154158 | -118.650099 | | 10/1/2026 | 20:37 | 421 | 10/1/2026 | 20:55 | 1,000 | Trench |

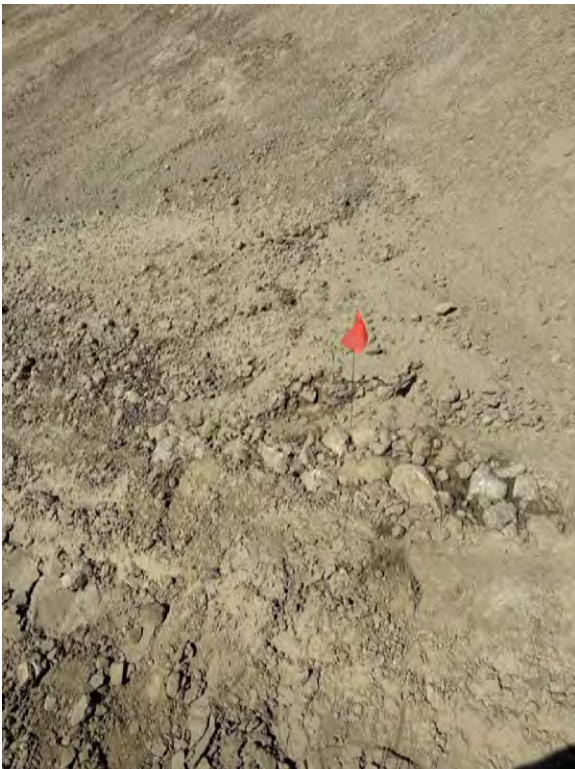
7. SnifferDRONE Verification

| LOCATION DETAILS | | | | | | INSPECTION RESULTS | | | | | | |
|---|---|---|---|---|---|---|---|---|---|---|---|---|
| 7 | 34.431491 | -118.644564 | 34.43142662 | -118.644640 | | 10/1/2026 | 18:11 | 231 | 10/1/2026 | 18:24 | 920 | |

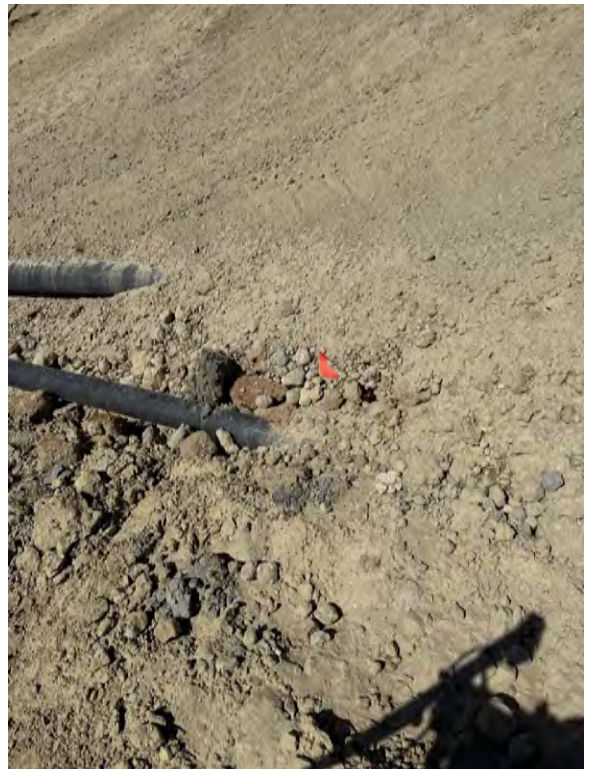
8. SnifferDRONE Verification

| LOCATION DETAILS | | | | | | INSPECTION RESULTS | | | | | | |
|---|---|---|---|---|---|---|---|---|---|---|---|---|
| 8 | 34.431427 | -118.644705 | 34.43137359 | -118.644704 | | 10/1/2026 | 18:11 | 738 | 10/1/2026 | 18:26 | 910 | |

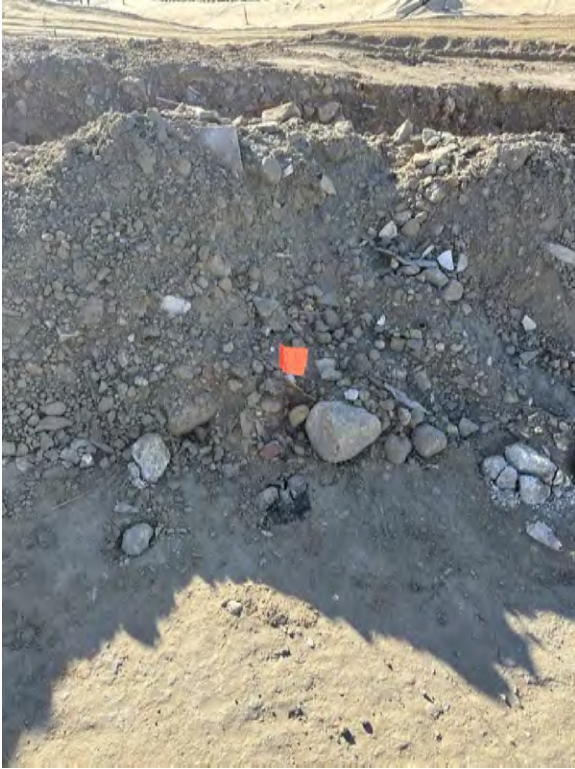
9. SnifferDRONE Verification

| LOCATION DETAILS | | | | | | INSPECTION RESULTS | | | | | | |
|---|---|---|---|---|---|---|---|---|---|---|---|---|
| 9 | 34.432700 | -118.646649 | 34.4327456 | -118.646749 | | 10/1/2026 | 15:07 | 614 | 10/1/2026 | 15:38 | 900 | Trench |

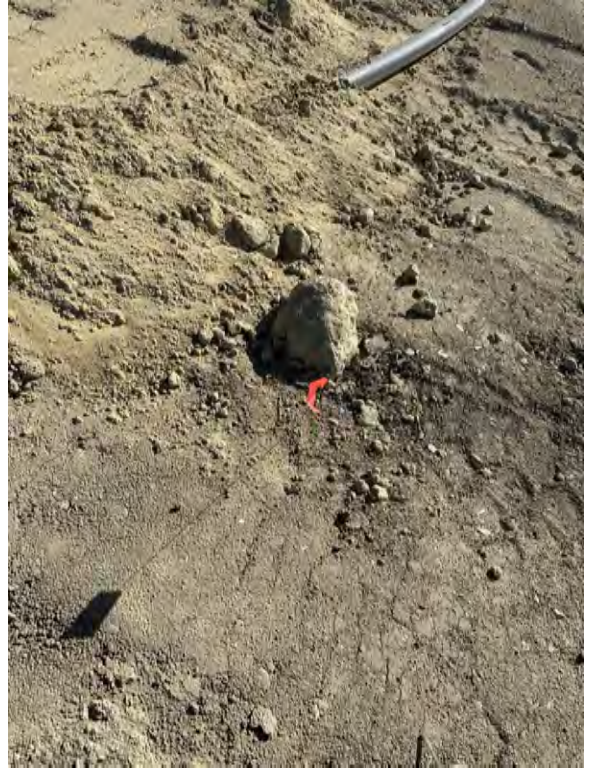
10. SnifferDRONE Verification

| LOCATION DETAILS | | | | | | INSPECTION RESULTS | | | | | | |
|---|---|---|---|---|---|---|---|---|---|---|---|---|
| 10 | 34.432633 | -118.646279 | 34.43259916 | -118.646372 | | 10/1/2026 | 15:08 | 231 | 10/1/2026 | 15:49 | 780 | |

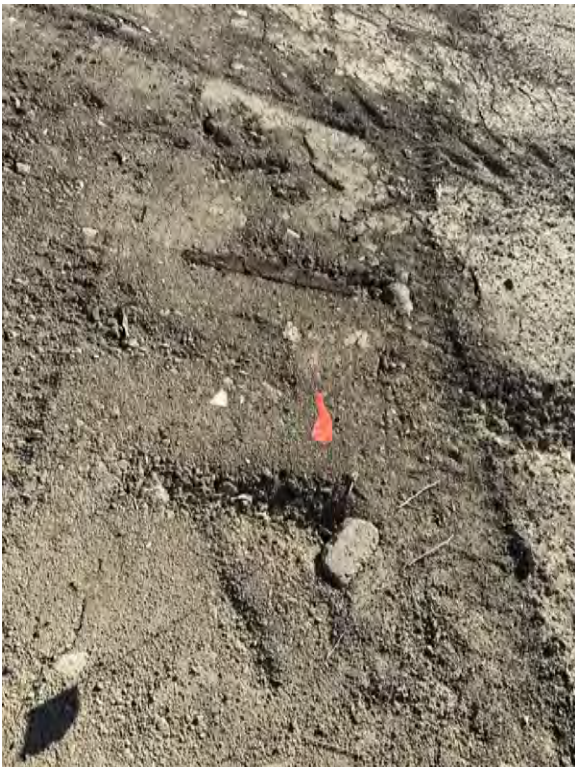
11. SnifferDRONE Verification

| LOCATION DETAILS | | | | | | INSPECTION RESULTS | | | | | | |
|---|---|---|---|---|---|---|---|---|---|---|---|---|
| 11 | 34.432513 | -118.646510 | 34.43255072 | -118.646407 | | 10/1/2026 | 15:08 | 348 | 10/1/2026 | 15:47 | 770 | |

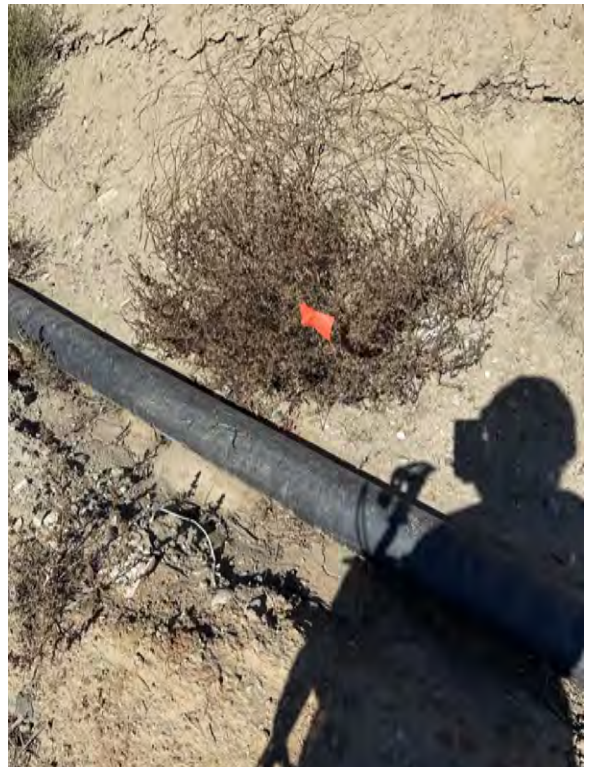
12. SnifferDRONE Verification

| LOCATION DETAILS | | | | | | INSPECTION RESULTS | | | | | | |
|---|---|---|---|---|---|---|---|---|---|---|---|---|
| 12 | 34.432529 | -118.642958 | 34.43255188 | -118.643049 | | 10/1/2026 | 16:56 | 2,360 | 10/1/2026 | 17:46 | 750 | |

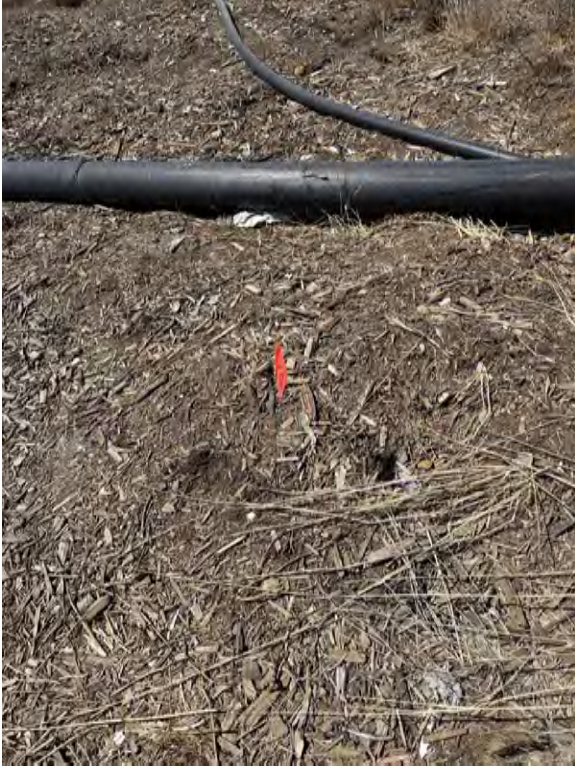
13. SnifferDRONE Verification

| LOCATION DETAILS | | | | | | INSPECTION RESULTS | | | | | | |
|---|---|---|---|---|---|---|---|---|---|---|---|---|
| 13 | 34.428228 | -118.650005 | 34.42826382 | -118.649996 | | 10/1/2026 | 19:50 | 204 | 10/1/2026 | 20:13 | 34 | |

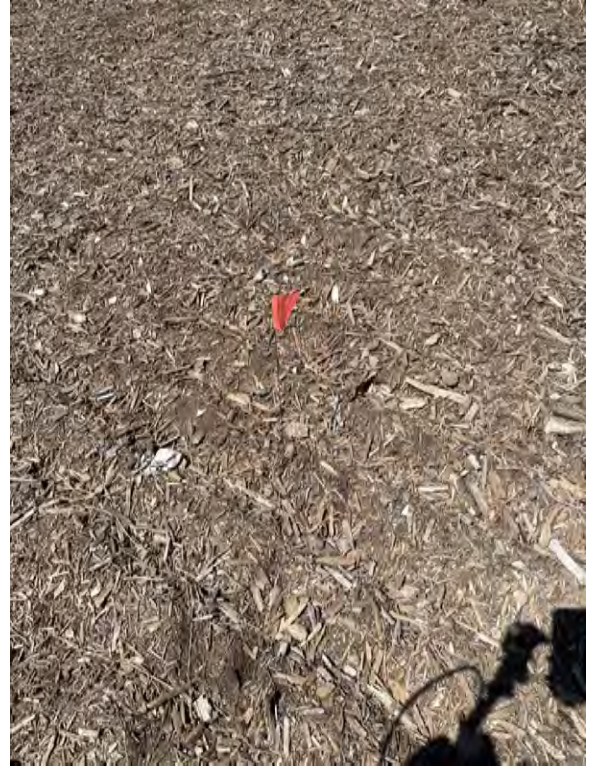
14. SnifferDRONE Verification

| LOCATION DETAILS | | | | | | INSPECTION RESULTS | | | | | | |
|---|---|---|---|---|---|---|---|---|---|---|---|---|
| 14 | 34.430118 | -118.648539 | 34.43007134 | -118.648508 | | 10/1/2026 | 18:49 | 234 | 10/1/2026 | 19:19 | 20 | |

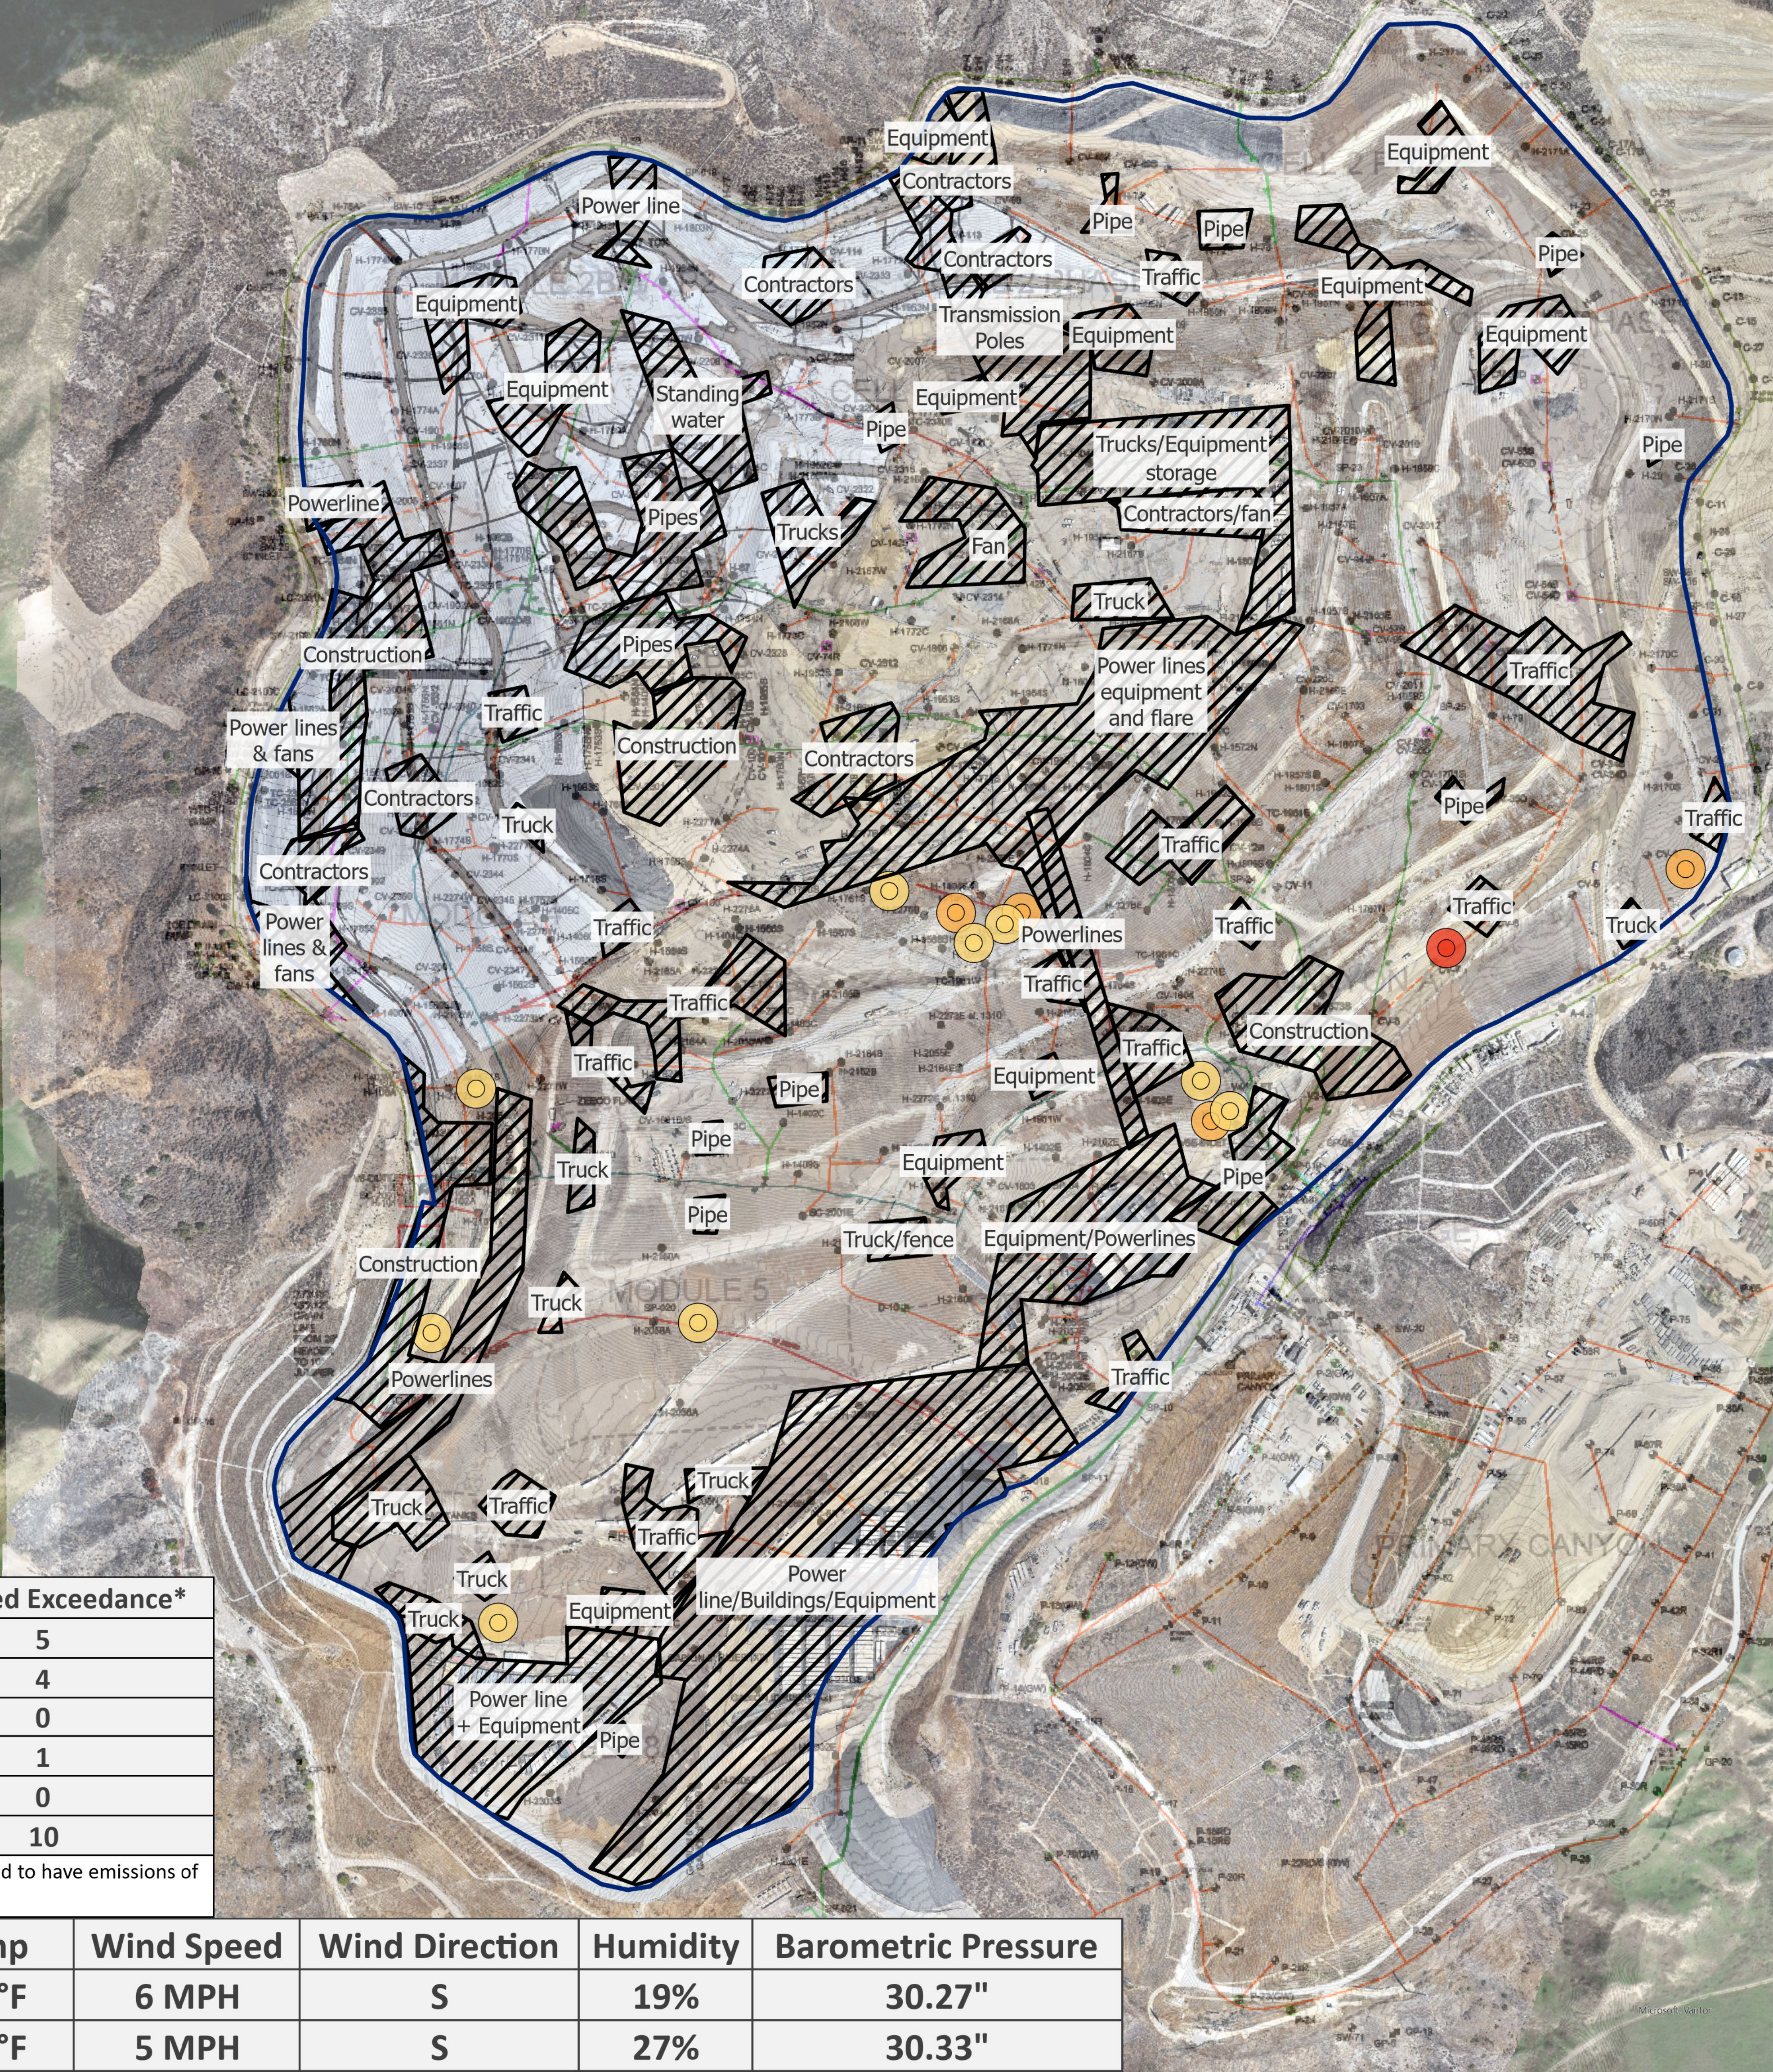
# Chiquita Canyon Landfill Methane Emissions Local Peak Values as Recorded by the SnifferDRONE™, over As-Built Drawing

Sep 30 - Oct 1, 2026

| | Leak Count | Estimated Exceedance* |
| 200-499 PPM | 9 | 5 |
| 500-1000 PPM | 4 | 4 |
| 2000-5000 PPM | 1 | 1 |
| Total | 14 | 10 |

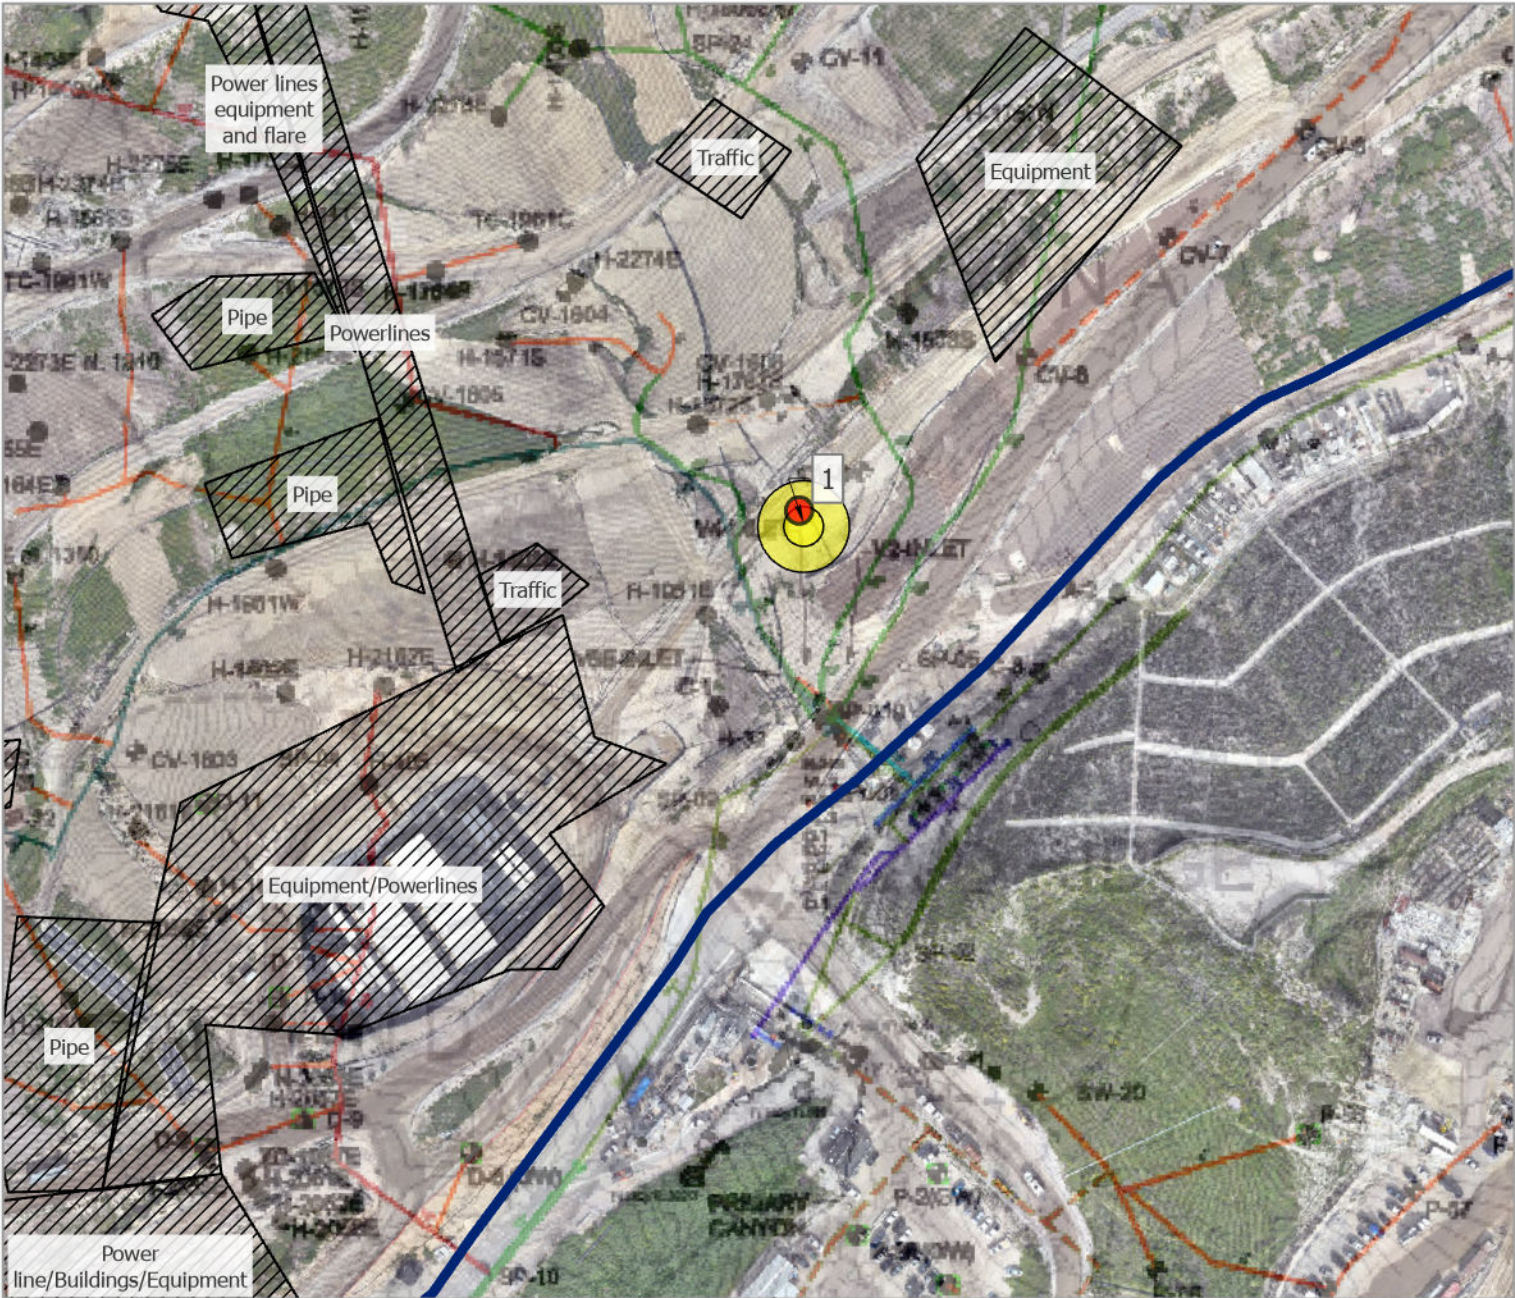
# Peak Verification Map

This map provides an overview of all increased meter readings of methane, or "Drone Flight Peaks", over the course of the inspection and the manual verification measurements taken at each peak.
