Waste Connections - Chiquita Canyon Landfill  
Project: 2026 10 Week 43 Emission Study  
Job: Non-Compliance Emission Study  
Report Submitted Oct 21, 2026

## Emission Study Daily Peaks Verification Report

Waste Connections - Chiquita Canyon Landfill  
Project: 2026 10 Week 42 Emission Study  
Job: Non-Compliance Emission Study  
Report Submitted Oct 15, 2026

Waste Connections - Chiquita Canyon Landfill  
Project: 2026 10 Week 41 Emission Study  
Job: Non-Compliance Emission Study  
Report Submitted Oct 8, 2026

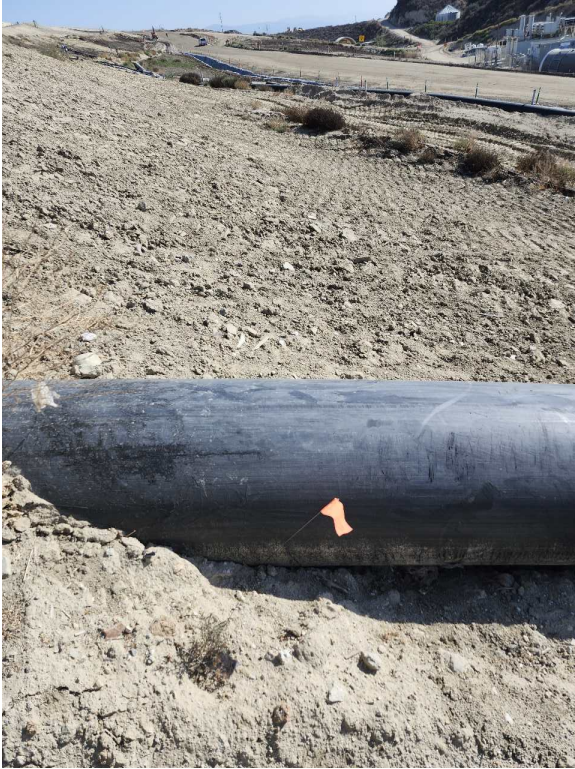
1. SnifferDRONE Verification

| LOCATION DETAILS | | | | | | INSPECTION RESULTS | | | | | | |
|---|---|---|---|---|---|---|---|---|---|---|---|---|
| 1 | 34.431652 | -118.644208 | 34.431695 | -118.644223 | - | 9/22/2026 | 16:28 | 202 | 9/22/2026 | 16:59 | 800 | |
