**Re: Chiquita Canyon, LLC's December 2024 State of the Landfill Report**

# STATE OF THE LANDFILL

A Summary of the Efforts to  
Mitigate the Elevated  
Temperature Landfill Event at the  
Chiquita Canyon Landfill

December 2024

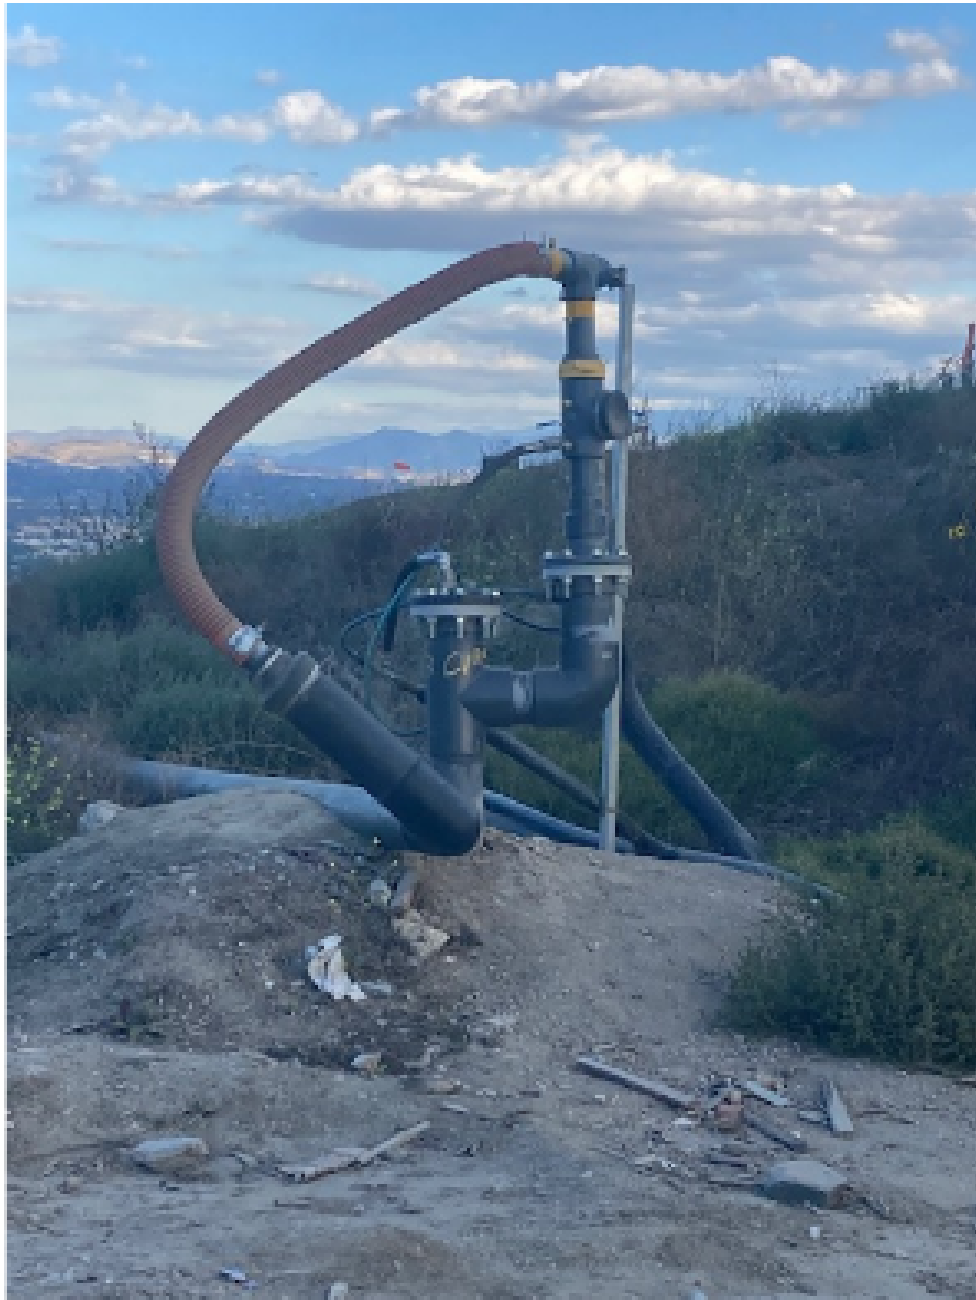
**Figure 2.** Picture of a vertical dual extraction landfill gas well. Chiquita installed over 220 such wells between December 6, 2023 and the end of October 2024.

Chiquita is doing everything it can to mitigate any impacts of the reaction. Chiquita’s actions include installing over 220 vertical dual extraction landfill gas wells since December 6, 2023 and equipping many of them with dewatering pumps, allowing Chiquita to remove hot gas and liquids from the Landfill (see [Figure 2](#)). Chiquita is destroying certain compounds (e.g., hydrogen and methane) in the gas removed from the Landfill by converting them to a harmless compound (i.e., carbon dioxide) in its landfill gas flares or thermal oxidizer (which is similar to a flare) (see [Figure 3](#)). Chiquita is managing the liquids by piping them from the Landfill, using granular activated carbon treatment systems to treat them as needed, and transporting them off-site for disposal at appropriate liquid waste disposal facilities. Chiquita is also constructing a geosynthetic cover (see [Figure 4](#)) over portions of the reaction area (see the red dashed line in [Figure 1](#)). Chiquita expects that this additional cover will reduce potential odors in the shorter term. Chiquita spends millions of dollars each month on engineers, contractors, and equipment to mitigate any potential impacts of the reaction and looks forward to continuing to collaborate with its regulators on the continued management of the Landfill, specifically the reaction area.

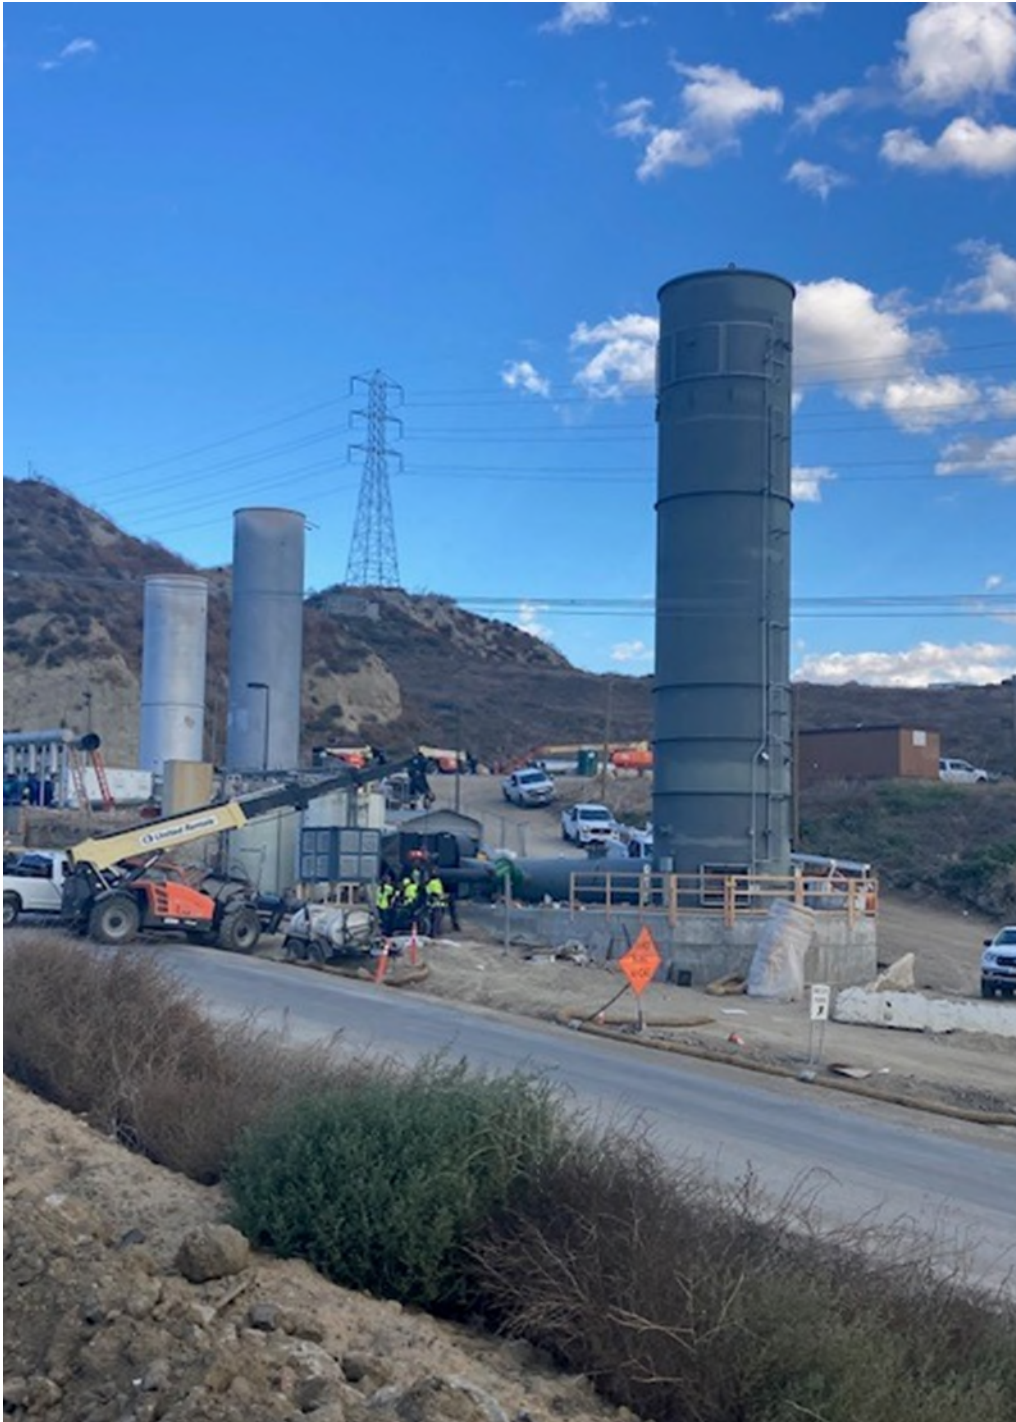
**Figure 3.** Picture of Chiquita's landfill gas flaring facility, showing the three existing flares.

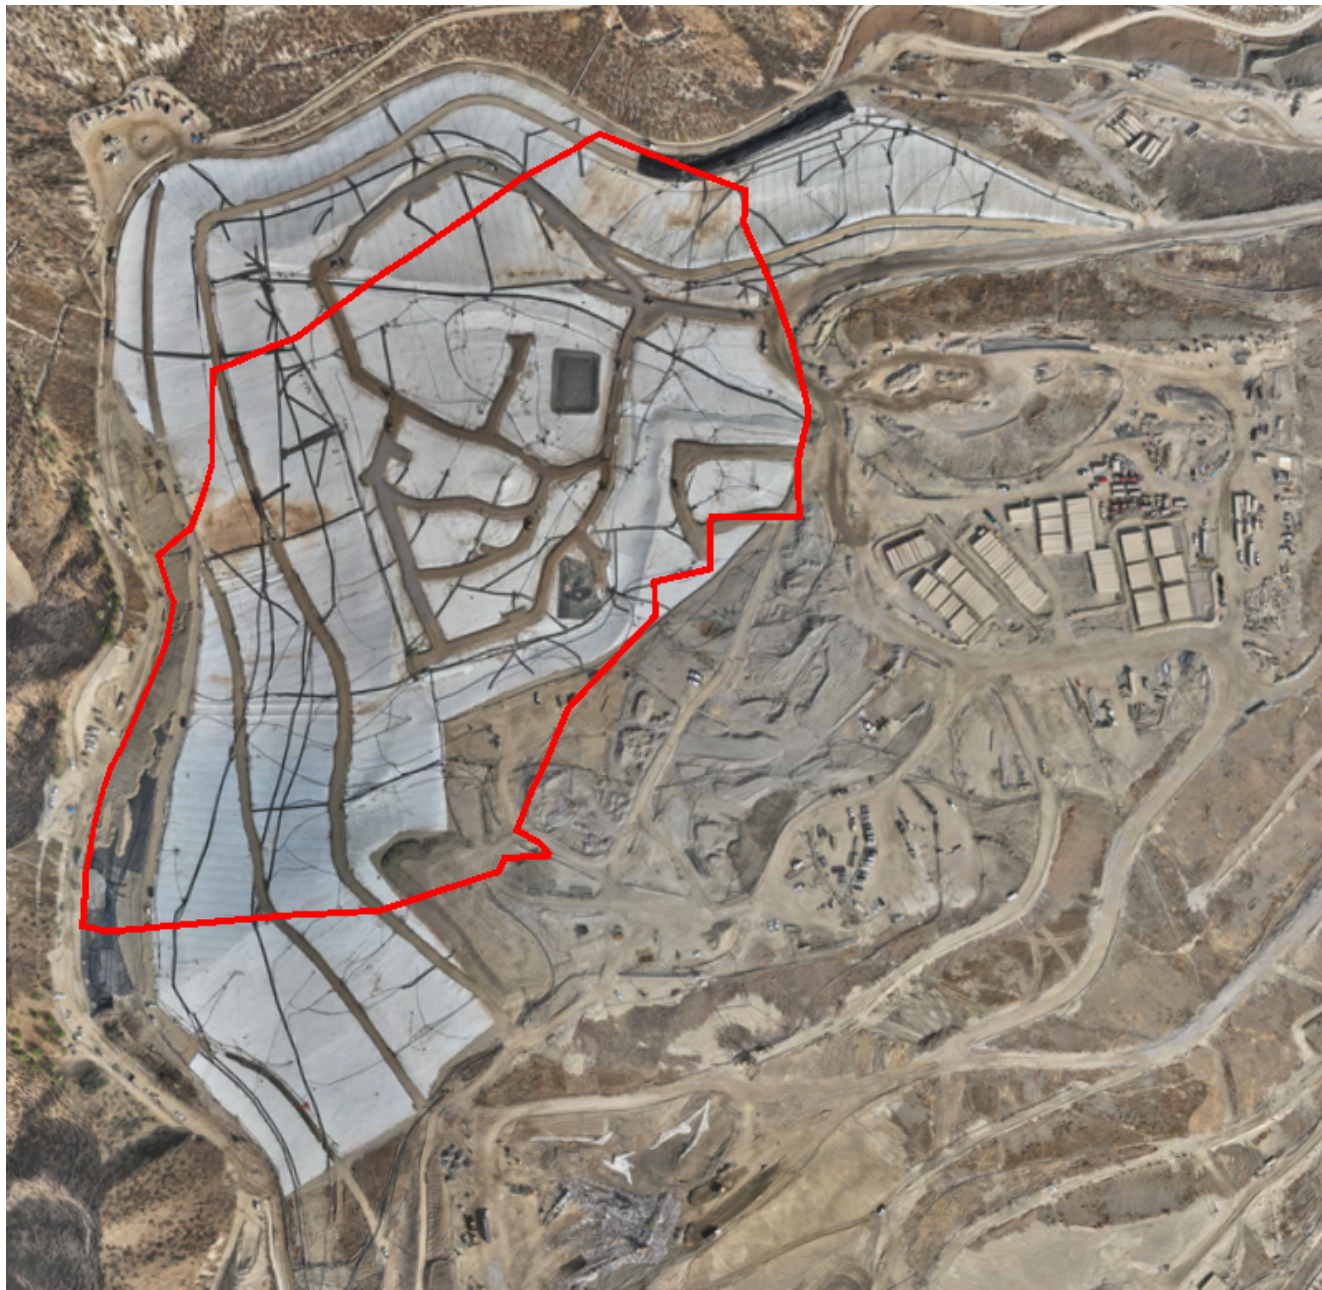
**Figure 4.** Aerial image of the geosynthetic cover over portions of the reaction area (approximated by the red line). Chiquita had installed approximately 41 acres of cover as of October 31, 2024.

Work to install the geosynthetic cover began in December 2023. As of October 31, 2024, Chiquita had installed approximately 41 acres of geosynthetic cover (see [Figure 4](#)), and approximately 3.4 additional acres remained to be covered on the west slope of the Landfill (see [Figure 21](#)). Chiquita estimates that the remaining 3.4 acres will be covered by January 2025. The west slope toe drain must be completed before installation of those remaining acres because the cover would cut off access to the installation of the toe drain.

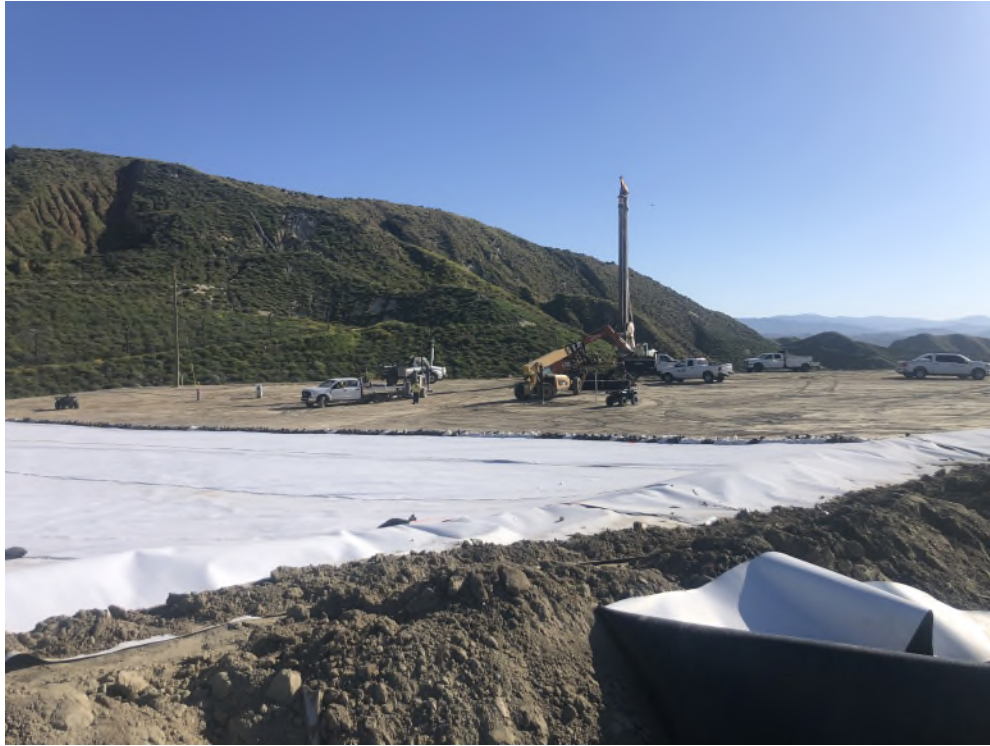
**Figure 6.** Picture of the installation of the geosynthetic cover at the Landfill.

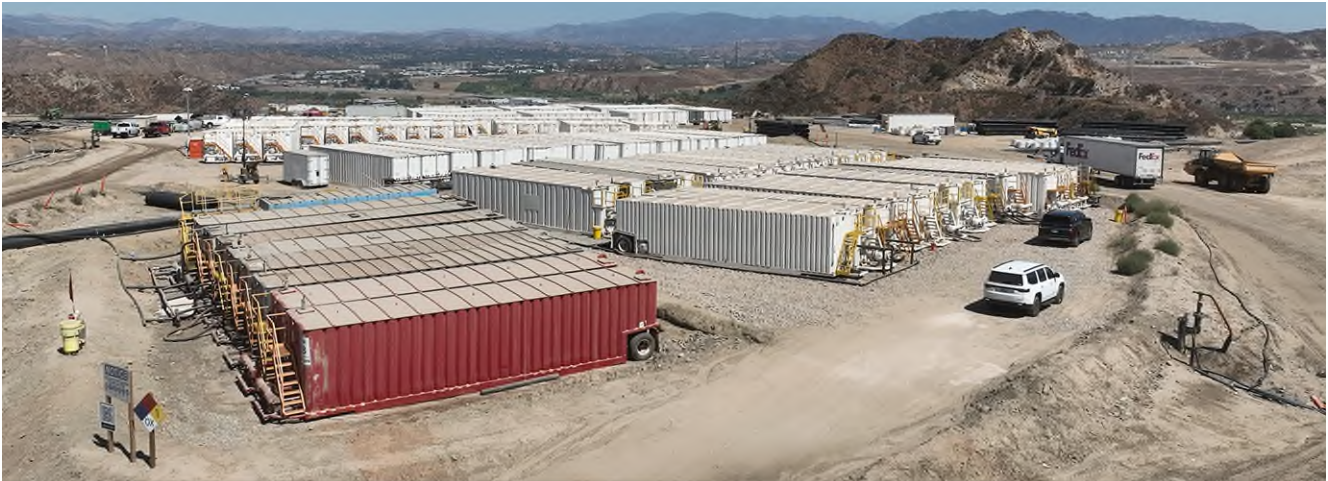
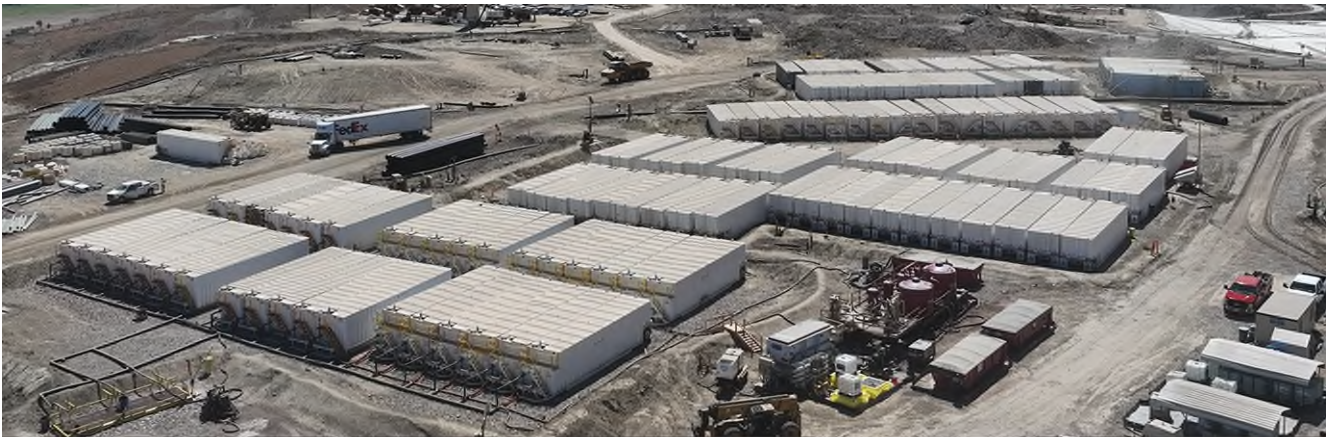
**Figure 11.** Images of a leachate tank farm at the Landfill.

From the extraction wells and sumps, leachate is then piped to tanks where it is accumulated for a brief period prior to treatment. Since the reaction began, Chiquita has rapidly expanded the number of enclosed leachate frac tanks onsite from four (4) to over 250 (see [Figure 11](#)).

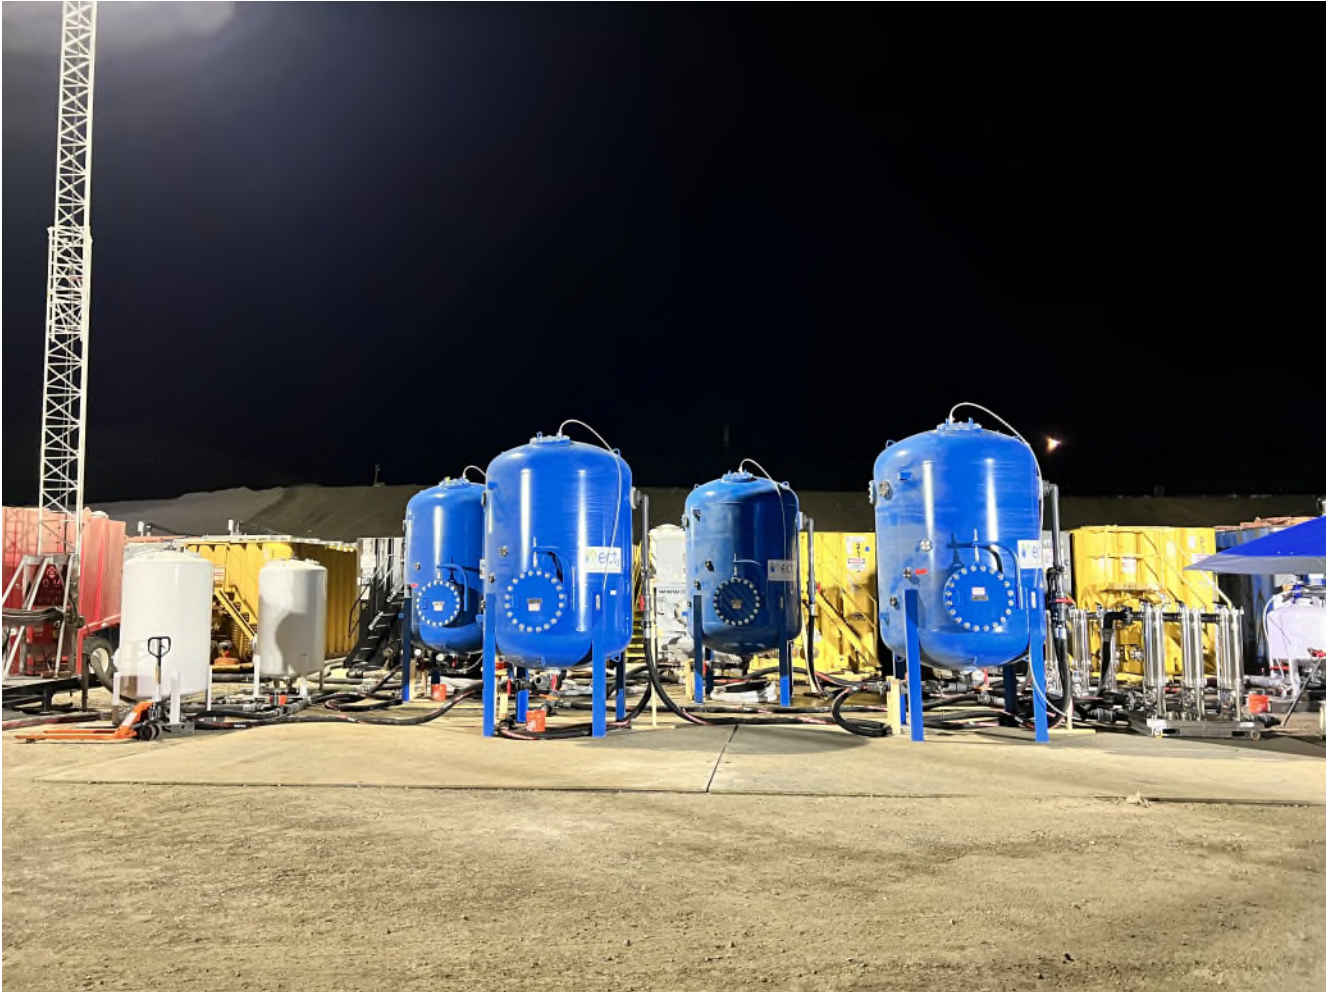
**Figure 14.** Picture of a GAC treatment system at the Landfill.

Chiquita's current treatment capacity can treat more leachate per day than is collected and requires treatment. There are currently two enclosed GAC systems in place at the Landfill (see [Figure 14](#) for an image of one of the Landfill's GAC systems). Treatment capacity can be expanded if needed.

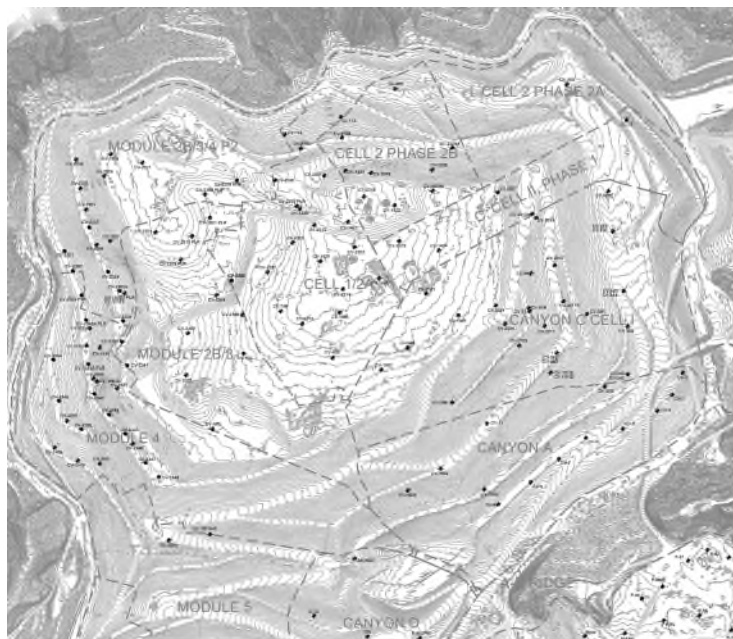
**Figure 16.** Map of vertical landfill gas wells installed at the Landfill as of December 6, 2023.

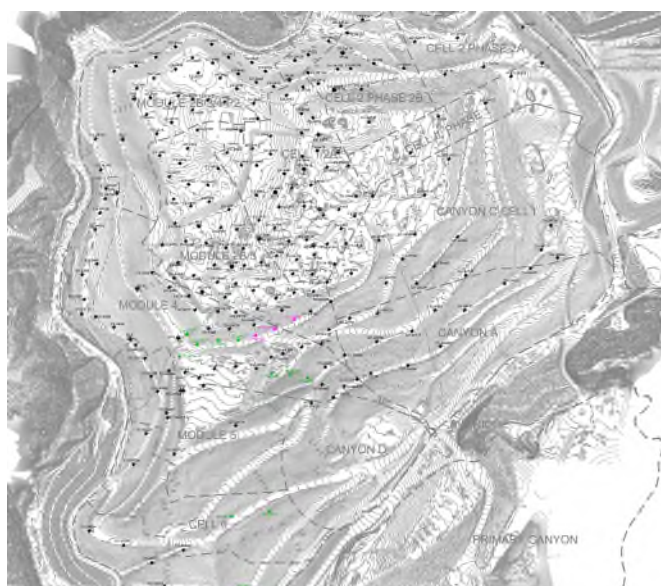
**Figure 17.** Map of vertical landfill gas wells installed at the Landfill as of October 31, 2024. The green wells are those proposed and in the process of being installed. Chiquita installed over 220 vertical wells between December 6, 2023 and October 31, 2024.

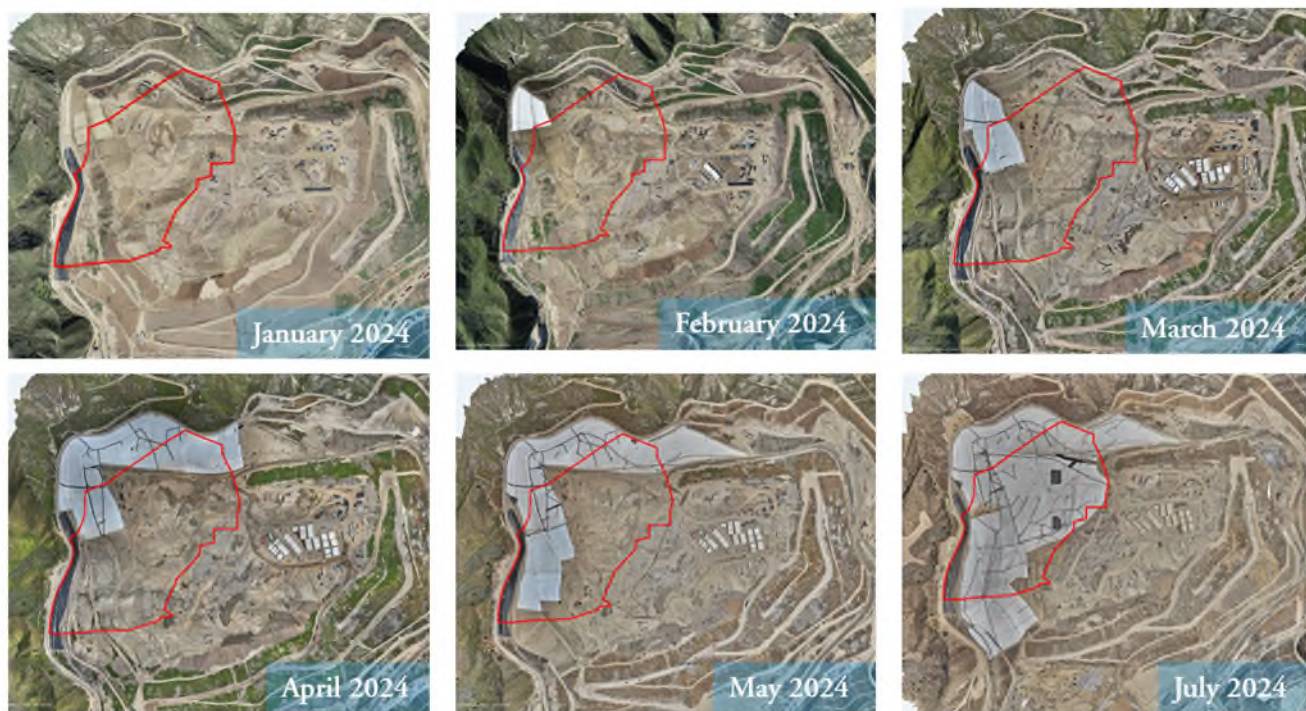
**Figure 20.** Aerial images of the progression of Chiquita's installation of the geosynthetic cover from January to July 2024. The red line illustrates the approximate boundaries of the data-driven reaction area.

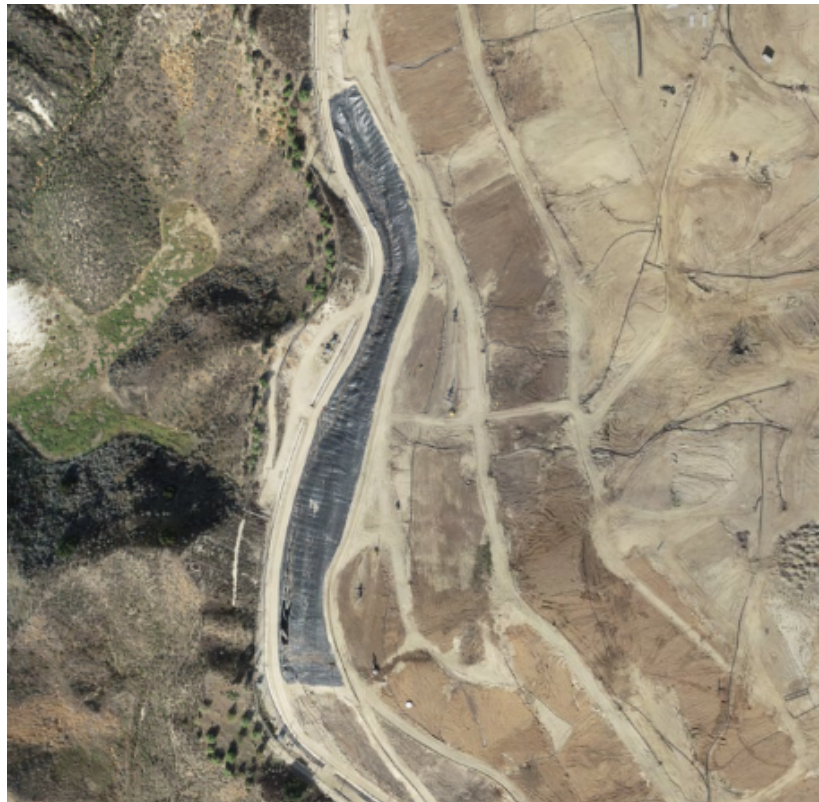
**Figure 22.** Aerial image of the temporary plastic cover (scrim) on the west slope of the Landfill (December 2023).

Before the start of this project, approximately 1.8 acres of the west slope were covered by a temporary plastic cover, also referred to as the scrim, the black cover shown in [Figure 22](#) below. This cover and the drainage features under it were installed in about August 2023. Due to the amount of sediment in the liquids running through these drainage features, Chiquita decided to replace these drainage features at the same time as its installation of the upgraded system.

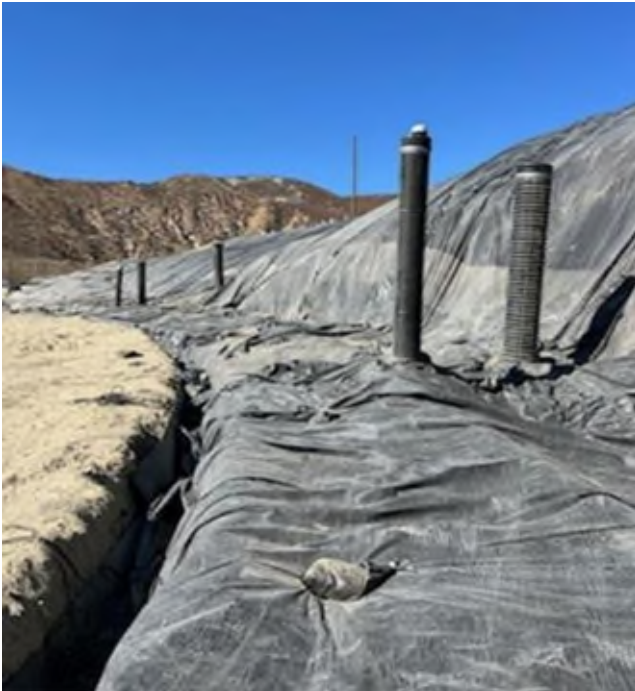
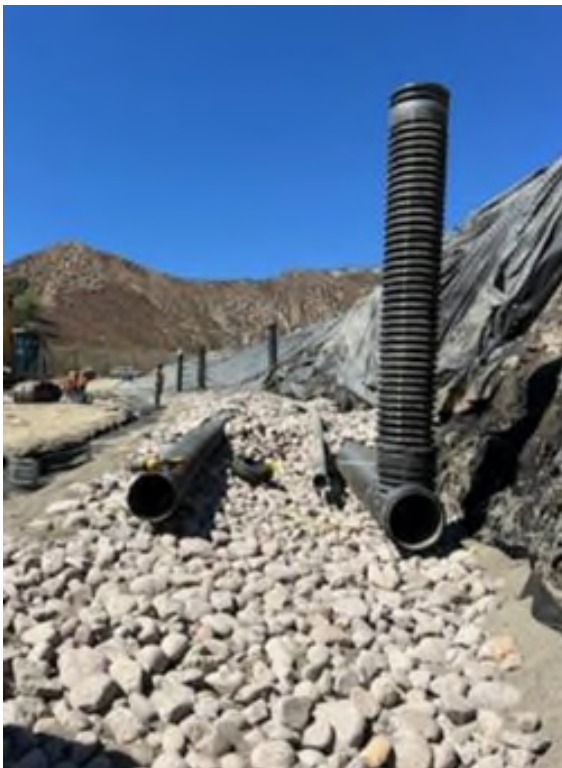
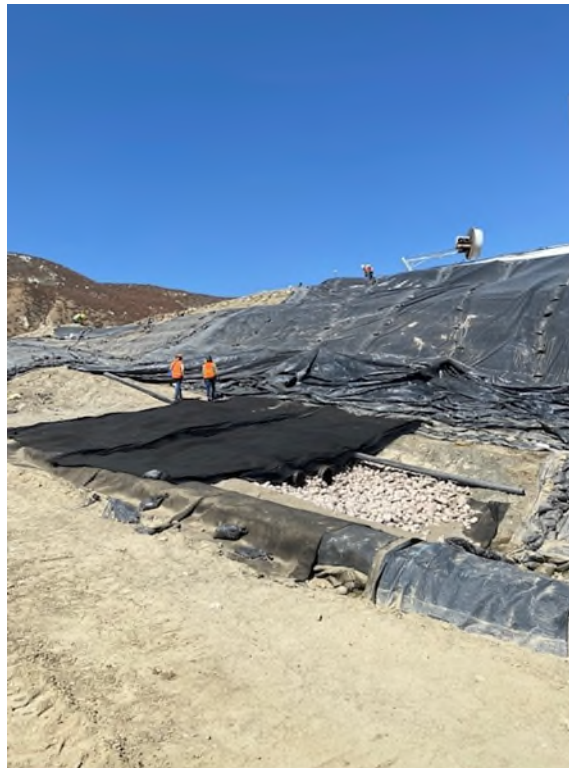
**Figure 24.** Images of the west slope post-excavation and installation of the new toe drain.

Chiquita completed the initial excavation portion of this project on October 24, 2024, and anticipated at that time that the installation of the new toe drain would be completed in November. Chiquita completed the excavation across an area measuring approximately 32,659 square feet (representing a volume of 7,329 cubic yards of soil and buried waste).
