Subsurface Elevated Temperature (SET) Event

Chiquita Canyon
Landfill June 4, 2025

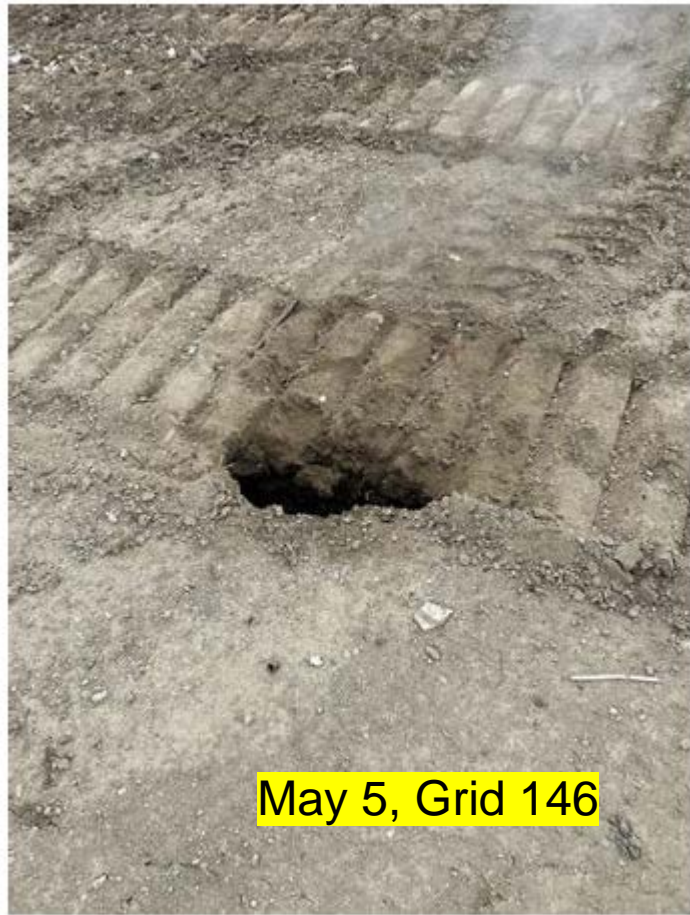
Photo 4

Settlement, Fissures and Repairs -May 2025

May 5, Grid 146

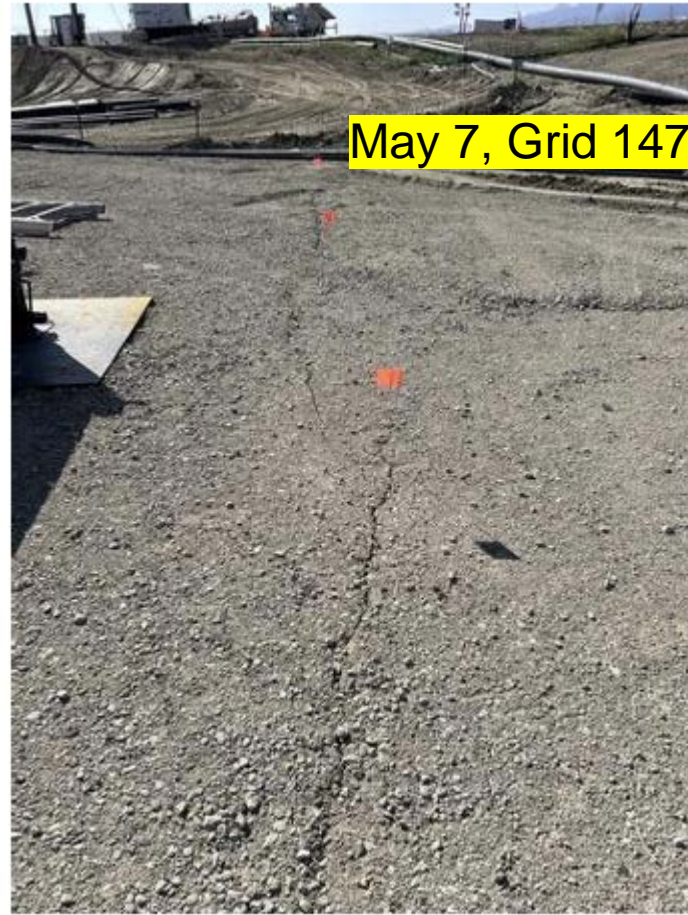
Photo 2

May 7, Grid 147
