March 20, 2026
File No. 01204123.42, Task 10

Subject: February 2026 Monthly Report for Modified Stipulated Order for Abatement (Case No. 6177-4), Chiquita Canyon Landfill (Facility ID 119219), Castaic, California

Chiquita Canyon Landfill (CCL) is a landfill/solid waste disposal facility located at 29201 Henry Mayo Dr., Castaic, California, 91384 (SCAQMD Facility No. 119219). In connection with the landfill, Chiquita operates a landfill gas collection and control system.

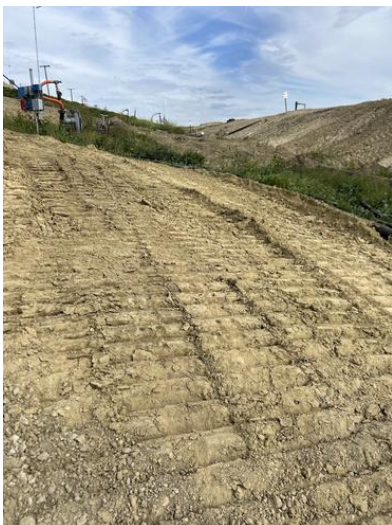
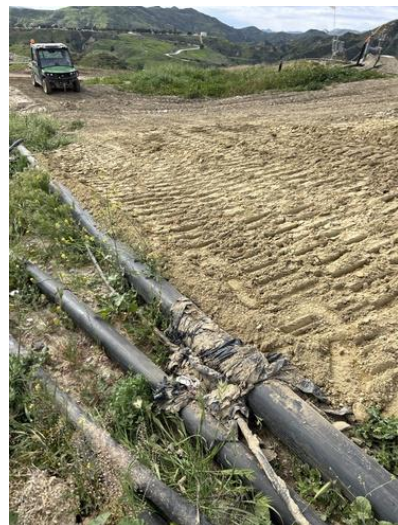
Length of crack (ft) or area containing multiple cracks (ft x ft) 4ft

Was Fissure or Crack fixed? If yes, add photo and description of repairs performed Yes

Date and time of repairs 5 Feb 2026 11:34 AM PST

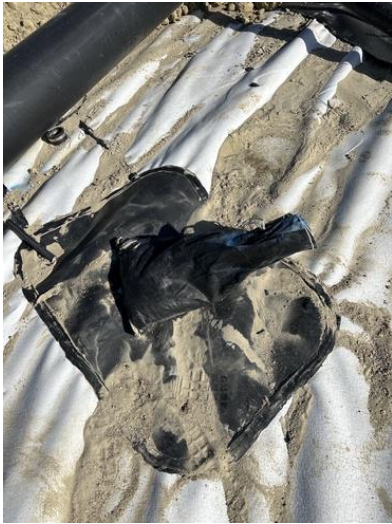
Hole where a pole was removed needs to be patched and extrusion welded.

Description of repair work

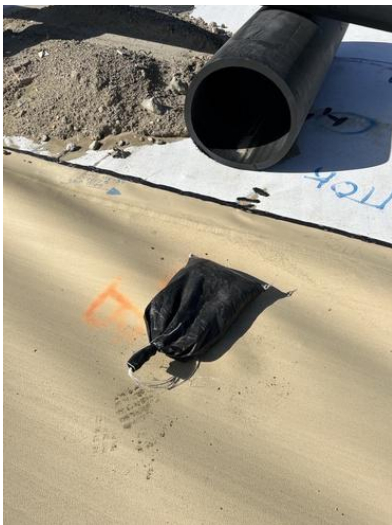
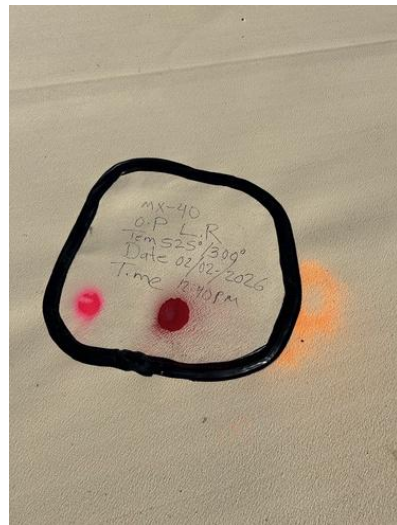
Hole in liner needs to be patched/extrusion welded.

Description of repair work

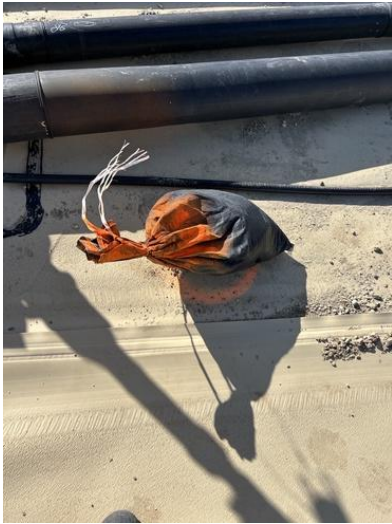
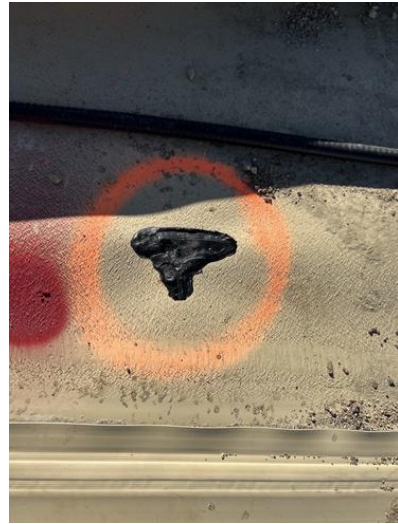
Hole in liner needs to be patched/extrusion welded.

Description of repair work

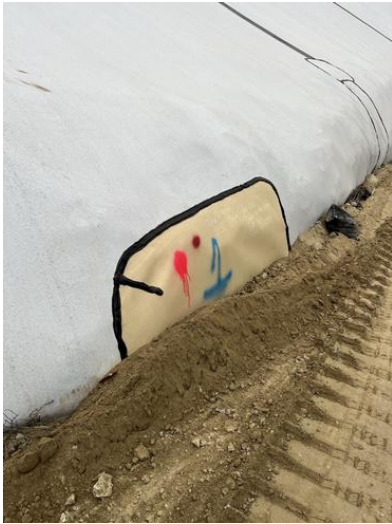
Photo 2

Tear in liner needs to be patched and extrusion welded.

Description of repair work	Tear was patched and extrusion welded.
Date and time of repair (within 2 hours)	10 Feb 2026 1:09 PM PST
Are further permanent repairs required?	No
Date and Time of final repair (if necessary)	
Instability under the cover	
Are there any anomalous (unusual or unexpected) areas of cover damage or deformation that may indicate underlying instability?	No
Are there any signs of a downslope tension crack at the top of the slope or bulging at or near the toe of the slope?	No
Is there any movement of the equipment that vertically penetrates the cover (e.g., tilting)?	No
