SOUTH COAST AIR QUALITY MANAGEMENT DISTRICT

In The Matter Of SOUTH COAST AIR QUALITY MANAGEMENT DISTRICT, Petitioner, vs. CHIQUITA CANYON, LLC a Delaware Corporation, [Facility ID No. 119219] Respondent.	**Case No. 6177-4** **EXHIBIT E TO DECLARATION OF PATRICK SULLIVAN, BCES, CPP, REPA** Health and Safety Code § 41700, and District Rules 402, 431.1, 3002, 203, 1150 Hearing Date: October 29 and November 12, 2025 Hearing Time: 9:30 A.M. Place: Hearing Board South Coast Air Quality Management District, 21865 Copley Drive Diamond Bar, CA 91765

Subject: June 2025 Monthly Report for Modified Stipulated Order for Abatement (Case No. 6177-4), Chiquita Canyon Landfill (Facility ID 119219), Castaic, California

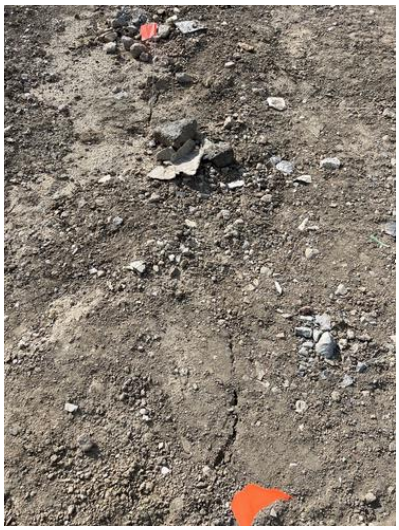
Photo 1

Fissure or Tension Crack Found?	Yes

Length of crack (ft) or area containing multiple cracks (ft x ft)	20ft x 30ft
Horizontal Offset (width)	Small 0.5-2" in width
Vertical Offset (height)	Extra small <0.5" in height
Orientation (direction)	NW to SE
Location	(34.43370354561001, -118.64895078983625)
Was Fissure or Crack fixed? If yes, add photo and description of repairs performed	Yes

Date and time of repairs	3 Jun 2025 10:15 AM PDT
Description of repairs	Cracks were track walked.

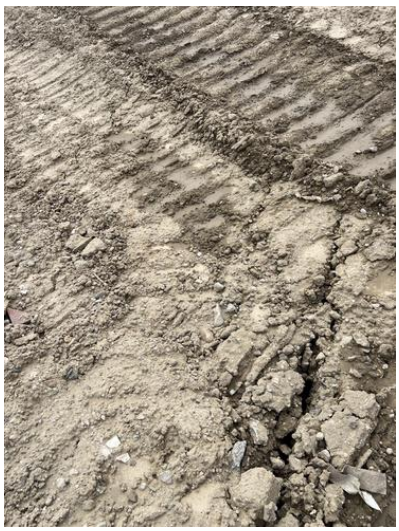
Photo 5

Fissure or Tension Crack Found?	Yes

Length of crack (ft) or area containing multiple cracks (ft x ft)	5ft x 15ft
Horizontal Offset (width)	Large >4" in width
Vertical Offset (height)	Extra small <0.5" in height
Orientation (direction)	NW to SE

Location	Castaic CA 91384 United States (34.43547840015769, -118.64688121522936)
Was Fissure or Crack fixed? If yes, add photo and description of repairs performed	Yes

Date and time of repairs	3 Jun 2025 12:23 PM PDT
Description of repairs	Other (please describe)

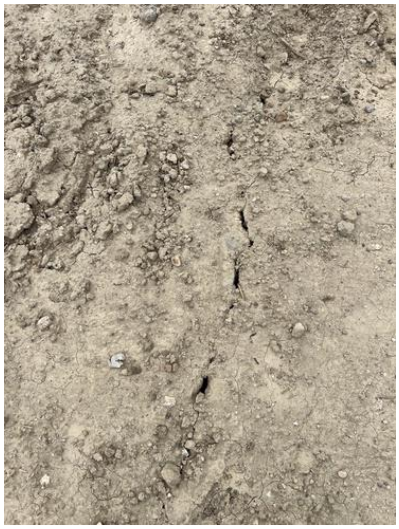
Photo 3

Fissure or Tension Crack Found?	Yes

Length of crack (ft) or area containing multiple cracks (ft x ft)	25ft x 45ft
Horizontal Offset (width)	Medium 2-4" in width
Vertical Offset (height)	Extra small <0.5" in height
Orientation (direction)	NW to SE
Location	Castaic CA 91384 United States (34.435534235122084, -118.64661656331144)
Was Fissure or Crack fixed? If yes, add photo and description of repairs performed	Yes

Date and time of repairs	4 Jun 2025 12:28 PM PDT
Description of repairs	Other (please describe)

Dirt was added and cracks were track walked.

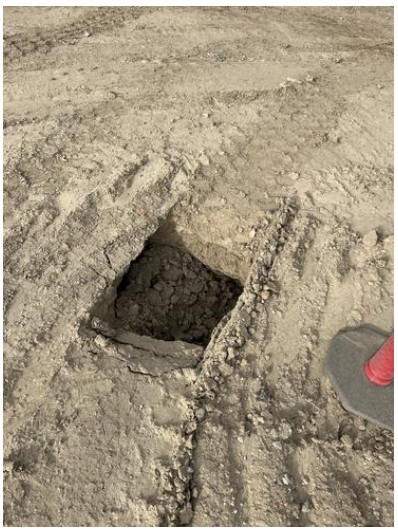
Photo 1

Length of crack (ft) or area containing multiple cracks (ft x ft)	115ft x 5ft
Horizontal Offset (width)	Large >4" in width
Vertical Offset (height)	Large >4" in height
Orientation (direction)	NW to SE
Location	Castaic CA 91384 United States (34.43589922509569, -118.64700447779022)
Was Fissure or Crack fixed? If yes, add photo and description of repairs performed	Yes

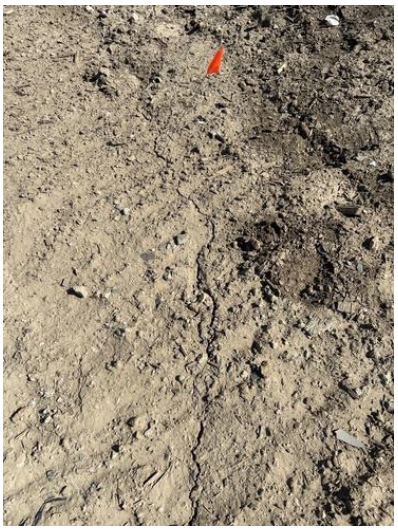
Photo 5

ft)	
Horizontal Offset (width)	Extra Small <0.5 in width
Vertical Offset (height)	Extra small <0.5" in height
Orientation (direction)	N to S
Location	Castaic CA 91384 United States (34.435851979927236, -118.6467560784657)
Was Fissure or Crack fixed? If yes, add photo and description of repairs performed	Yes

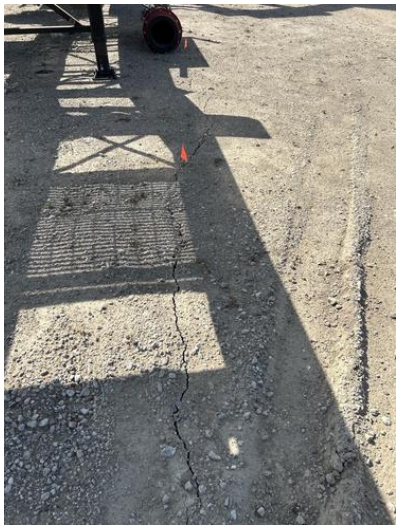
Photo 14

Length of crack (ft) or area containing multiple cracks (ft x ft)	16ft
Horizontal Offset (width)	Extra Small <0.5 in width
Vertical Offset (height)	Extra small <0.5" in height
Orientation (direction)	NW to SE
Location	Castaic CA 91384 United States (34.4355503033791, -118.64752380631421)
Was Fissure or Crack fixed? If yes, add photo and description of repairs performed	Yes

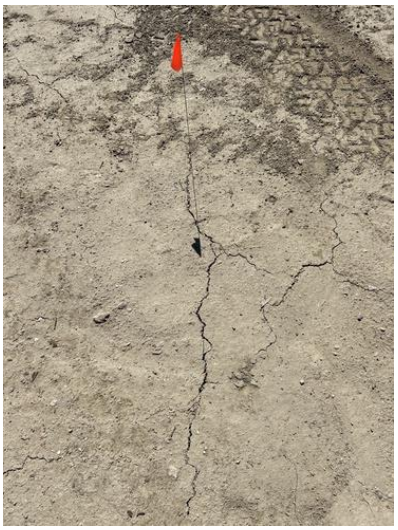
Photo 1

Length of crack (ft) or area containing multiple cracks (ft x ft)	20ft x 25 ft area
Horizontal Offset (width)	Extra Small <0.5 in width
Vertical Offset (height)	Extra small <0.5" in height
Orientation (direction)	NW to SE
Location	27714 Henry Mayo Dr Castaic CA 91384 United States (34.431227360056276, -118.62027174275336)
Was Fissure or Crack fixed? If yes, add photo and description of repairs performed	Yes

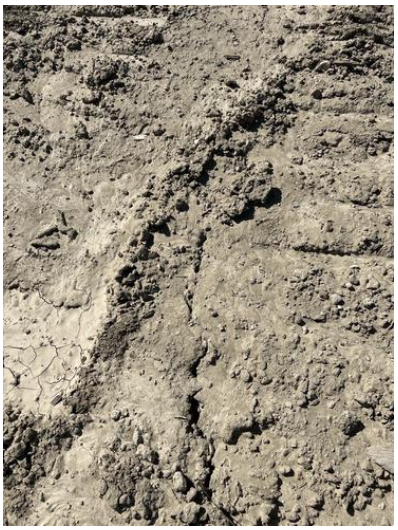
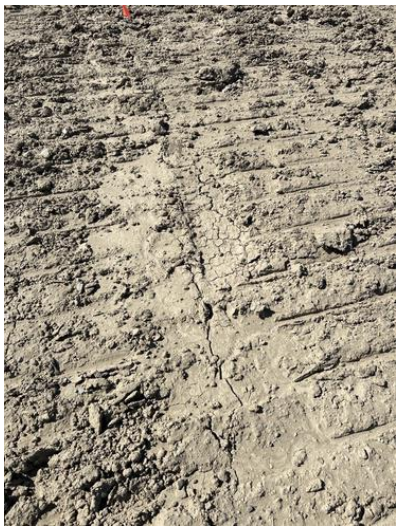
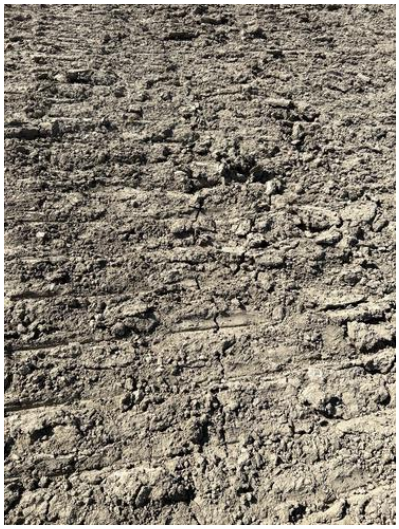
Length of crack (ft) or area containing multiple cracks (ft x ft)	25ft
Horizontal Offset (width)	Extra Small <0.5 in width
Vertical Offset (height)	Extra small <0.5" in height
Orientation (direction)	N to S
Location	Castaic CA 91384 United States (34.435697289158526, -118.64707646417907)
Was Fissure or Crack fixed? If yes, add photo and description of repairs performed	Yes

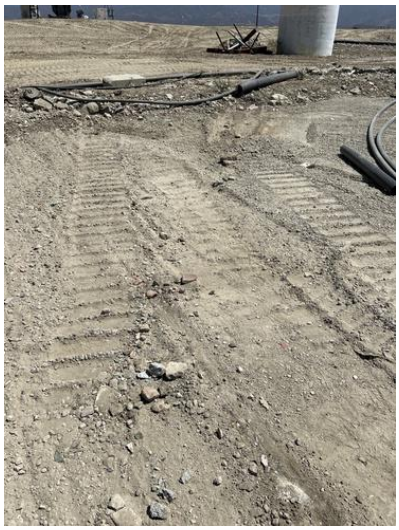
Photo 9

ft)	
Horizontal Offset (width)	Small 0.5-2" in width
Vertical Offset (height)	Extra small <0.5" in height
Orientation (direction)	NE to SW
Location	Castaic CA 91384 United States (34.43415886277589, -118.6469657982719)
Was Fissure or Crack fixed? If yes, add photo and description of repairs performed	Yes

Date and time of repairs	20 Jun 2025 12:45 PM PDT
Description of repairs	Cracks were track walked.
Instability	
Are there any indications of slope stability concerns?	No

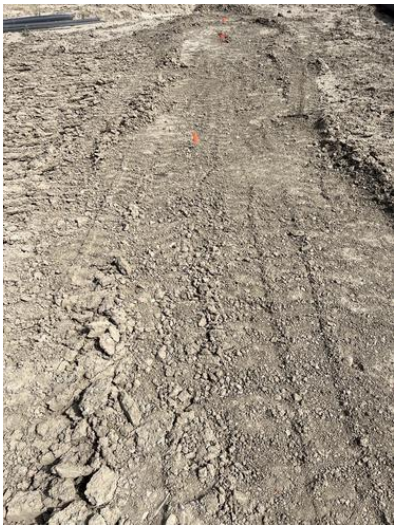
Photo 6

Length of crack (ft) or area containing multiple cracks (ft x ft)	35 ft
Horizontal Offset (width)	Small 0.5-2" in width
Vertical Offset (height)	Extra small <0.5" in height
Orientation (direction)	NW to SE
Location	Castaic CA 91384 United States (34.43587624780028, -118.64704375188676)
Was Fissure or Crack fixed? If yes, add photo and description of repairs performed	Yes

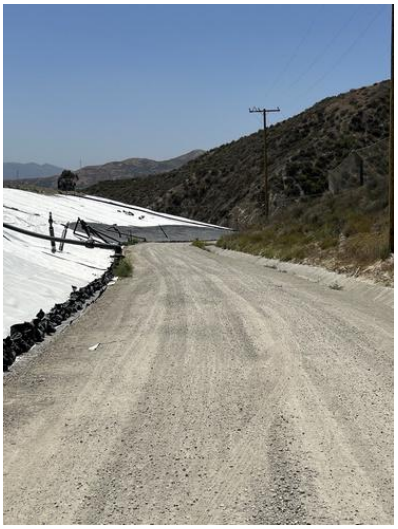
Photo 1

Has a leachate seep/pooling been located?	No

Description of area in photo where there is no leachate seepage or pooling.	North perimeter road.

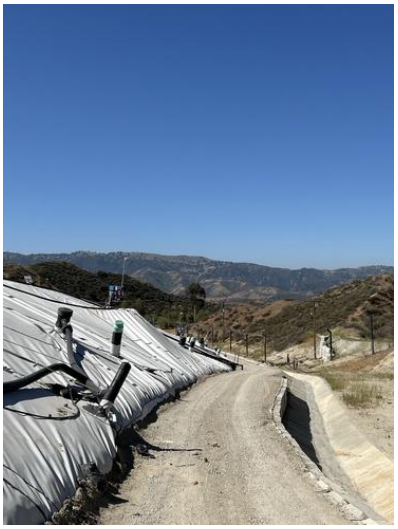
Photo 1

Has a leachate seep/pooling been located?	No

Description of area in photo where there is no leachate seepage or pooling.	West side perimeter road

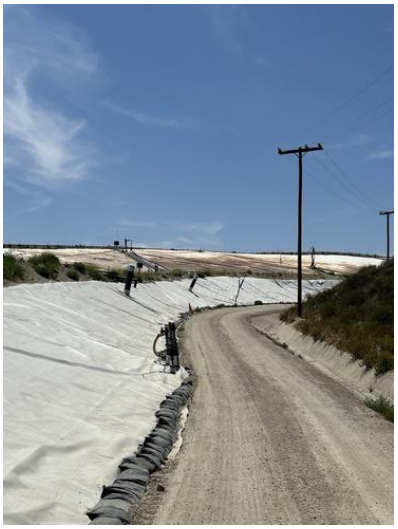
Photo 1

Has a leachate seep/pooling been located?	No

Description of area in photo where there is no leachate seepage or pooling.	North side perimeter road

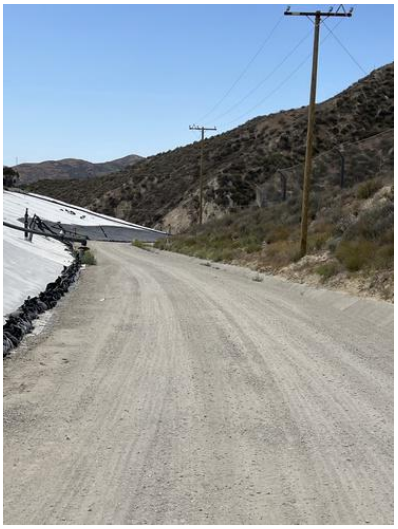
Photo 1

Has a leachate seep/pooling been located?	No

Description of area in photo where there is no leachate seepage or pooling.	North perimeter road.

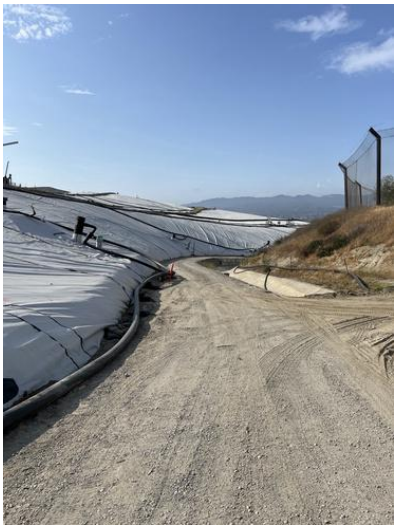
Photo 1

Has a leachate seep/pooling been located?	No

Description of area in photo where there is no leachate seepage or pooling.	Westside perimeter road.

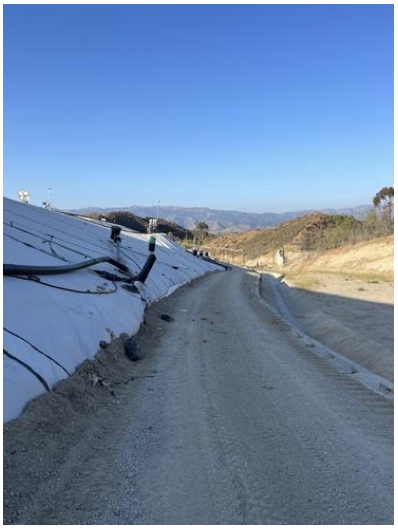
Photo 1

Has a leachate seep/pooling been located?	No

Description of area in photo where there is no leachate seepage or pooling.	Westside perimeter road.

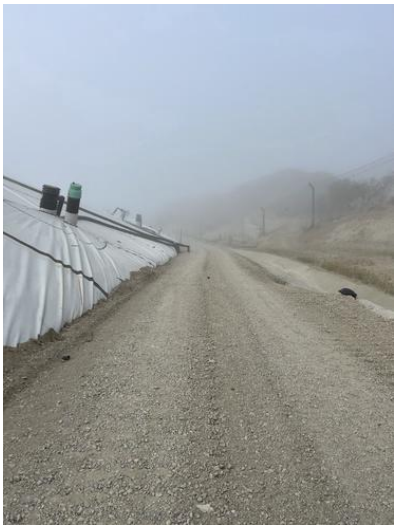
Photo 1

Has a leachate seep/pooling been located?	No

Description of area in photo where there is no leachate seepage or pooling.	Westside perimeter road.

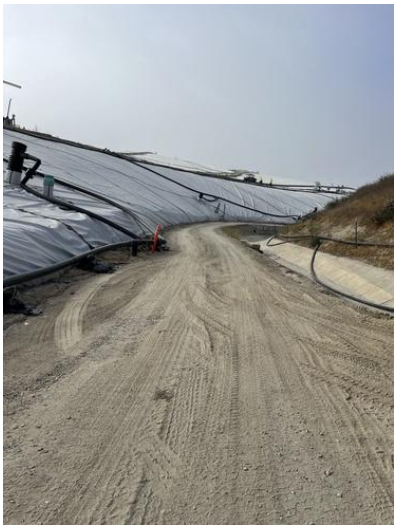
Photo 1

Has a leachate seep/pooling been located?	No

Description of area in photo where there is no leachate seepage or pooling.	Westside perimeter road.

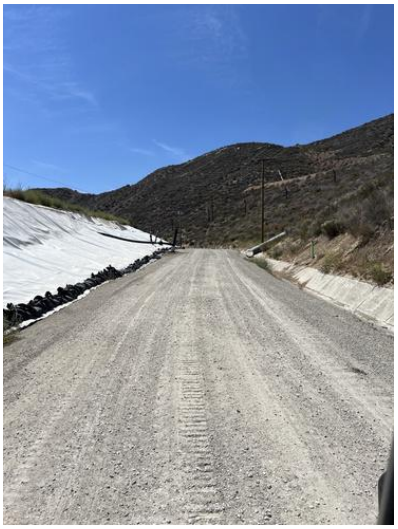
Photo 1

Has a leachate seep/pooling been located?	No

Description of area in photo where there is no leachate seepage or pooling.	North perimeter road.

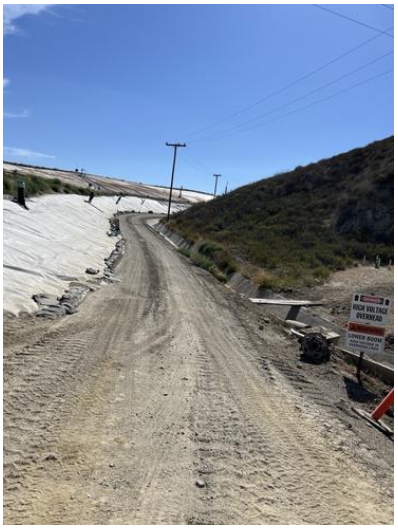
Photo 1

Has a leachate seep/pooling been located?	No

Description of area in photo where there is no leachate seepage or pooling.	North side perimeter road

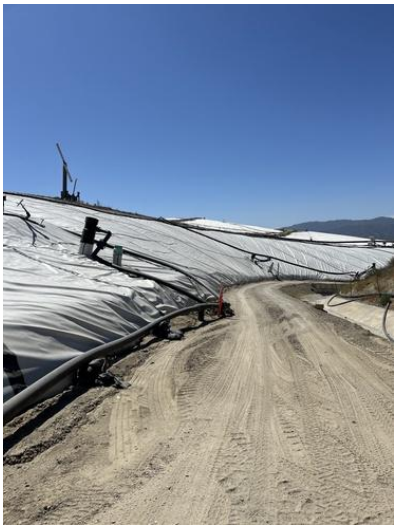
Photo 1

Description of area in photo where there is no leachate seepage or pooling.	West side perimeter road

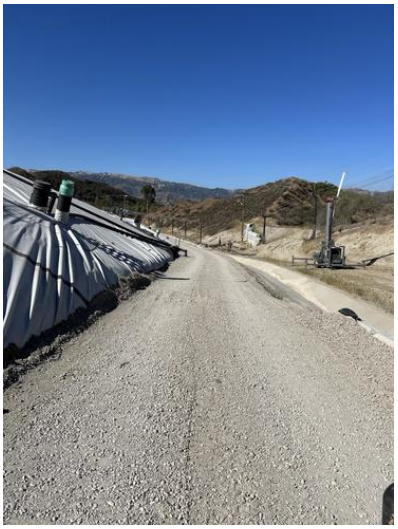
Photo 1

Description of area in photo where there is no leachate seepage or pooling.	Westside perimeter road.

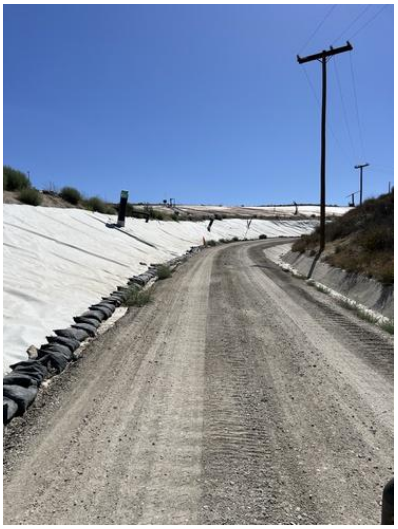
Photo 1

Description of area in photo where there is no leachate seepage or pooling.	North perimeter road.

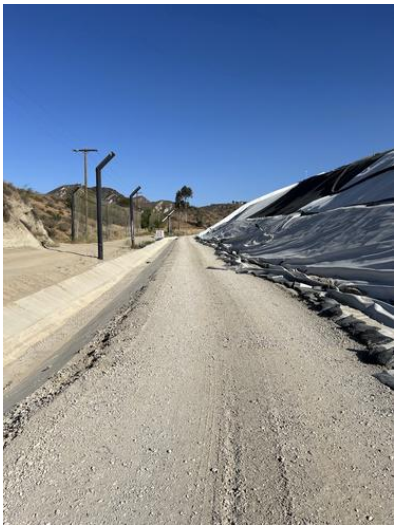
Photo 1

Description of area in photo where there is no leachate seepage or pooling.	Westside perimeter road.

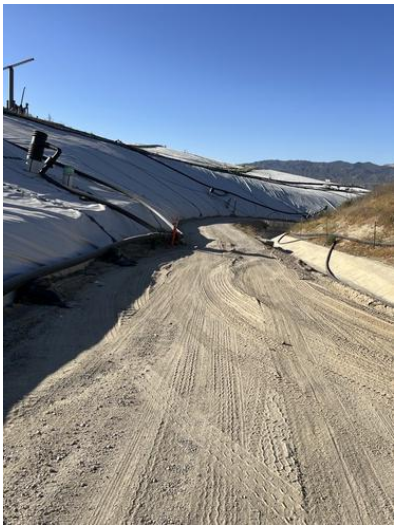
Photo 1

Description of area in photo where there is no leachate seepage or pooling.	Westside perimeter road.

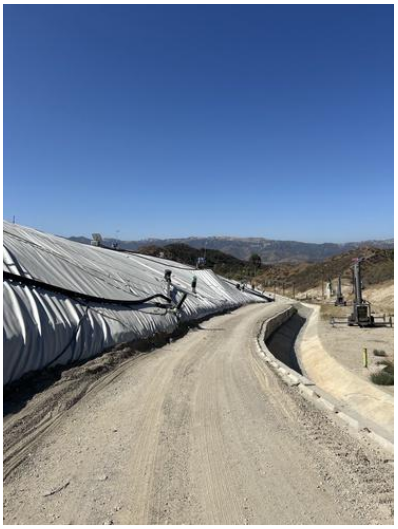
Photo 1

Description of area in photo where there is no leachate seepage or pooling.	West side perimeter road

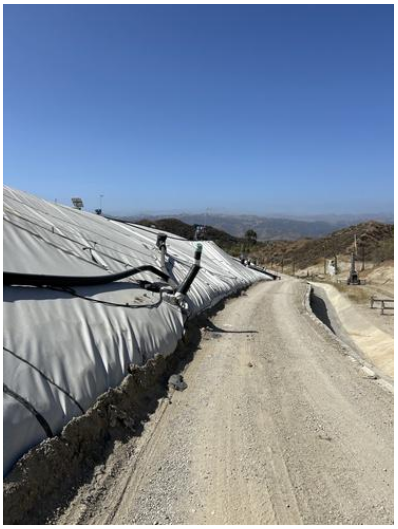
Photo 1

Description of area in photo where there is no leachate seepage or pooling.	West side perimeter road

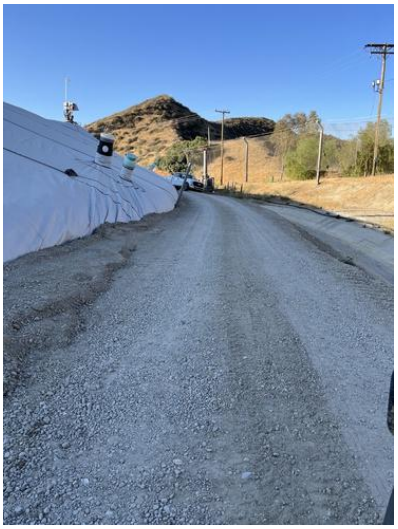
Photo 1

Description of area in photo where there is no leachate seepage or pooling.	Westside perimeter road.

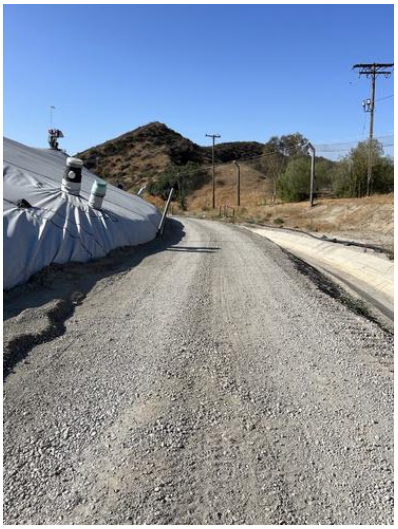
Photo 1

Description of area in photo where there is no leachate seepage or pooling.	Westside perimeter road.

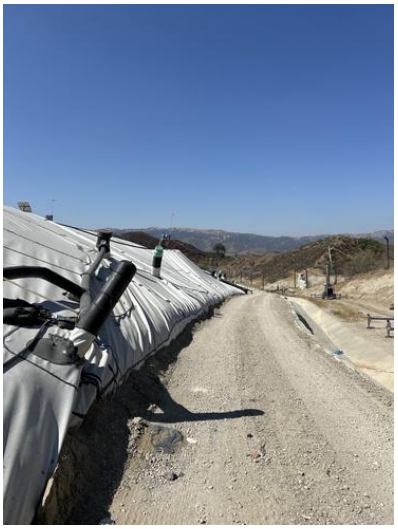
Photo 1

Description of area in photo where there is no leachate seepage or pooling.	West side perimeter road

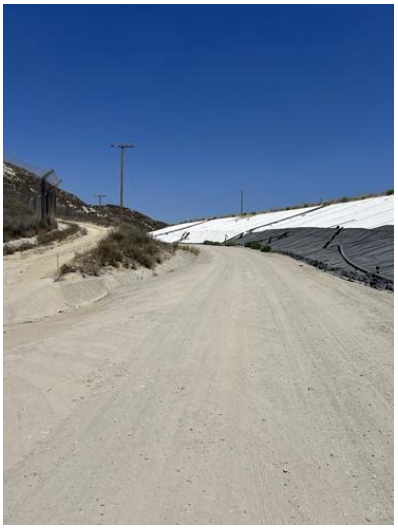
Photo 1

Description of area in photo where there is no leachate seepage or pooling.	North side perimeter road

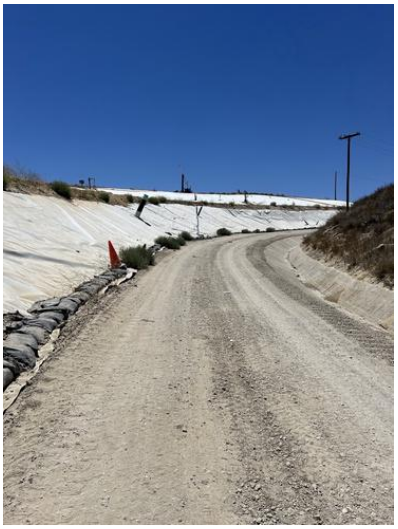
Photo 1

Description of area in photo where there is no leachate seepage or pooling.	North perimeter road.

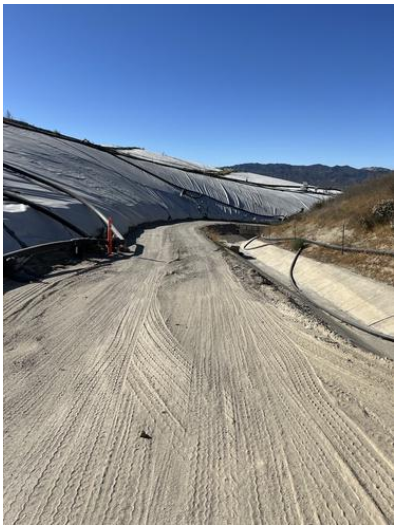
Photo 1

Description of area in photo where there is no leachate seepage or pooling.	Westside perimeter road.

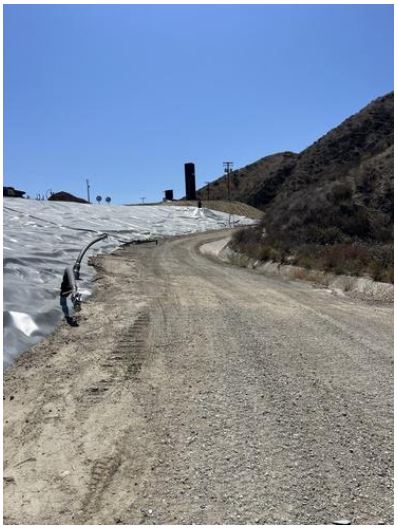
Photo 1

Description of area in photo where there is no leachate seepage or pooling.	North perimeter road.

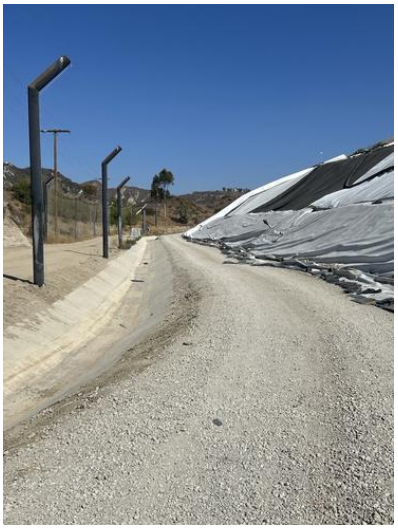
Photo 1

Description of area in photo where there is no leachate seepage or pooling.	West side perimeter road

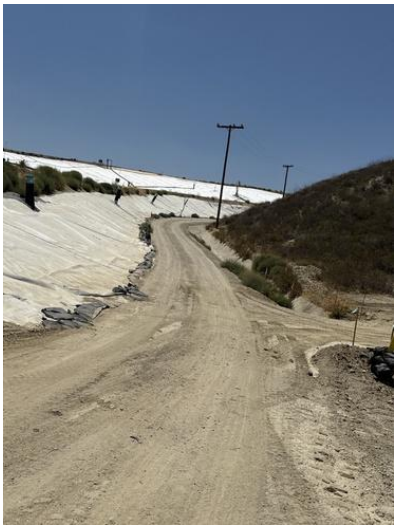
Photo 1

Description of area in photo where there is no leachate seepage or pooling.	North side perimeter road

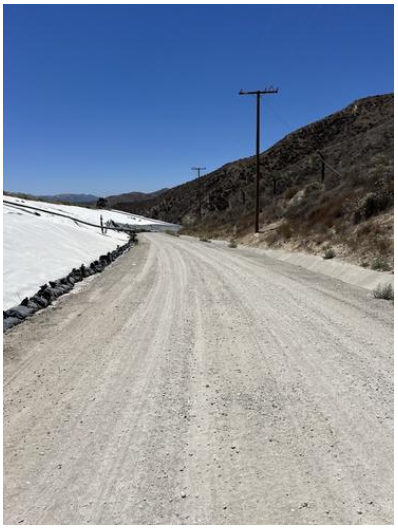
Photo 1

Description of area in photo where there is no leachate seepage or pooling.	North perimeter road.
