SOUTH COAST AIR QUALITY MANAGEMENT DISTRICT

CHIQUITA CANYON, LLC a Delaware Corporation,
[Facility ID No. 119219]

Case No. 6177-4

Subject: November 2025 Monthly Report for Modified Stipulated Order for Abatement (Case No. 6177-4), Chiquita Canyon Landfill (Facility ID 119219), Castaic, California

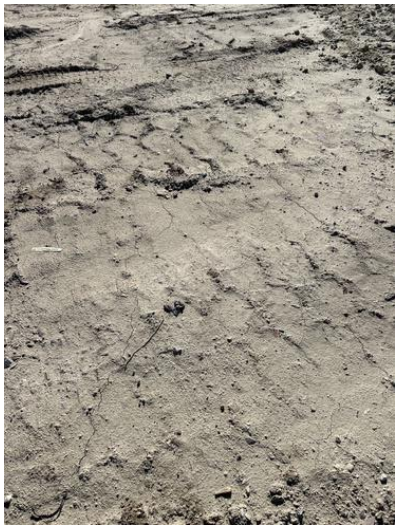
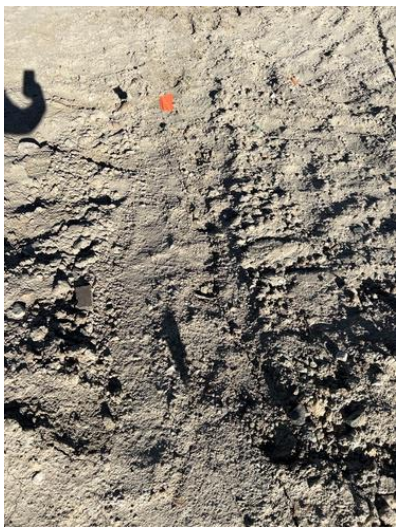
Grid Location	147.148
Date and Time Found	27 Oct 2025 10:38 AM PDT

Length of crack (ft) or area containing multiple cracks (ft x ft)	40ft x 95ft

No single crack over 50ft in length.

Horizontal Offset (width)	Small 0.5-2" in width
Vertical Offset (height)	Extra small <0.5" in height
Orientation (direction)	NW to SE
Location	Castaic CA 91384 United States (34.43548875526501, -118.64624249169393)
Was Fissure or Crack fixed? If yes, add photo and description of repairs performed	Yes

Date and time of repairs	27 Oct 2025 12:21 PM PDT
Description of repairs	Cracks were track walked.
Instability	
Are there any indications of slope stability concerns?	No

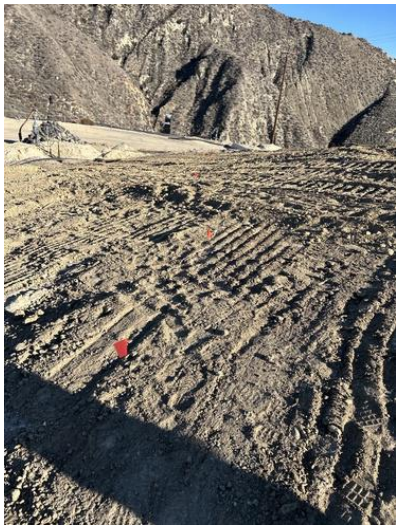
Photo 4

Length of crack (ft) or area containing multiple cracks (ft x ft)	60ft x 5ft
No individual crack longer than 50ft	
Horizontal Offset (width)	Small 0.5-2" in width
Vertical Offset (height)	Extra small <0.5" in height
Orientation (direction)	N to S
Location	Castaic CA 91384 United States (34.43598244531228, -118.64678979979162)
Was Fissure or Crack fixed? If yes, add photo and description of repairs performed	Yes

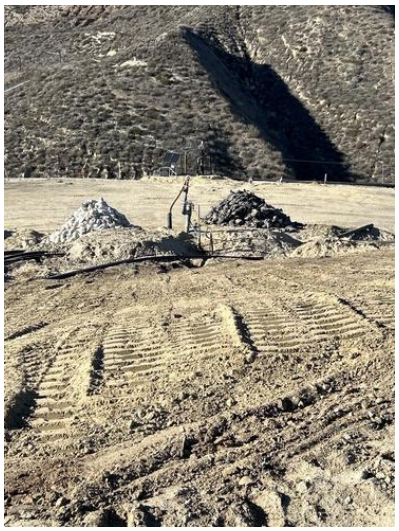
Photo 5

Grid Location	146
Date and Time Found	29 Oct 2025 9:12 AM PDT

Date and time of repairs	29 Oct 2025 10:05 AM PDT

Description of repairs	Cracks were track walked.
Instability	
Are there any indications of slope stability concerns?	No

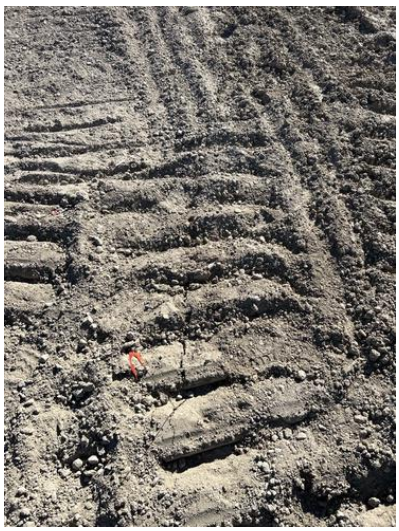
Grid Location	147
Date and Time Found	30 Oct 2025 11:04 AM PDT

Length of crack (ft) or area containing multiple cracks (ft x ft)	80ft x 10ft
No individual crack longer than 50ft.	
Horizontal Offset (width)	Medium 2-4" in width
Vertical Offset (height)	Extra small <0.5" in height
Orientation (direction)	NW to SE
Location	Castaic CA 91384 United States (34.435747955930495, -118.64674927592255)
Was Fissure or Crack fixed? If yes, add photo and description of repairs performed	Yes

Date and time of repairs	30 Oct 2025 12:21 PM PDT

Description of repairs	Cracks were track walked.
Instability	
Are there any indications of slope stability concerns?	No

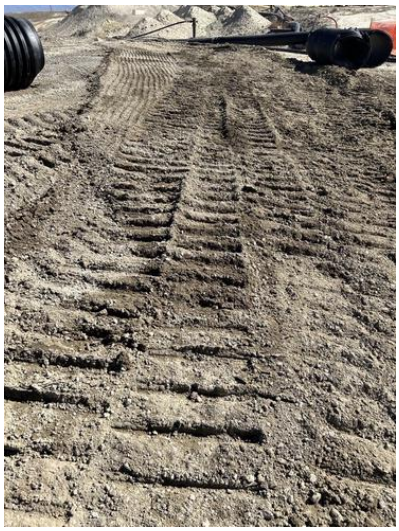
Horizontal Offset (width)	Small 0.5-2" in width
Vertical Offset (height)	Extra small <0.5" in height
Orientation (direction)	N to S
Location	Castaic CA 91384 United States (34.436419968828076, -118.64696340131236)
Was Fissure or Crack fixed? If yes, add photo and description of repairs performed	Yes

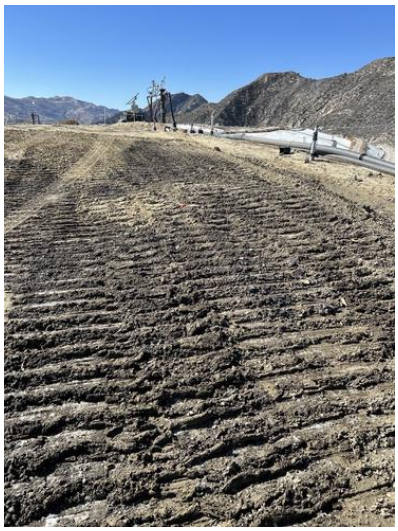
Photo 2

Grid Location	146
Date and Time Found	31 Oct 2025 10:39 AM PDT

Length of crack (ft) or area containing multiple cracks (ft x ft)	3ft

Date and time of repairs	31 Oct 2025 12:07 PM PDT
Description of repairs	Cracks were track walked.

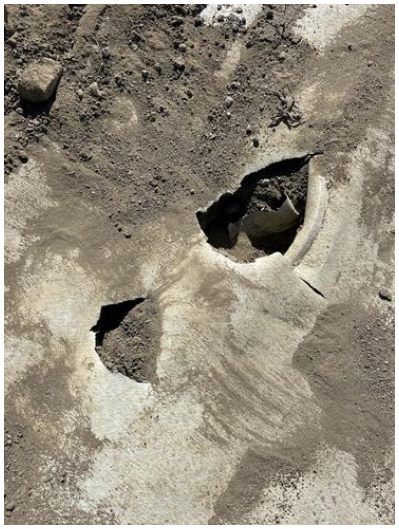
Grid 202

Are there any issues with the geosynthetic cover?	Yes
Date and Time Issue Found	6 Nov 2025 12:07 PM PST

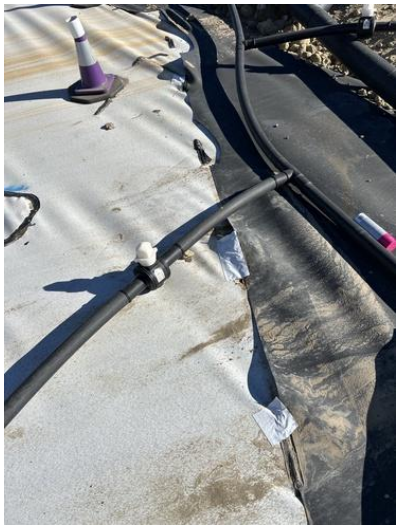
Grid 145

Identification of Issues	
Identified Issue	
Identified Issue 1	
Are there any issues with the geosynthetic cover?	Yes
Date and Time Issue Found	7 Nov 2025 12:21 PM PST

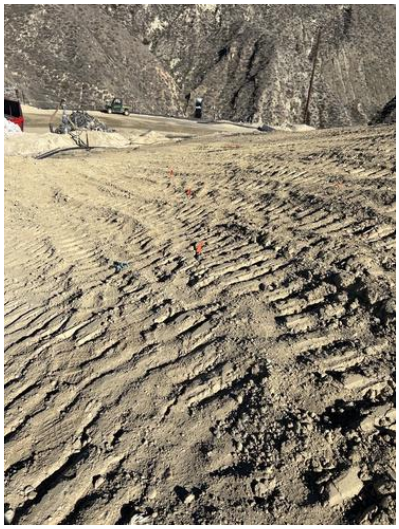
Length of crack (ft) or area containing multiple cracks (ft x ft)	8ft x 25ft
Horizontal Offset (width)	Small 0.5-2" in width
Vertical Offset (height)	Extra small <0.5" in height
Orientation (direction)	NW to SE
Location	Castaic CA 91384 United States (34.43648100738489, -118.64679440910662)
Was Fissure or Crack fixed? If yes, add photo and description of repairs performed	Yes

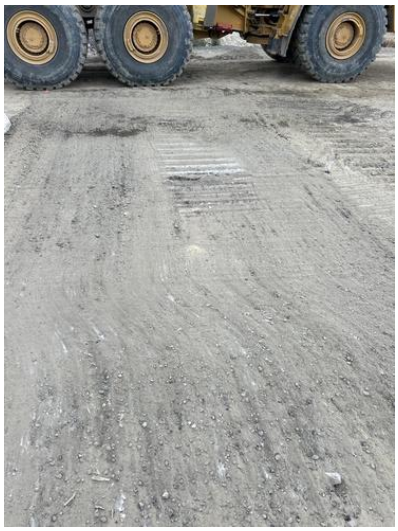
Length of crack (ft) or area containing multiple cracks (ft x ft)	25ftx4ft area
Horizontal Offset (width)	Small 0.5-2" in width
Vertical Offset (height)	Extra small <0.5" in height
Orientation (direction)	NE to SW
Location	Castaic CA 91384 United States (34.43305905430511, -118.64750840127373)
Was Fissure or Crack fixed? If yes, add photo and description of repairs performed	Yes

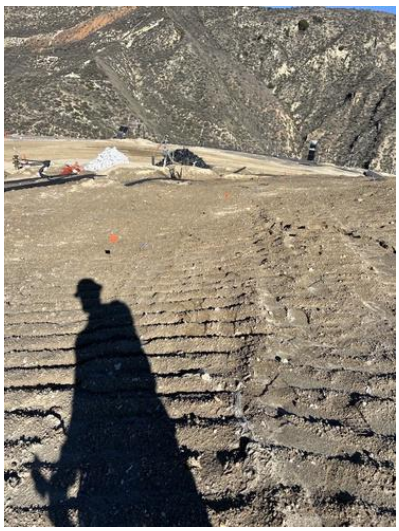
Photo 5

Length of crack (ft) or area containing multiple cracks (ft x ft)	45ft x 15ft
Horizontal Offset (width)	Large >4" in width
Vertical Offset (height)	Extra small <0.5" in height
Orientation (direction)	N to S
Location	Castaic CA 91384 United States (34.43591857887537, -118.64689834943746)
Was Fissure or Crack fixed? If yes, add photo and description of repairs performed	Yes

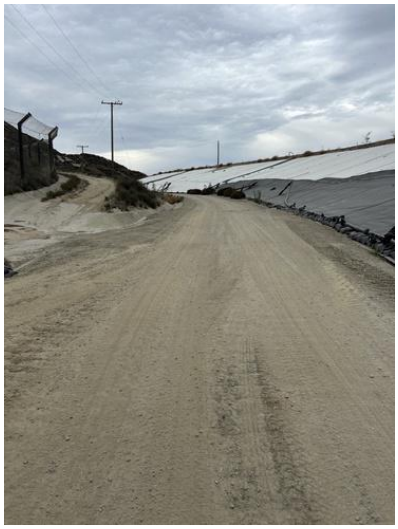
Photo 1

Description of area in photo where there is no leachate seepage or pooling.	North perimeter road.

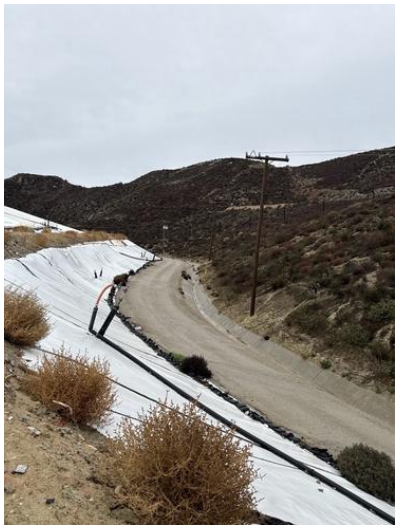
Photo 1

Description of area in photo where there is no leachate seepage or pooling.	North side perimeter road

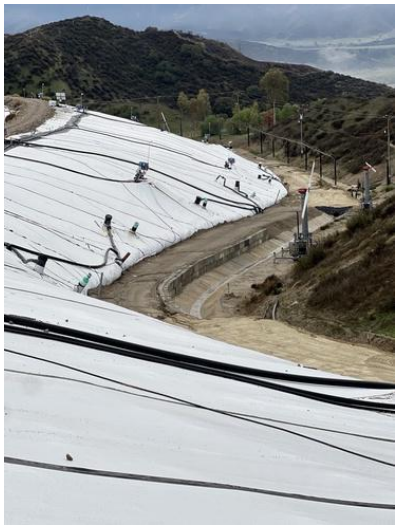
Photo 1

Description of area in photo where there is no leachate seepage or pooling.	Westside perimeter road.

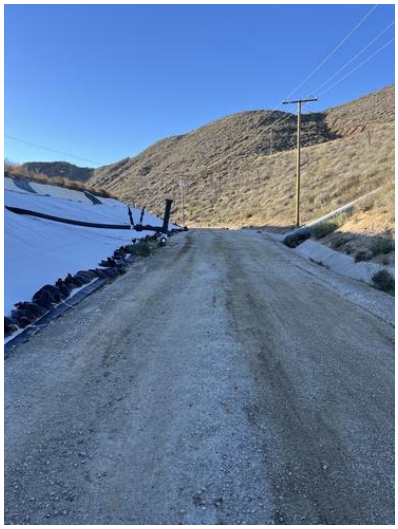
Photo 1

Description of area in photo where there is no leachate seepage or pooling.	North perimeter road.

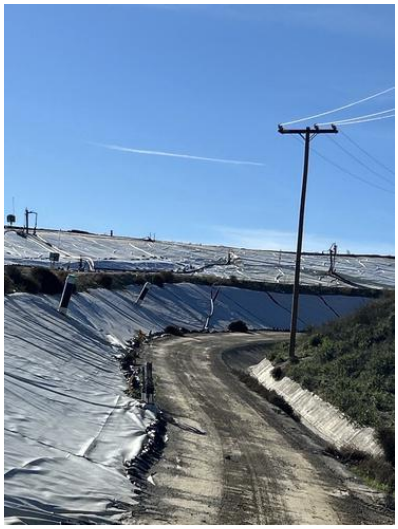
Photo 1

Description of area in photo where there is no leachate seepage or pooling.	North side perimeter road

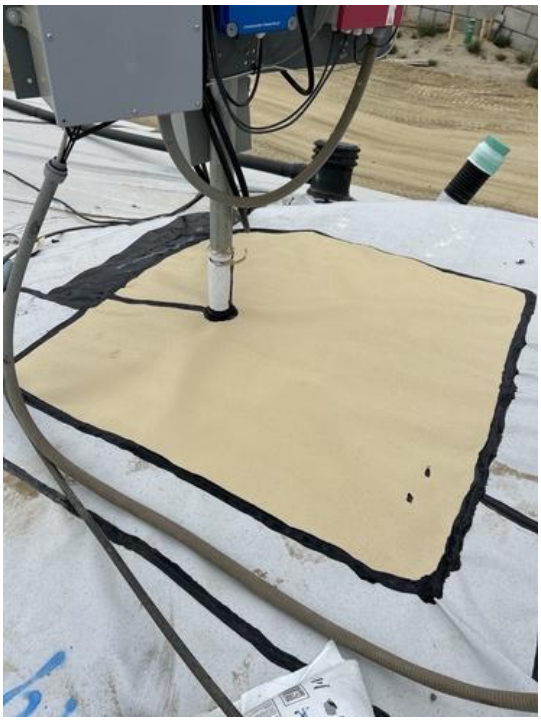
Photo 4

Notate what the issue is and what needs to be repaired	Two boots separated from liner in close proximity to each other. Newd to be patched and extrusion welded

Description of repair work	One poll was removed, liner was patched and extrusion welded in both locations
Date and time of repair	12 Nov 2025 4:54 PM PST
Are further permanent repairs required?	No
