**Case No. 6177-4**

**EXHIBIT G TO DECLARATION OF PATRICK SULLIVAN, BCES, CPP, REPA**

Subject: December 2025 Monthly Report for Modified Stipulated Order for Abatement (Case No. 6177-4), Chiquita Canyon Landfill (Facility ID 119219), Castaic, California

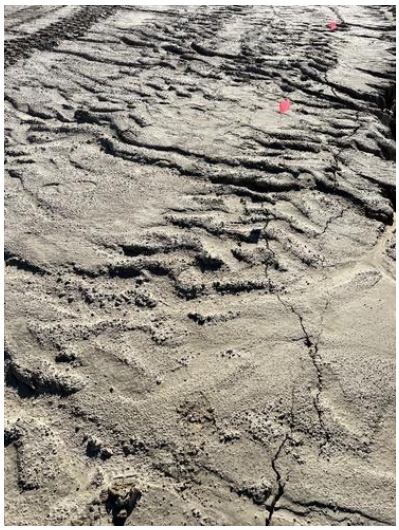
Photo 1

| **Fissure or Tension Crack Found?** | Yes |

| **Date and Time Found** | 1 Dec 2025 9:32 AM PST |

| **Length of crack (ft) or area containing multiple cracks (ft x ft)** | 65ft x 6ft |

Longest crack approximately 25ft

| **Was Fissure or Crack fixed? If yes, add photo and description of repairs performed** | Yes |

| **Date and time of repairs** | 1 Dec 2025 10:51 AM PST |

| **Description of repairs** | Cracks were track walked. |

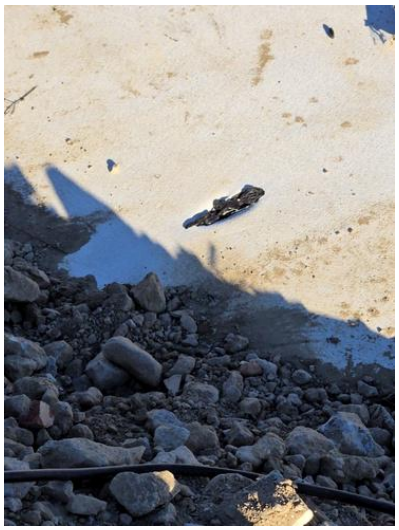
Permanent repairs were conducted on 12/11/25 at 8:30am. Liner was patched and extrusion welded

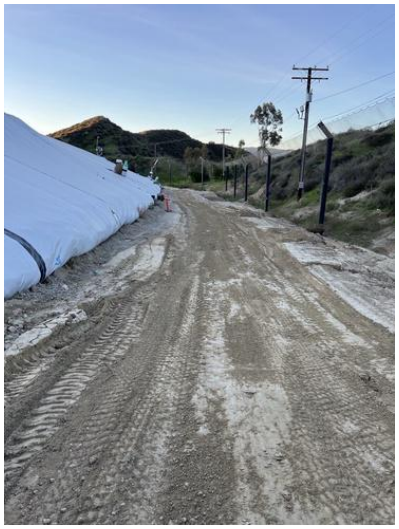
Photo 1

| **Has a leachate seep/pooling been located?** | No |

| **Description of area in photo where there is no leachate seepage or pooling.** | Westside perimeter road. |

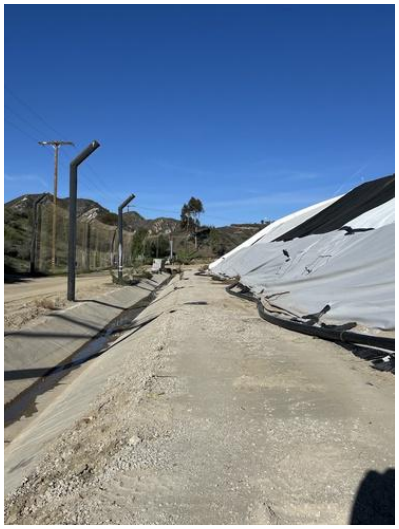
Photo 1

| **Has a leachate seep/pooling been located?** | No |

| **Description of area in photo where there is no leachate seepage or pooling.** | West side perimeter road |

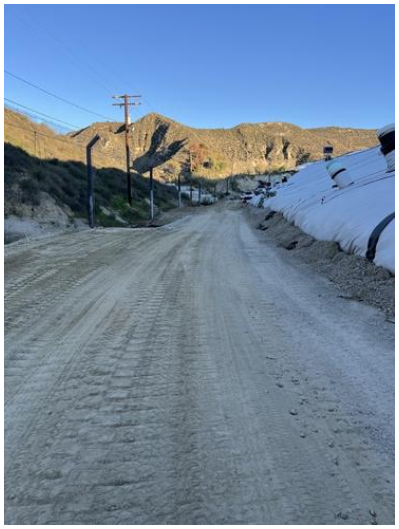
Photo 1

| **Has a leachate seep/pooling been located?** | No |

| **Description of area in photo where there is no leachate seepage or pooling.** | Westside perimeter road. |

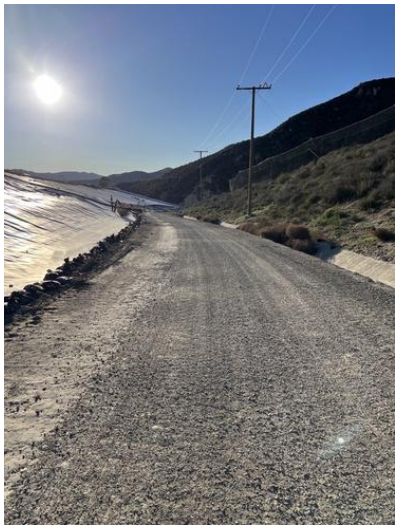
Photo 1

| **Has a leachate seep/pooling been located?** | No |

| **Description of area in photo where there is no leachate seepage or pooling.** | North perimeter road. |

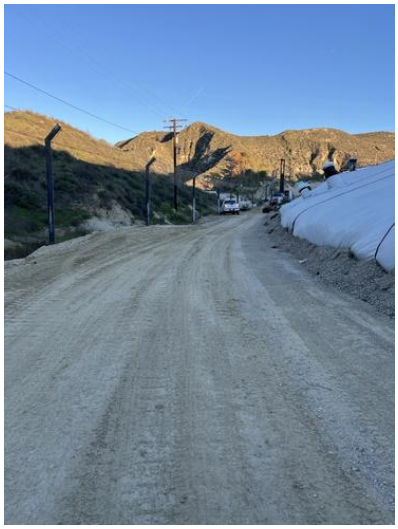
Photo 1

| **Has a leachate seep/pooling been located?** | No |

| **Description of area in photo where there is no leachate seepage or pooling.** | Westside perimeter road. |

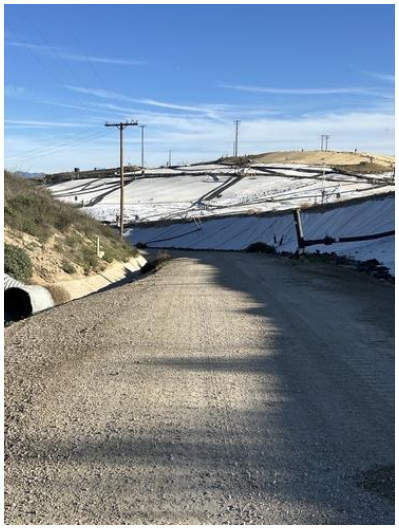
Photo 1

| **Has a leachate seep/pooling been located?** | No |

| **Description of area in photo where there is no leachate seepage or pooling.** | North side perimeter road |

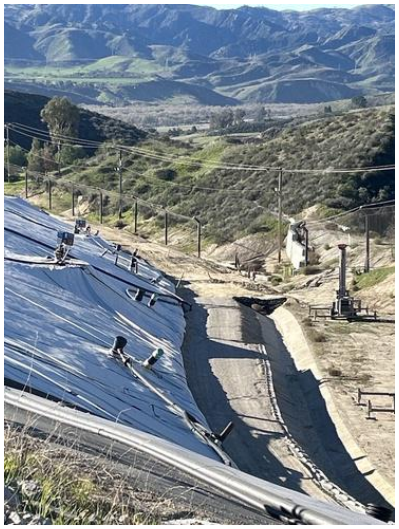
Photo 1

| **Has a leachate seep/pooling been located?** | No |

| **Description of area in photo where there is no leachate seepage or pooling.** | West side perimeter road |

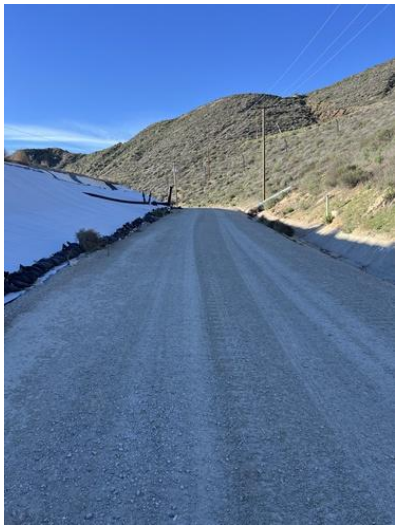
Photo 1

| **Has a leachate seep/pooling been located?** | No |

| **Description of area in photo where there is no leachate seepage or pooling.** | North perimeter road. |

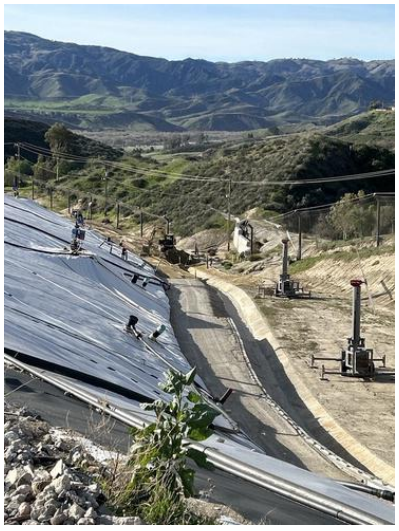
Photo 1

| **Has a leachate seep/pooling been located?** | No |

| **Description of area in photo where there is no leachate seepage or pooling.** | West side perimeter road |

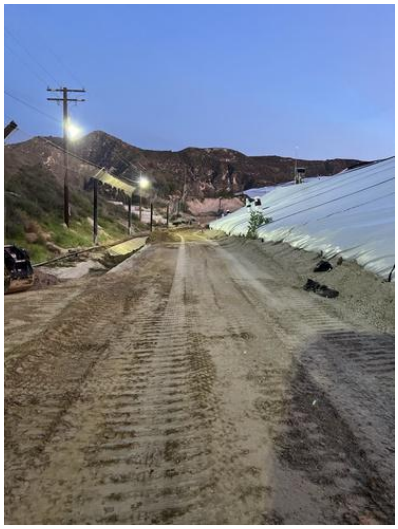
Photo 1

| **Has a leachate seep/pooling been located?** | No |

| **Description of area in photo where there is no leachate seepage or pooling.** | Westside perimeter road. |

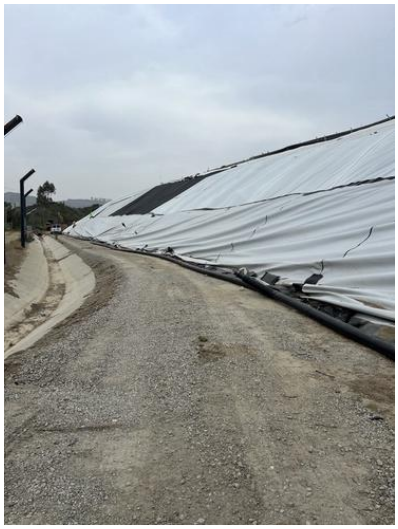
Photo 1

| **Has a leachate seep/pooling been located?** | No |

| **Description of area in photo where there is no leachate seepage or pooling.** | Westside perimeter road. |

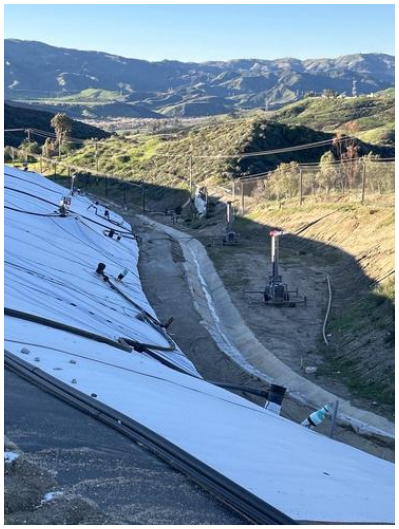
Photo 1

| **Has a leachate seep/pooling been located?** | No |

| **Description of area in photo where there is no leachate seepage or pooling.** | Westside perimeter road. |
