SOUTH COAST AIR QUALITY MANAGEMENT DISTRICT

Case No. 6177-4

Subject: January 2026 Monthly Report for Modified Stipulated Order for Abatement (Case No. 6177-4), Chiquita Canyon Landfill (Facility ID 119219), Castaic, California

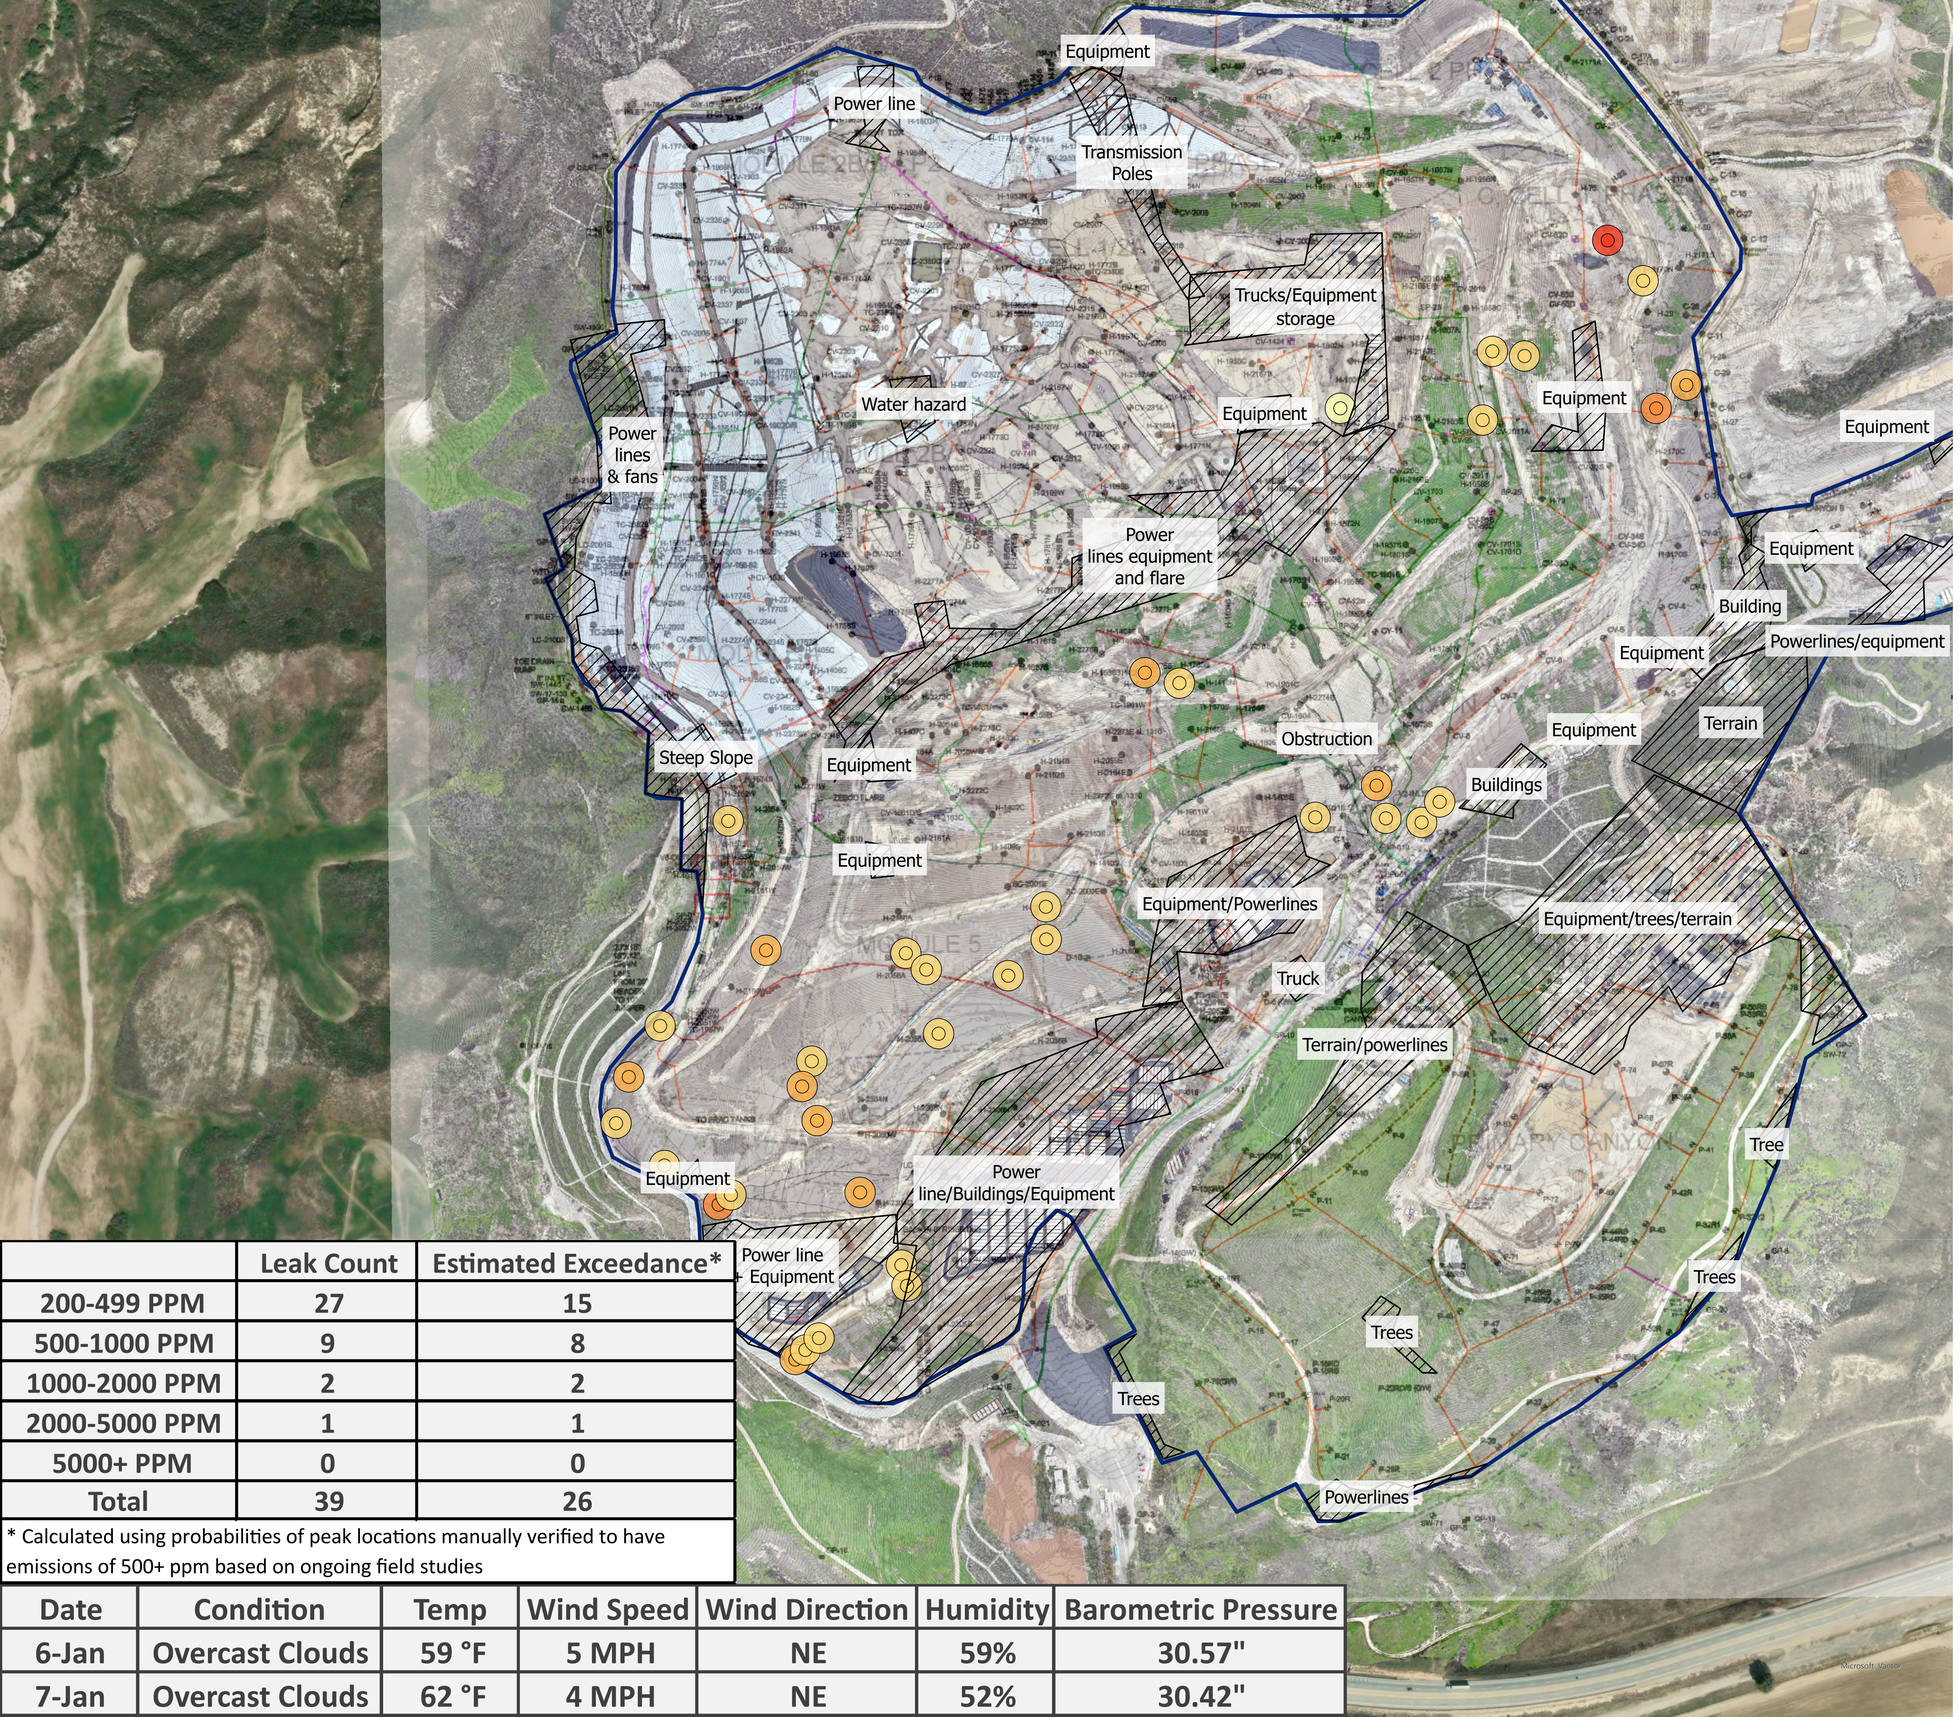
Leak Count	Estimated Exceedance*
200-499 PPM	27	15
500-1000 PPM	9	8
1000-2000 PPM	2	2
2000-5000 PPM	1	1
5000+ PPM	0	0
Total	39	26

* Calculated using probabilities of peak locations manually verified to have emissions of 500+ ppm based on ongoing field studies
