SOUTH COAST AIR QUALITY MANAGEMENT DISTRICT

In The Matter Of SOUTH COAST AIR QUALITY MANAGEMENT DISTRICT, Petitioner, vs. CHIQUITA CANYON, LLC a Delaware Corporation, [Facility ID No. 119219] Respondent.	**Case No. 6177-4** **EXHIBIT J TO DECLARATION OF PATRICK SULLIVAN, BCES, CPP, REPA** Health and Safety Code § 41700, and District Rules 402, 431.1, 3002, 203, 1150 Hearing Date: May 28, 2026 Hearing Time: 9:30 A.M. Place: Hearing Board South Coast Air Quality Management District, 21865 Copley Drive Diamond Bar, CA 91765

Subject: March 2026 Monthly Report for Modified Stipulated Order for Abatement (Case No. 6177-4), Chiquita Canyon Landfill (Facility ID 119219), Castaic, California

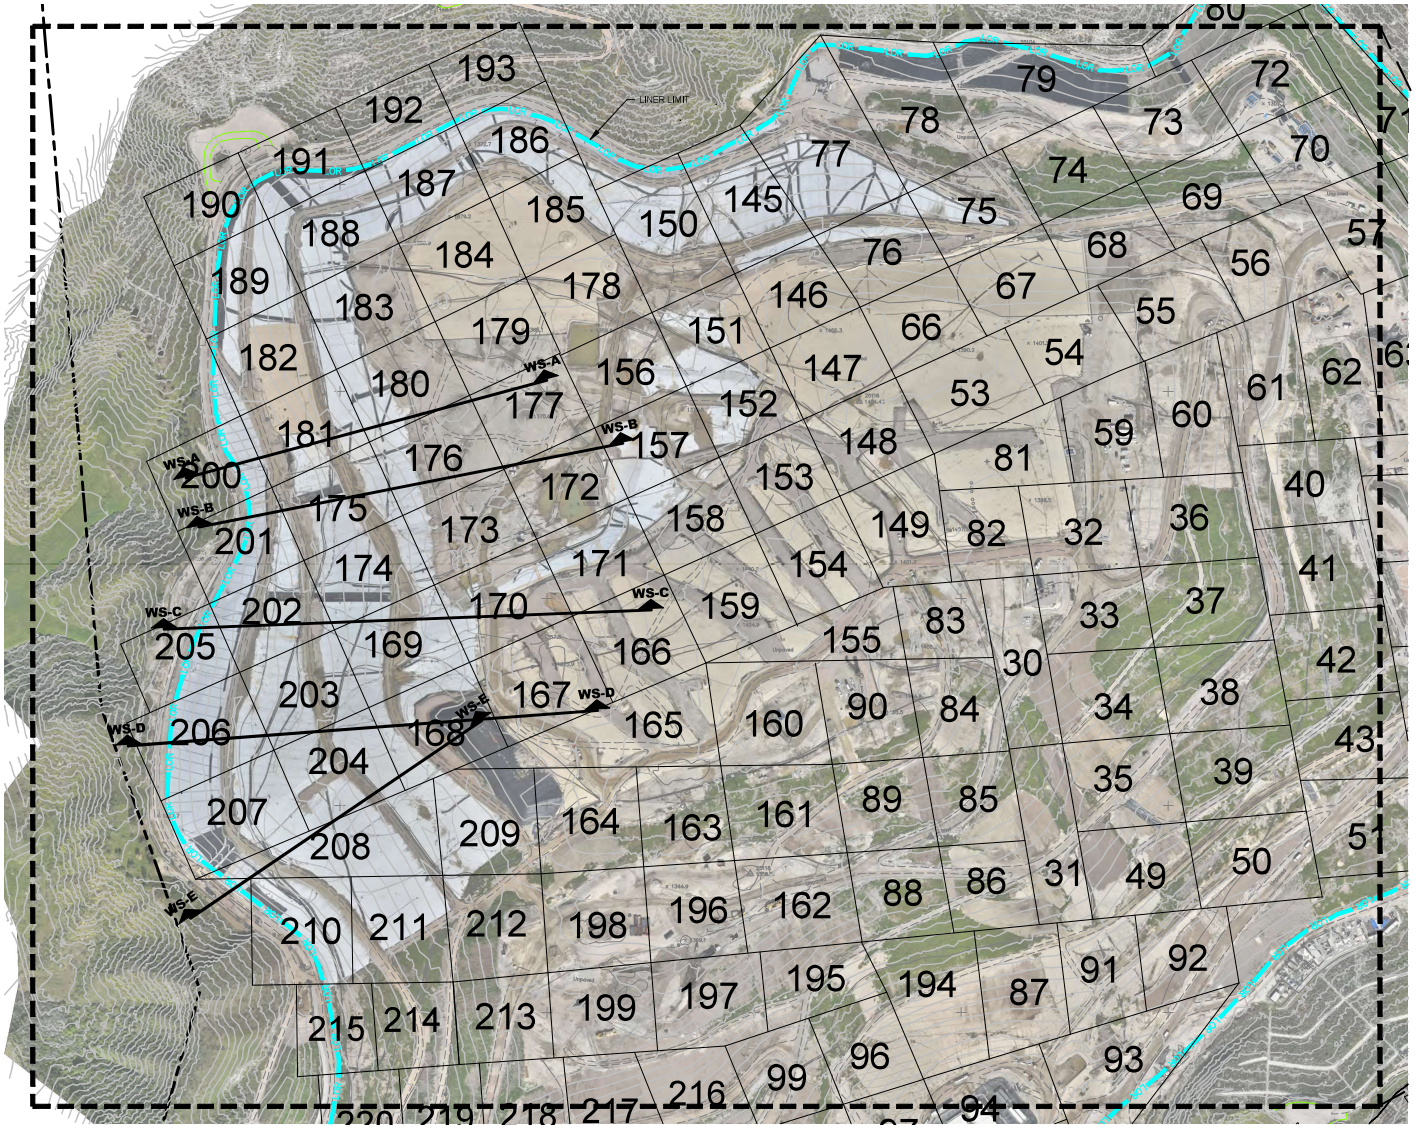
1. A hole where a pole was removed in Grid 184 needs to be patched and repaired. Hole was taped and sandbagged on discovery and the area was covered with soil. This area is scheduled to be covered with new EVOH liner.

2. A hole in the liner in Grid 170 needs to be patched and extrusion welded. The hole was taped and sandbagged on discovery and was later patched and extrusion welded.

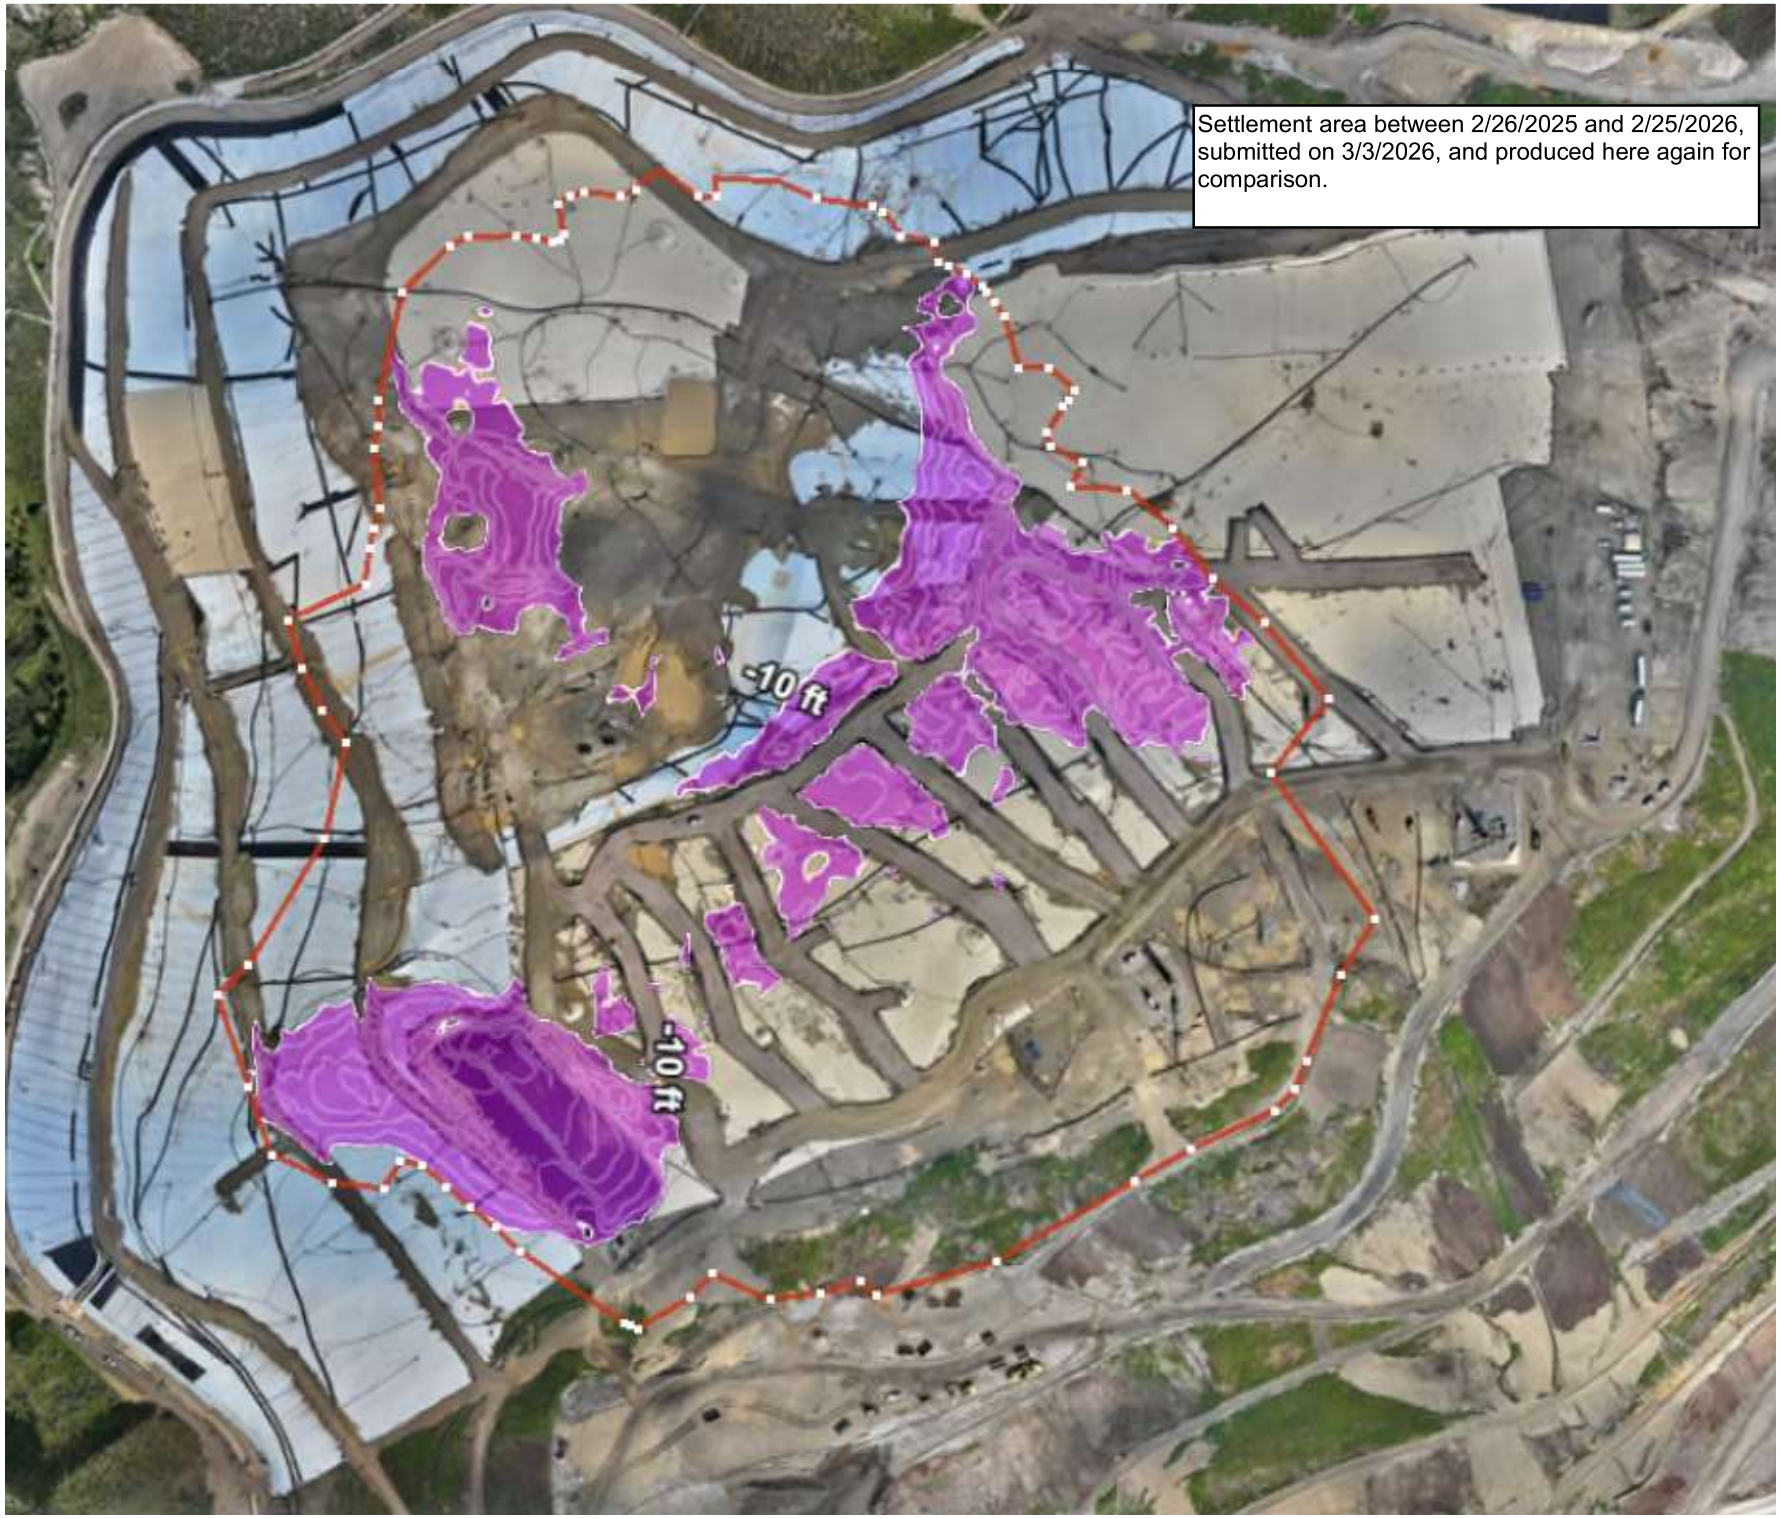
Settlement area between 2/26/2025 and 2/25/2026, submitted on 3/3/2026, and produced here again for comparison.
-10 ft
-10 ft

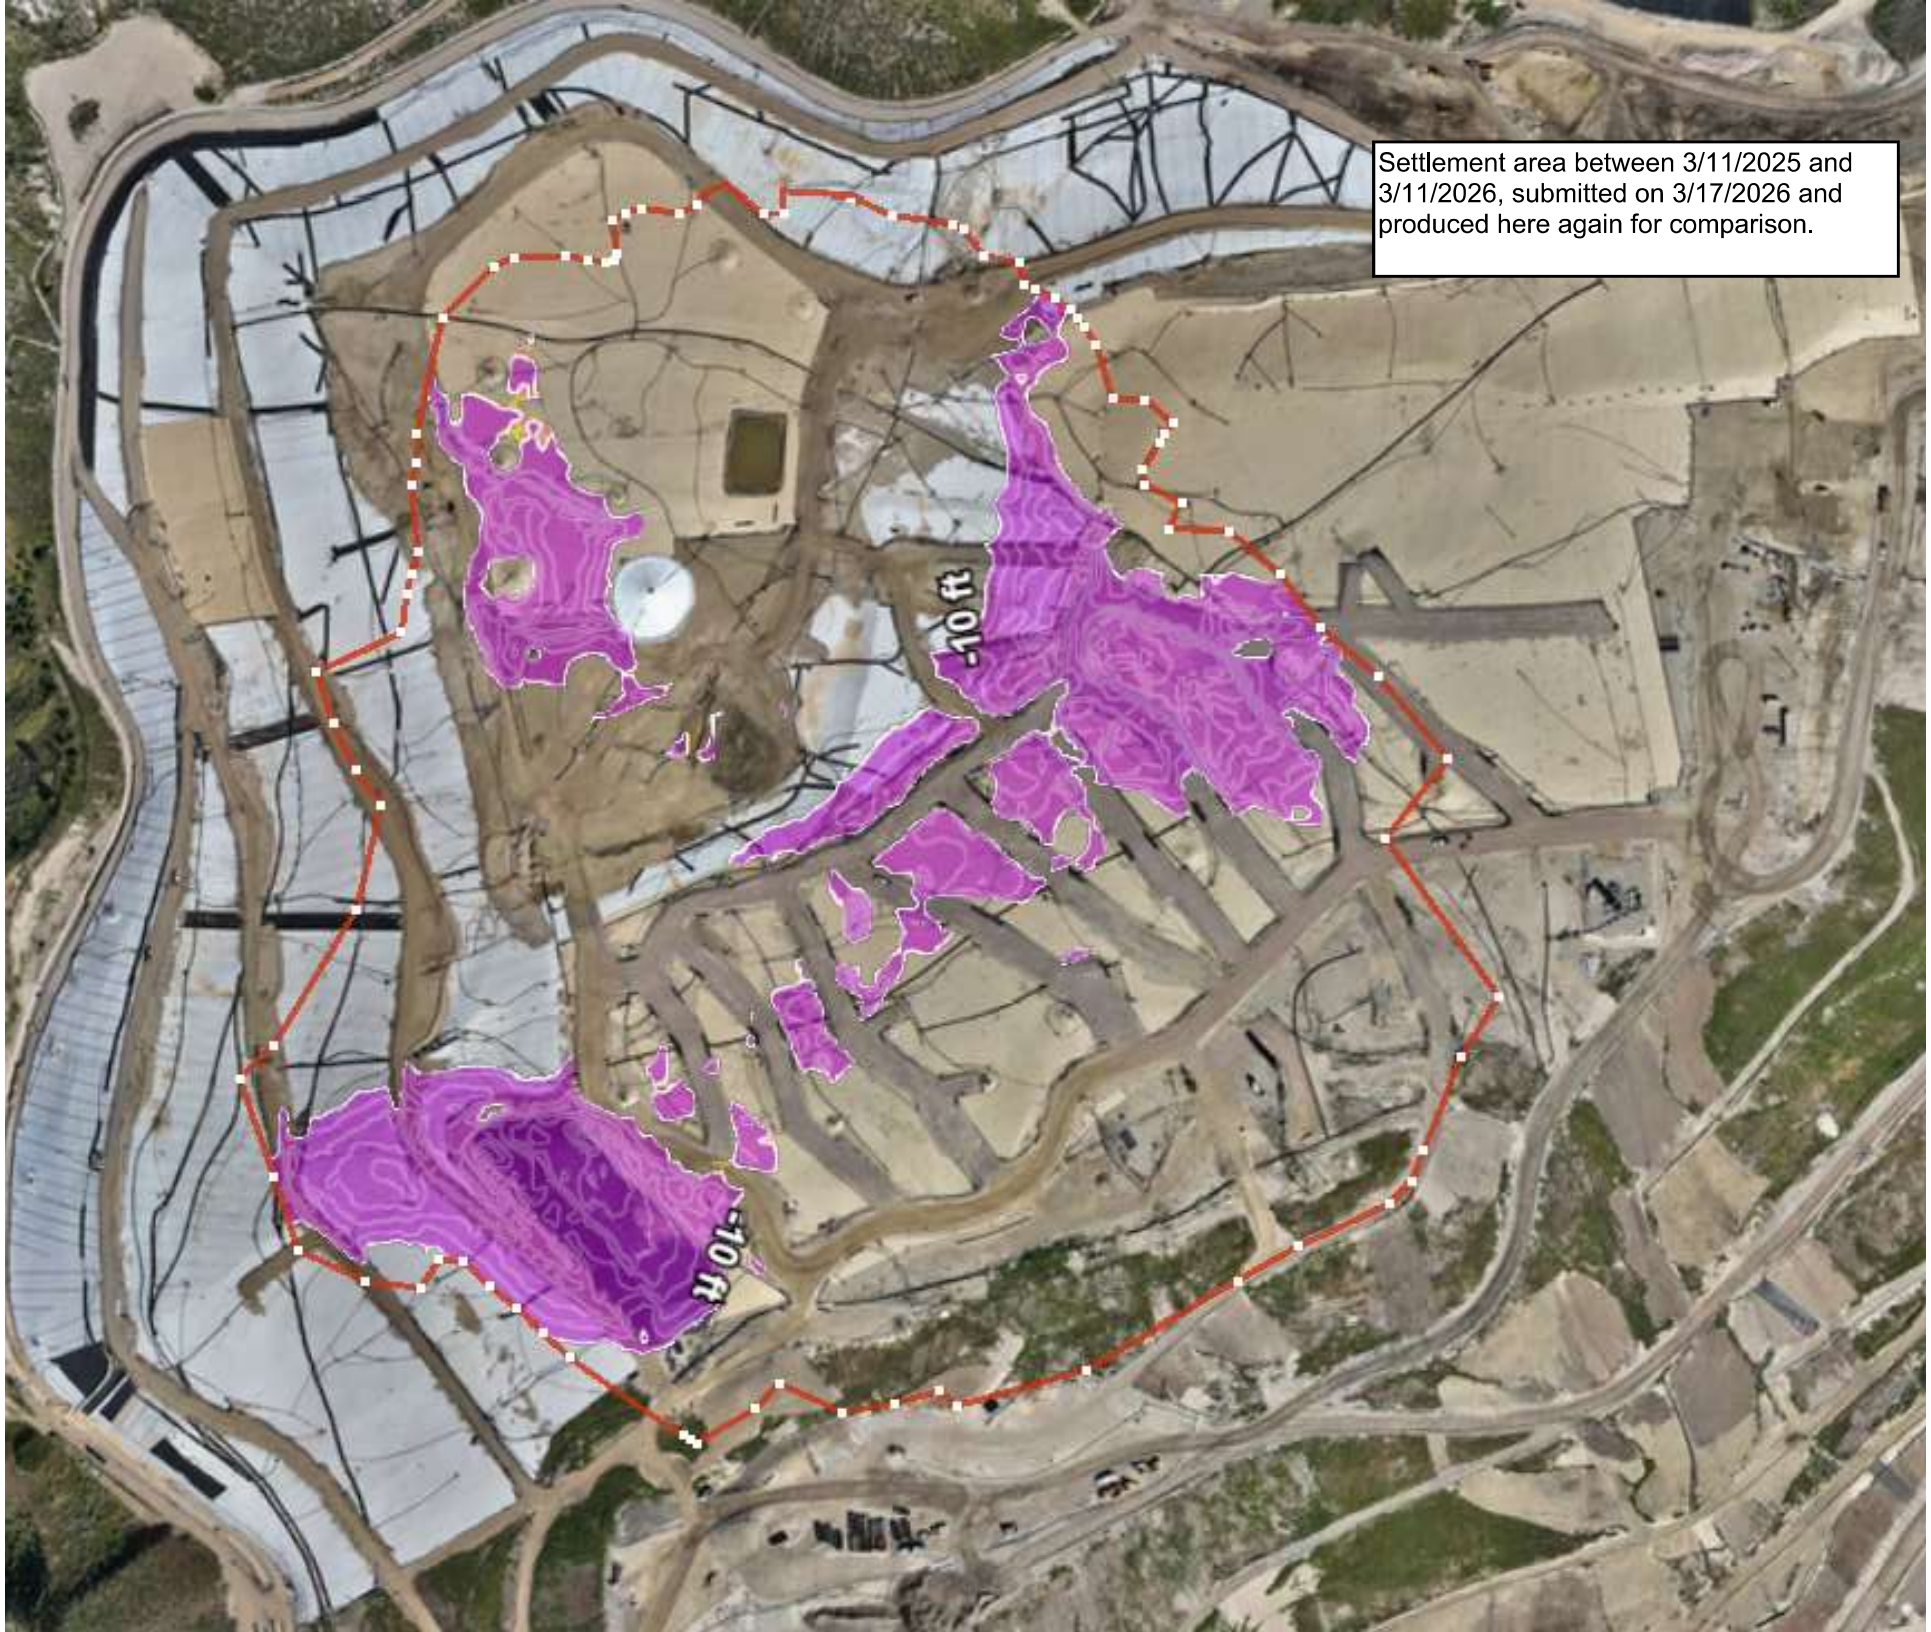
Settlement area between 3/11/2025 and 3/11/2026, submitted on 3/17/2026 and produced here again for comparison.
-10 ft
-10 ft

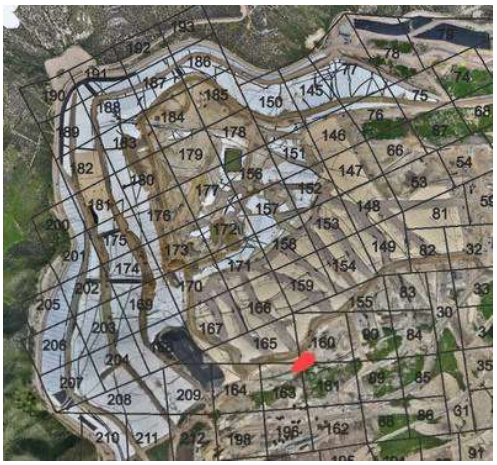
Grid Location	163

Fissure or Tension Crack Found?	Yes

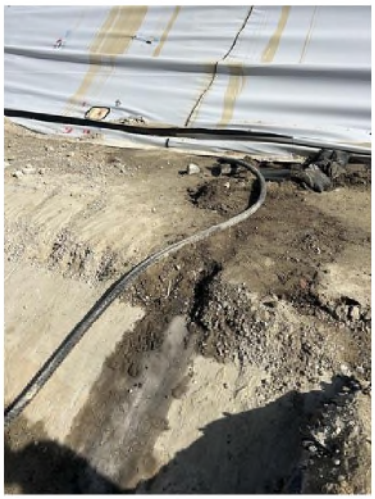
Photo 2

Did the seep/pooling travel into the stormwater channel? Yes
