SOUTH COAST AIR QUALITY MANAGEMENT DISTRICT

Case No. 6177-4

Subject: April 2026 Monthly Report for Modified Stipulated Order for Abatement (Case No. 6177-4), Chiquita Canyon Landfill (Facility ID 119219), Castaic, California

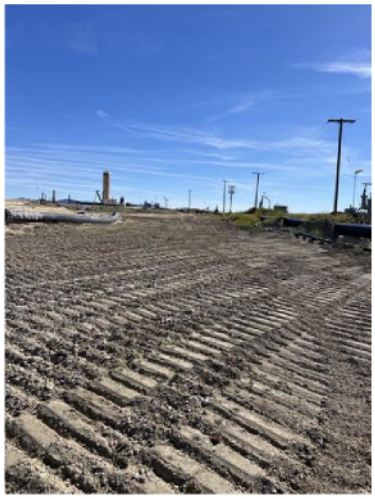
Chiquita Canyon Landfill (CCL) is a landfill/solid waste disposal facility located at 29201 Henry Mayo Dr., Castaic, California, 91384 (SCAQMD Facility No. 119219). In connection with the landfill, Chiquita operates a landfill gas collection and control system.

This report covers the monthly period for April 2026. Per Condition No. 8, the monthly report for April 2026 is due on the 20th of the month (or the next business day), which is Wednesday, May 20, 2026.

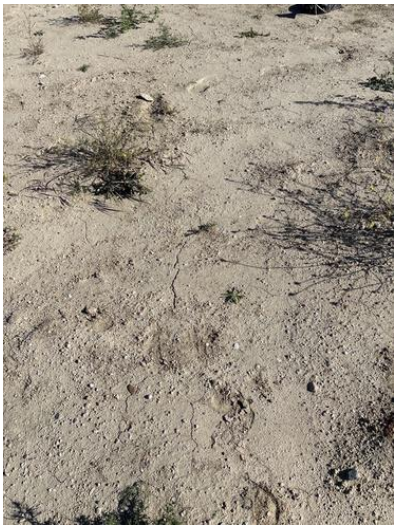
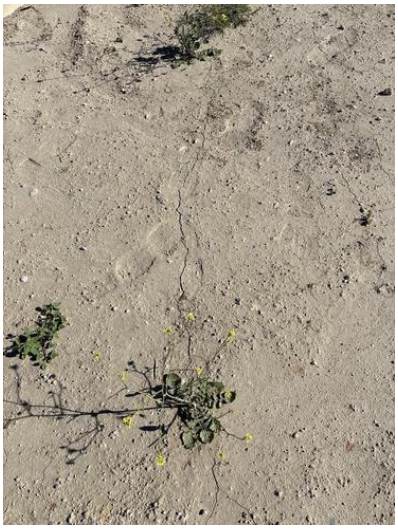
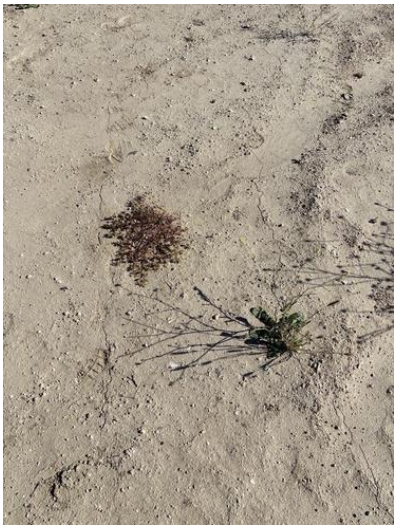
Grid Location	164
Date and Time Found	14 Apr 2026 9:19 AM PDT

Length of crack (ft) or area containing multiple cracks (ft x ft)	15ft x 65ft
No individual crack 50ft or longer	
Horizontal Offset (width)	Extra Small <0.5 in width
Vertical Offset (height)	Extra small <0.5" in height
Orientation (direction)	N to S
Location	Castaic CA 91384 United States (34.432828185542846, -118.64833848975654)
Was Fissure or Crack fixed? If yes, add photo and description of repairs performed	Yes

Date and time of repairs	14 Apr 2026 9:50 AM PDT

Description of repairs	Cracks were track walked.
Instability	
Are there any indications of slope stability concerns?	No

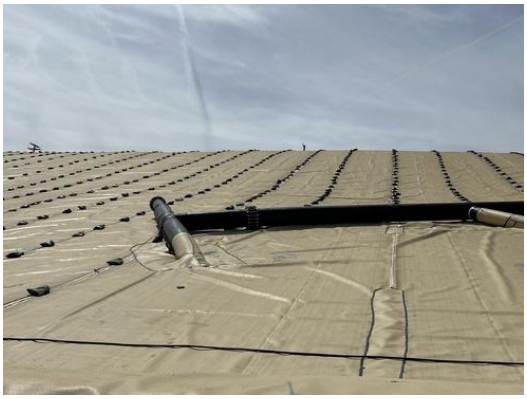
Photo 4

Notate what the issue is and what needs to be repaired	Tear in liner needs to be patched and extrusion welded.

Description of repair work	Tear taped and sandbagged upon discovery.
Date and time of repair (within 2 hours)	14 Apr 2026 9:47 AM PDT
Are further permanent repairs required?	No
Date and Time of final repair (if necessary)	14 Apr 2026 1:53 PM PDT
Instability under the cover	
Are there any anomalous (unusual or unexpected) areas of cover damage or deformation that may indicate underlying instability?	No
Are there any signs of a downslope tension crack at the top of the slope or bulging at or near the toe of the slope?	No
Is there any movement of the equipment that vertically penetrates the cover (e.g., tilting)?	No

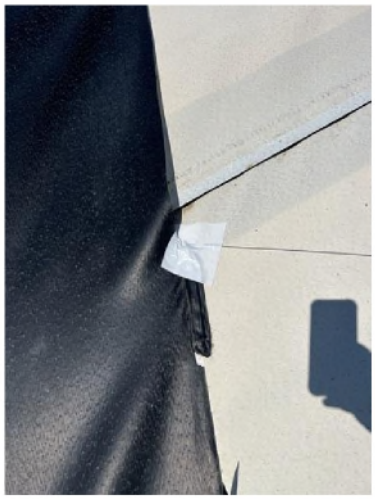
Photo 11

Notate what the issue is and what needs to be repaired	Small tear in liner needs to be patched/extrusion welded.

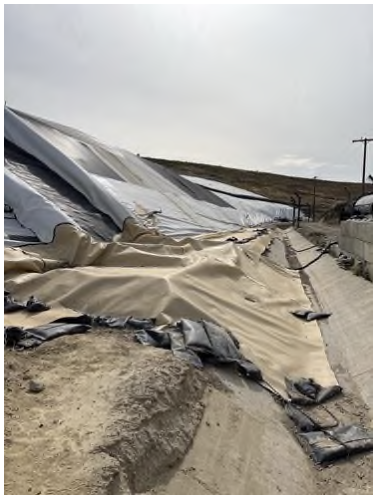
Photo 2

Description of area in photo where there is no leachate seepage or pooling.	Westside perimeter road. None of the seeps that occurred in this area were observed at the time of this inspection. Area continues to be monitored and vacuumed out as needed to prevent pooling

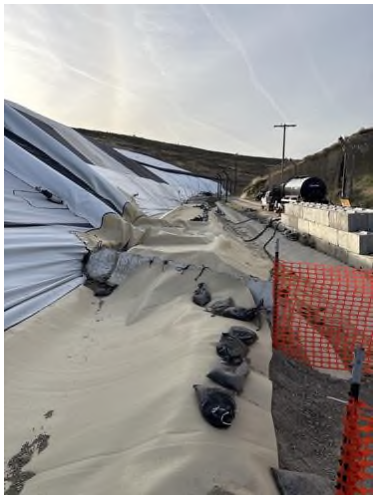
Photo 2

Description of area in photo where there is no leachate seepage or pooling.	Westside perimeter road. None of the seeps that occured in this area were observed at the time of this inspection Area continues to be monitored and vacuumed out as needed to prevent pooling

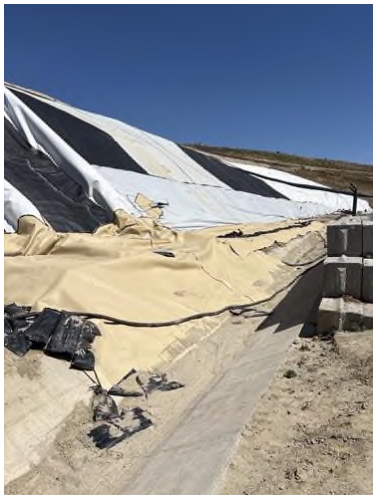
Photo 1

Description of area in photo where there is no leachate seepage or pooling.	Westside perimeter road. None of the seeps that occurred in this area were observed at the time of this inspection Area continues to be monitored and vacuumed out as needed to prevent pooling

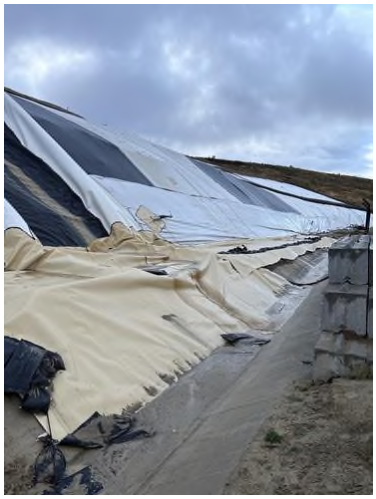
Photo 1

Has a leachate seep/pooling been located?	No

Description of area in photo where there is no leachate seepage or pooling.	Westside perimeter road. None of the seeps that occurred in this area were observed at the time of this inspection Area continues to be monitored and vacuumed out as needed to prevent pooling

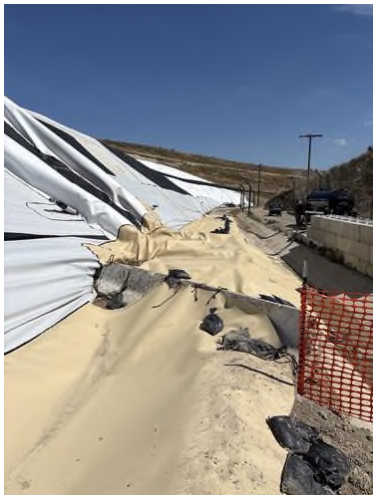
Photo 1

Has a leachate seep/pooling been located?	No

Description of area in photo where there is no leachate seepage or pooling.	Westside perimeter road. None of the seeps that occurred in this area were observed at the time of this inspection Area continues to be monitored and vacuumed out as needed to prevent pooling

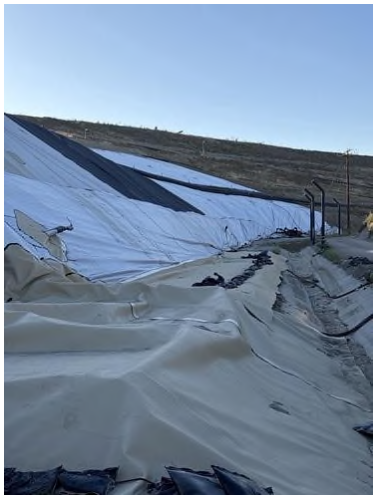
Photo 1

Has a leachate seep/pooling been located?	No

Description of area in photo where there is no leachate seepage or pooling.	Westside perimeter road. None of the seeps that occurred in this area were observed at the time of this inspection Area continues to be monitored and vacuumed out as needed to prevent pooling
