SOUTH COAST AIR QUALITY MANAGEMENT DISTRICT

Case No. 6177-4

EXHIBIT K TO DECLARATION OF PATRICK SULLIVAN, BCES, CPP, REPA

Subject: November 2024 Monthly Report for Modified Stipulated Order for Abatement (Case No. 6177-4), Chiquita Canyon Landfill (Facility ID 119219), Castaic, California

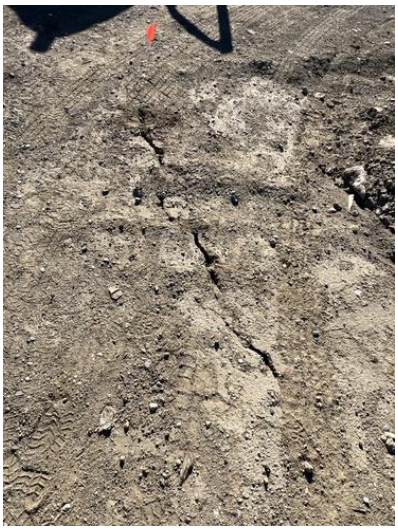
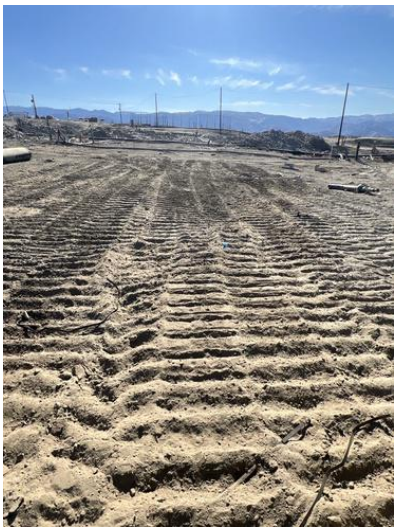
Photo 2

Length of crack (ft) or area containing multiple cracks (ft x ft)	8 ft

Horizontal Offset (width)	Small 0.5-2" in width
Vertical Offset (height)	Extra small <0.5" in height
Orientation (direction)	NW to SE
Location	Castaic CA 91384 United States (34.434227370689094, -118.64857994031034)
Was Fissure or Crack fixed? If yes, add photo and description of repairs performed	Yes

Date and time of repairs	18 Nov 2024 11:28 AM PST
Description of repairs	Cracks were track walked.

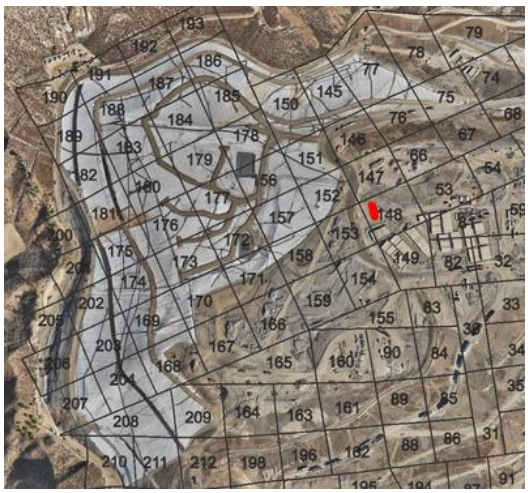
Grid Location	148

Fissure or Tension Crack Found?	Yes

Using the attached image, annotate all areas where inspectors identified a fissure or tension crack.

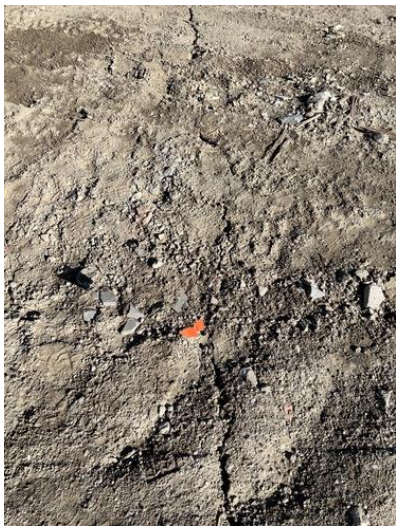
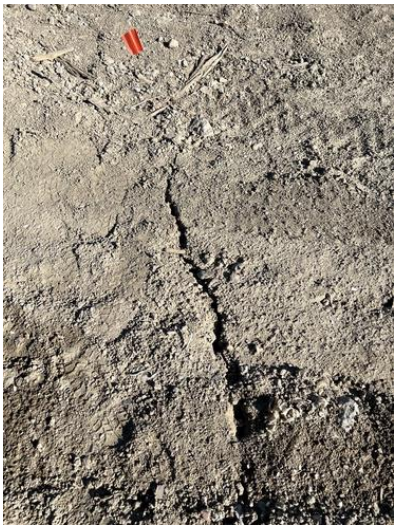
Length of crack (ft) or area containing multiple cracks (ft x ft)	20ft
Horizontal Offset (width)	Small 0.5-2" in width
Vertical Offset (height)	Extra small <0.5" in height
Orientation (direction)	N to S
Location	Castaic CA 91384 United States (34.43526957652944, -118.64670390274249)
Was Fissure or Crack fixed? If yes, add photo and description of repairs performed	Yes

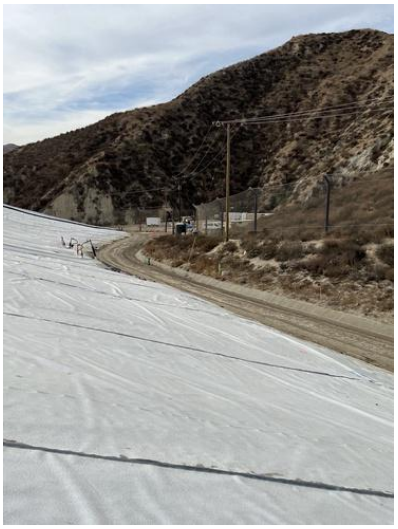
Photo 1

Description of area in photo where there is no leachate seepage or pooling.	North perimeter road.

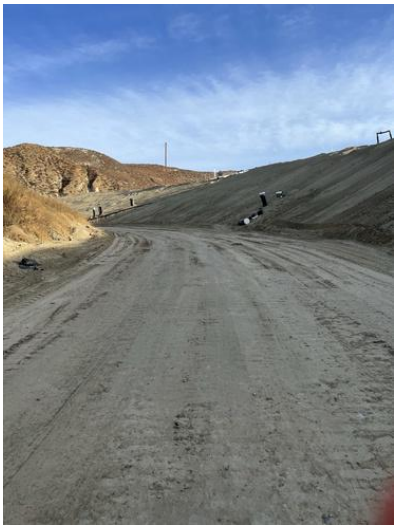
Photo 1

Description of area in photo where there is no leachate seepage or pooling.	Westside perimeter road.

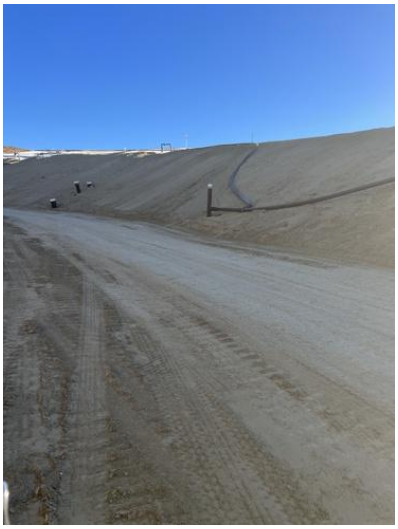
Photo 2

Description of area in photo where there is no leachate seepage or pooling.	West side perimeter road

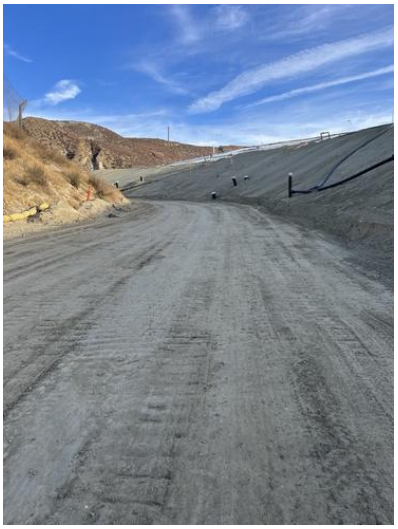
Photo 1

Description of area in photo where there is no leachate seepage or pooling.	Westside perimeter road.

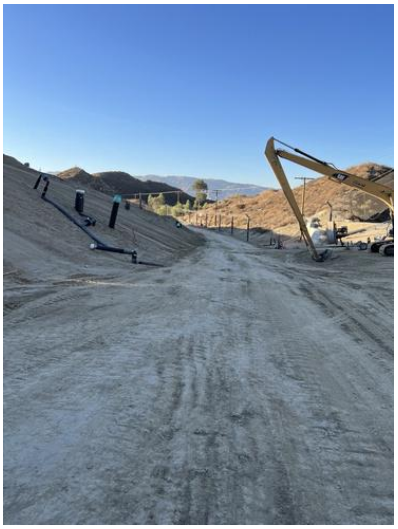
Photo 1

Description of area in photo where there is no leachate seepage or pooling.	Westside perimeter road.

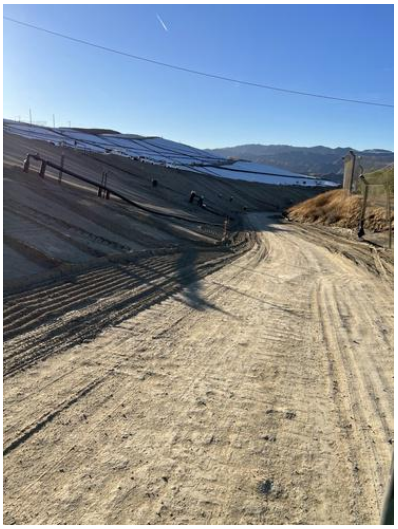
Photo 1

Description of area in photo where there is no leachate seepage or pooling.	Westside perimeter road.

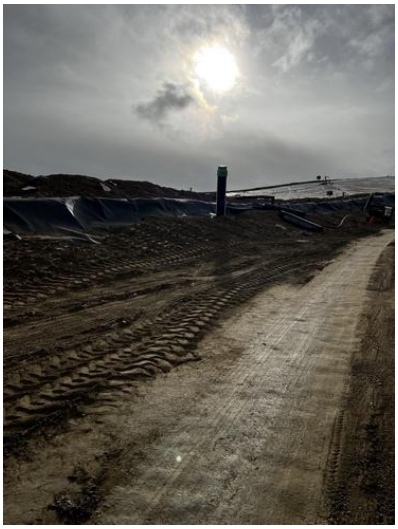
Has a leachate seep/pooling been located?	No

Description of area in photo where there is no leachate seepage or pooling.	North side perimeter road

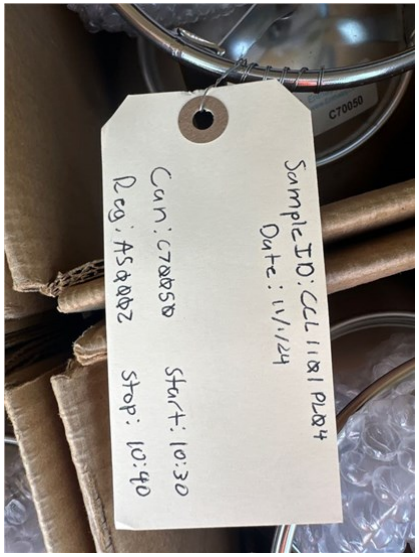
Condition 42 Support Sampling | **CCL1101PL04**

Comments: Light wind N

MultiRae - M01EA17446 - Voc 0.0ppm - LEL 0%

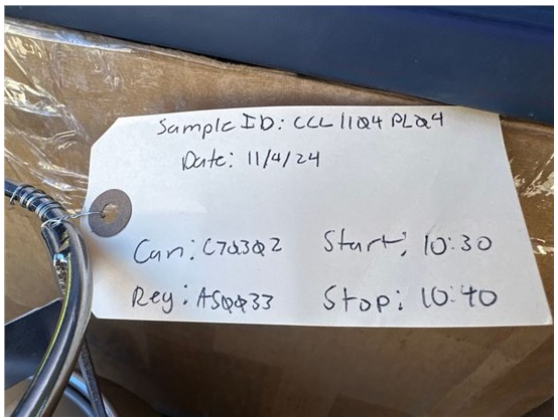
Condition 42 Support Sampling | **CCL1104PL04**

Comments: Light wind NE

MultiRae - M01FA02706 - Voc 0.0ppm - LEL 0%

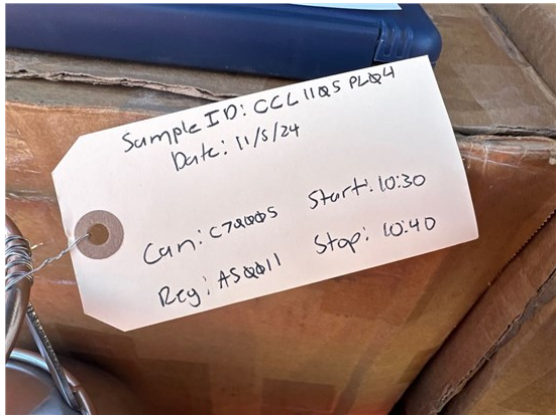
Condition 42 Support Sampling | **CCL1105PL04**

Comments: Light wind N

MultiRae - M01FA02706 - Voc 0.0ppm - LEL 0%

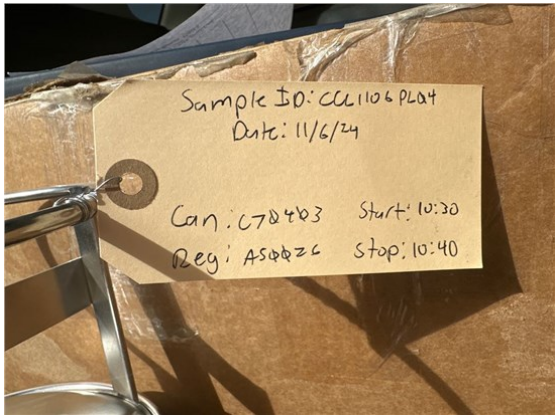
Condition 42 Support Sampling | **CCL1106PL04**

Comments: Heavy wind N

MultiRae - M01FA02706 - Voc 0.0ppm - LEL 0%

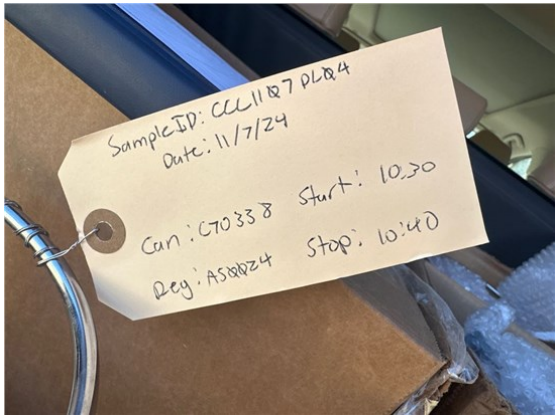
Condition 42 Support Sampling | **CCL1107PL04**

Comments: Light wind N

MultiRae - M01FA02706 - Voc 0.0ppm - LEL 0%

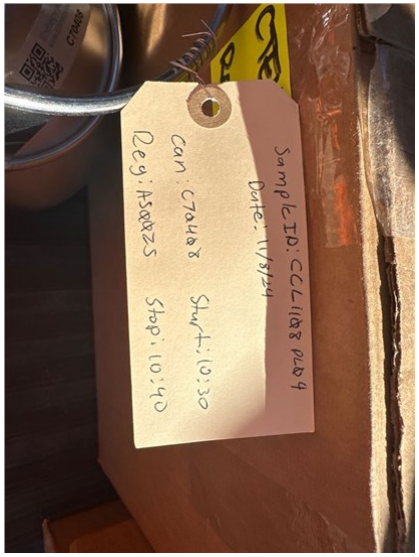
Condition 42 Support Sampling | **CCL1108PL04**

Comments: Light wind N

MultiRae - M01EA17446 - Voc 0.0ppm - LEL 0%

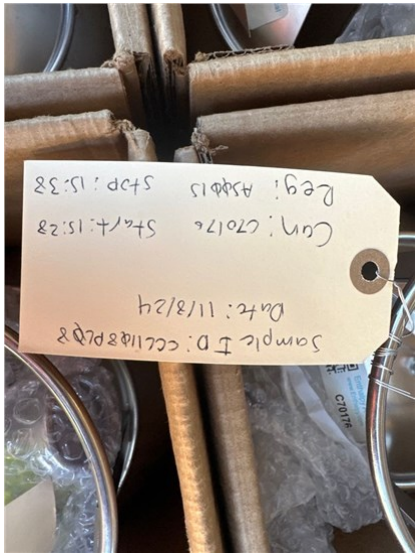
Condition 42 Support Sampling | **CCL1108PL08**

Comments: Light wind N

MultiRae - M01EA17446 - Voc 0.0ppm - LEL 0%

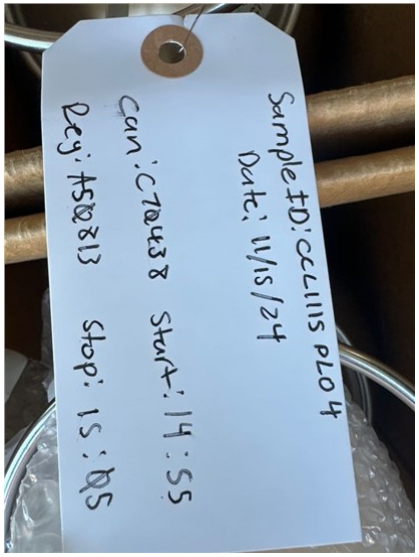
Condition 42 Support Sampling | **CCL1115PL04**

Comments: Light wind NNE

MultiRae - M01EA17446 - Voc 0.0ppm - LEL 0%

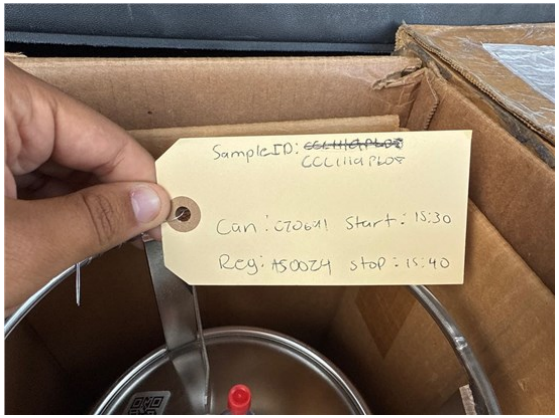
Condition 42 Support Sampling | **CCL1119PL08**

Comments: Light wind NE

MultiRae - M01EA17446 - Voc 0.0ppm - LEL 0%
