BEFORE THE HEARING BOARD OF THE

Case No. 6177-4

EXHIBIT L TO DECLARATION OF PATRICK SULLIVAN, BCES, CPP, REPA

Subject: December 2024 Monthly Report for Modified Stipulated Order for Abatement (Case No. 6177-4), Chiquita Canyon Landfill (Facility ID 119219), Castaic, California

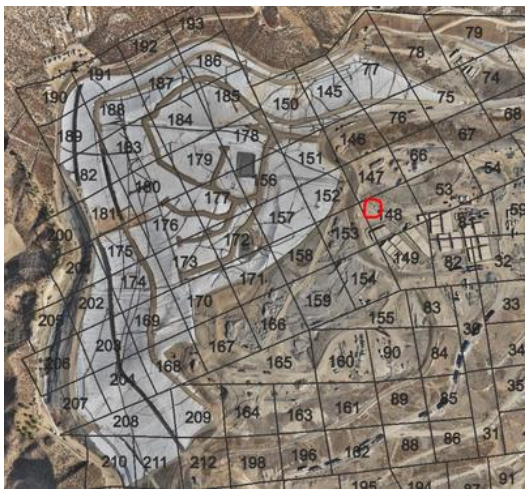
Using the attached image, annotate all areas where inspectors identified a fissure or tension crack.

Grid Location	148
Using the Media link below, attach the before photo of the fissure of tension crack.	4 Dec 2024 9:48 AM PST

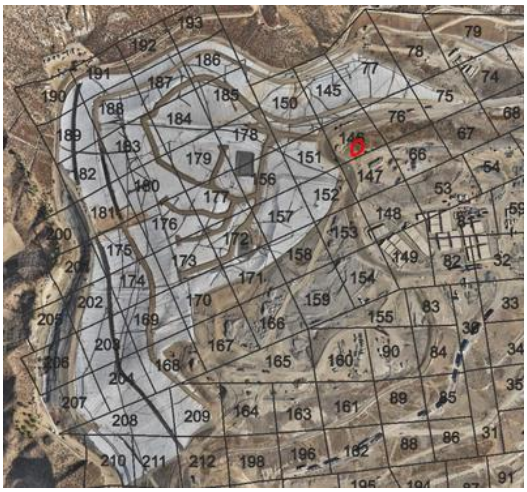
Using the attached image, annotate all areas where inspectors identified a fissure or tension crack.

Grid Location	146
Using the Media link below, attach the before photo of the fissure of tension crack.	4 Dec 2024 9:59 AM PST

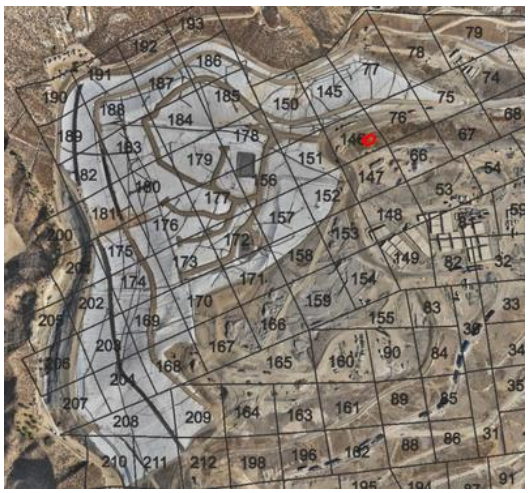
Grid Location	146

Using the attached image, annotate all areas where inspectors identified a fissure or tension crack.

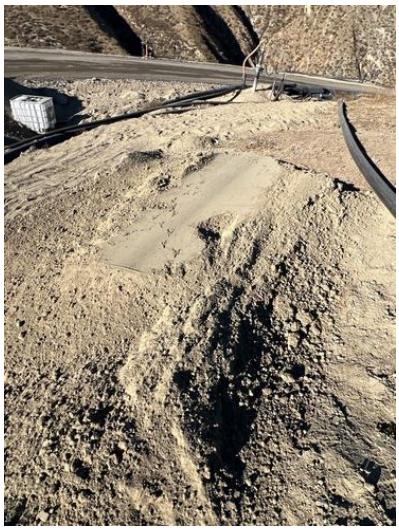
Photo 4

Length of crack (ft) or area containing multiple cracks (ft x ft)	10ft
Horizontal Offset (width)	Medium 2-4" in width
Vertical Offset (height)	Extra small <0.5" in height
Orientation (direction)	N to S
Location	(34.4360028, -118.6469787)
Was Fissure or Crack fixed? If yes, add photo and description of repairs performed	Yes

Date and time of repairs	6 Dec 2024 11:31 AM PST
Description of repairs	Other (please describe)

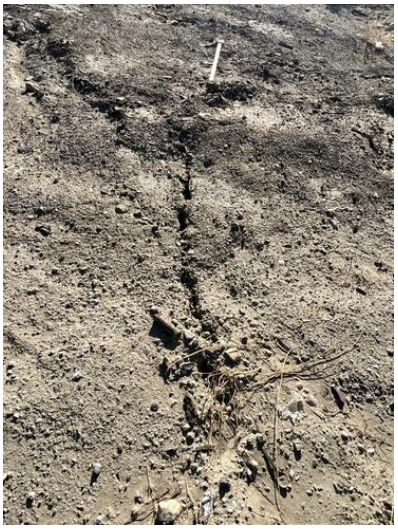
Length of crack (ft) or area containing multiple cracks (ft x ft)	20ft x 20ft area
Horizontal Offset (width)	Small 0.5-2" in width
Vertical Offset (height)	Extra small <0.5" in height
Orientation (direction)	NW to SE
Location	Castaic CA 91384 United States (34.43399894675079, -118.64865393358151)
Was Fissure or Crack fixed? If yes, add photo and description of repairs performed	Yes

Date and time of repairs	13 Dec 2024 11:21 AM PST
Description of repairs	Cracks were track walked.

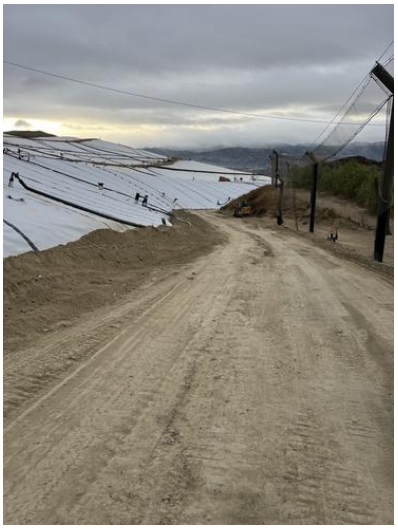
Photo 1

Description of area in photo where there is no leachate seepage or pooling.	Westside perimeter road.

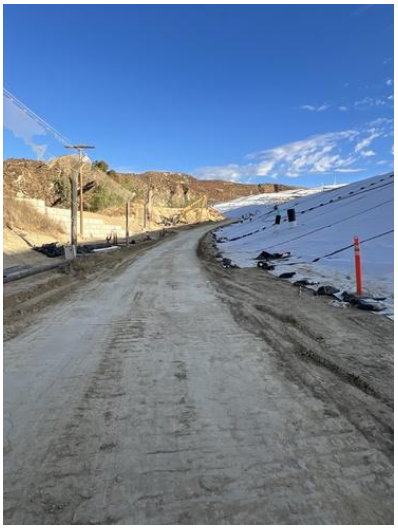
Photo 1

Description of area in photo where there is no leachate seepage or pooling.	Westside perimeter road.

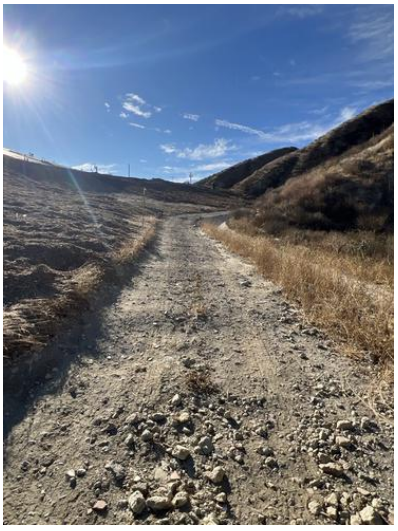
Photo 1

Description of area in photo where there is no leachate seepage or pooling.	North perimeter road. Seep from this morning was not observed during this inspection.

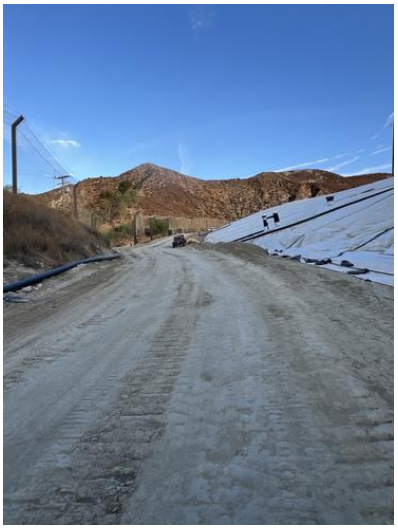
Photo 1

Description of area in photo where there is no leachate seepage or pooling.	Westside perimeter road.

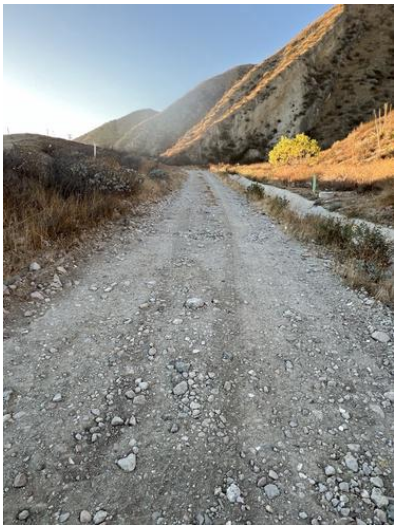
Photo 1

Description of area in photo where there is no leachate seepage or pooling.	North perimeter road.

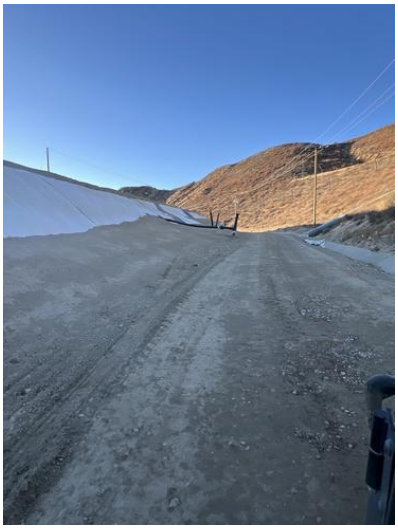
Photo 2

Description of area in photo where there is no leachate seepage or pooling.	North side perimeter road

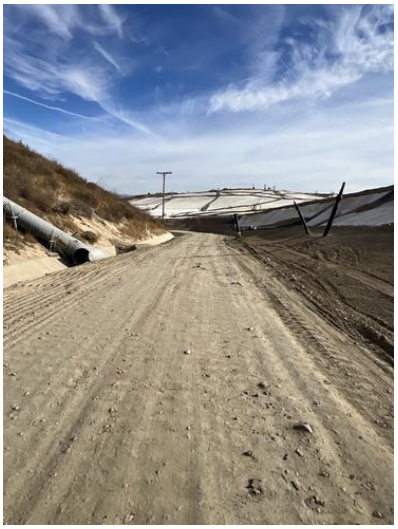
Photo 1

Description of area in photo where there is no leachate seepage or pooling.	North perimeter road.

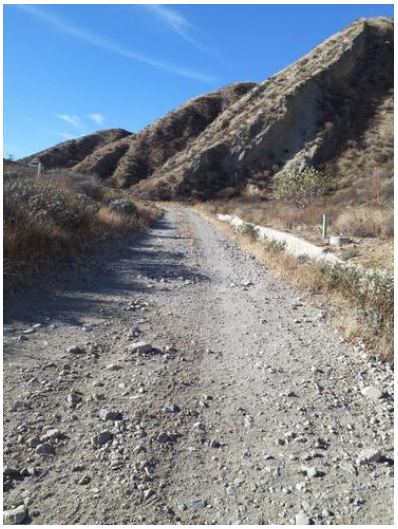
Photo 1

Description of area in photo where there is no leachate seepage or pooling.	North perimeter road

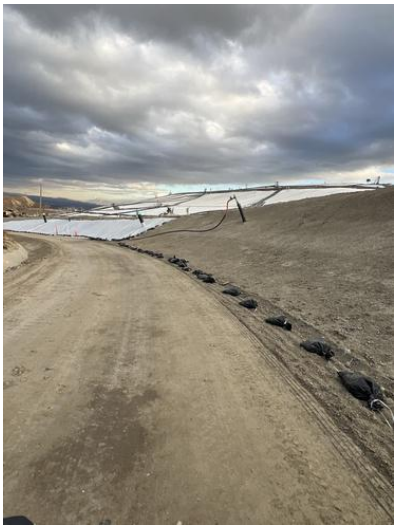
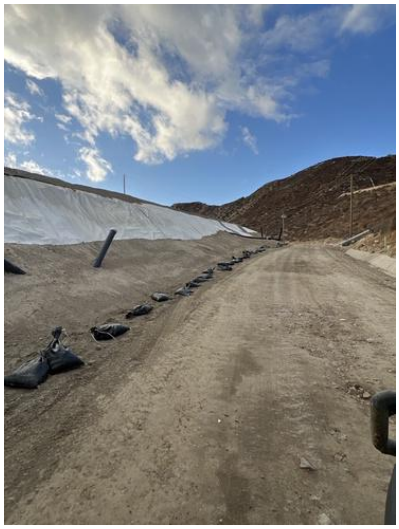
Description of area in photo where there is no leachate seepage or pooling.	North side perimeter road

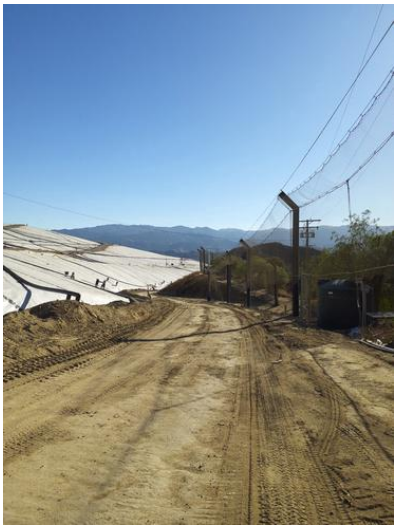
Photo 1

Description of area in photo where there is no leachate seepage or pooling.	West side perimeter road

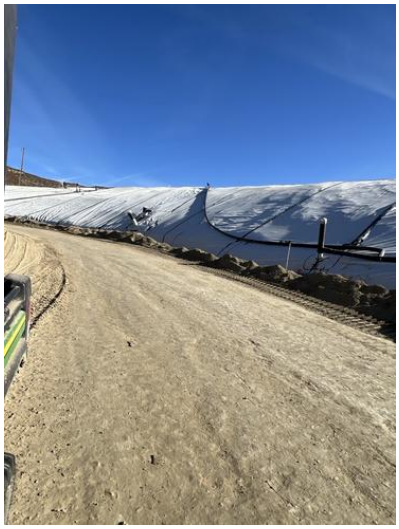
Description of area in photo where there is no leachate seepage or pooling.	West side perimeter road
