SOUTH COAST AIR QUALITY MANAGEMENT DISTRICT

Case No. 6177-4

EXHIBIT M TO DECLARATION OF PATRICK SULLIVAN, BCES, CPP, REPA

Subject: January 2025 Monthly Report for Modified Stipulated Order for Abatement (Case No. 6177-4), Chiquita Canyon Landfill (Facility ID 119219), Castaic, California

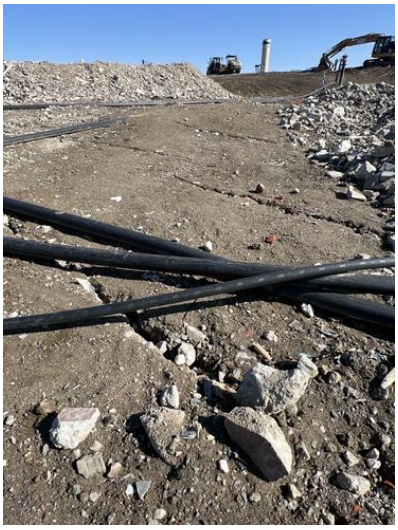
Photo 5

Grid Location	160
Using the Media link below, attach the before photo of the fissure of tension crack.	28 Jan 2025 12:00 PM PST

Length of crack (ft) or area containing multiple cracks (ft x ft)	30ft X 20ft
Horizontal Offset (width)	Medium 2-4" in width
Vertical Offset (height)	Extra small <0.5" in height
Orientation (direction)	NE to SW
Location	Castaic CA 91384 United States (34.43376262530023, -118.64779732402356)
Was Fissure or Crack fixed? If yes, add photo and description	Yes

Date and time of repairs	28 Jan 2025 1:51 PM PST
Description of repairs	Cracks were track walked.
Instability	
Are there any indications of slope stability concerns?	No
