December 29, 2025

POST-EXCEEDANCE AIR MONITORING INVESTIGATION MS-04, DECEMBER 22-23, 2025 – STIPULATED ORDER FOR ABATEMENT CONDITION NO. 34(d)

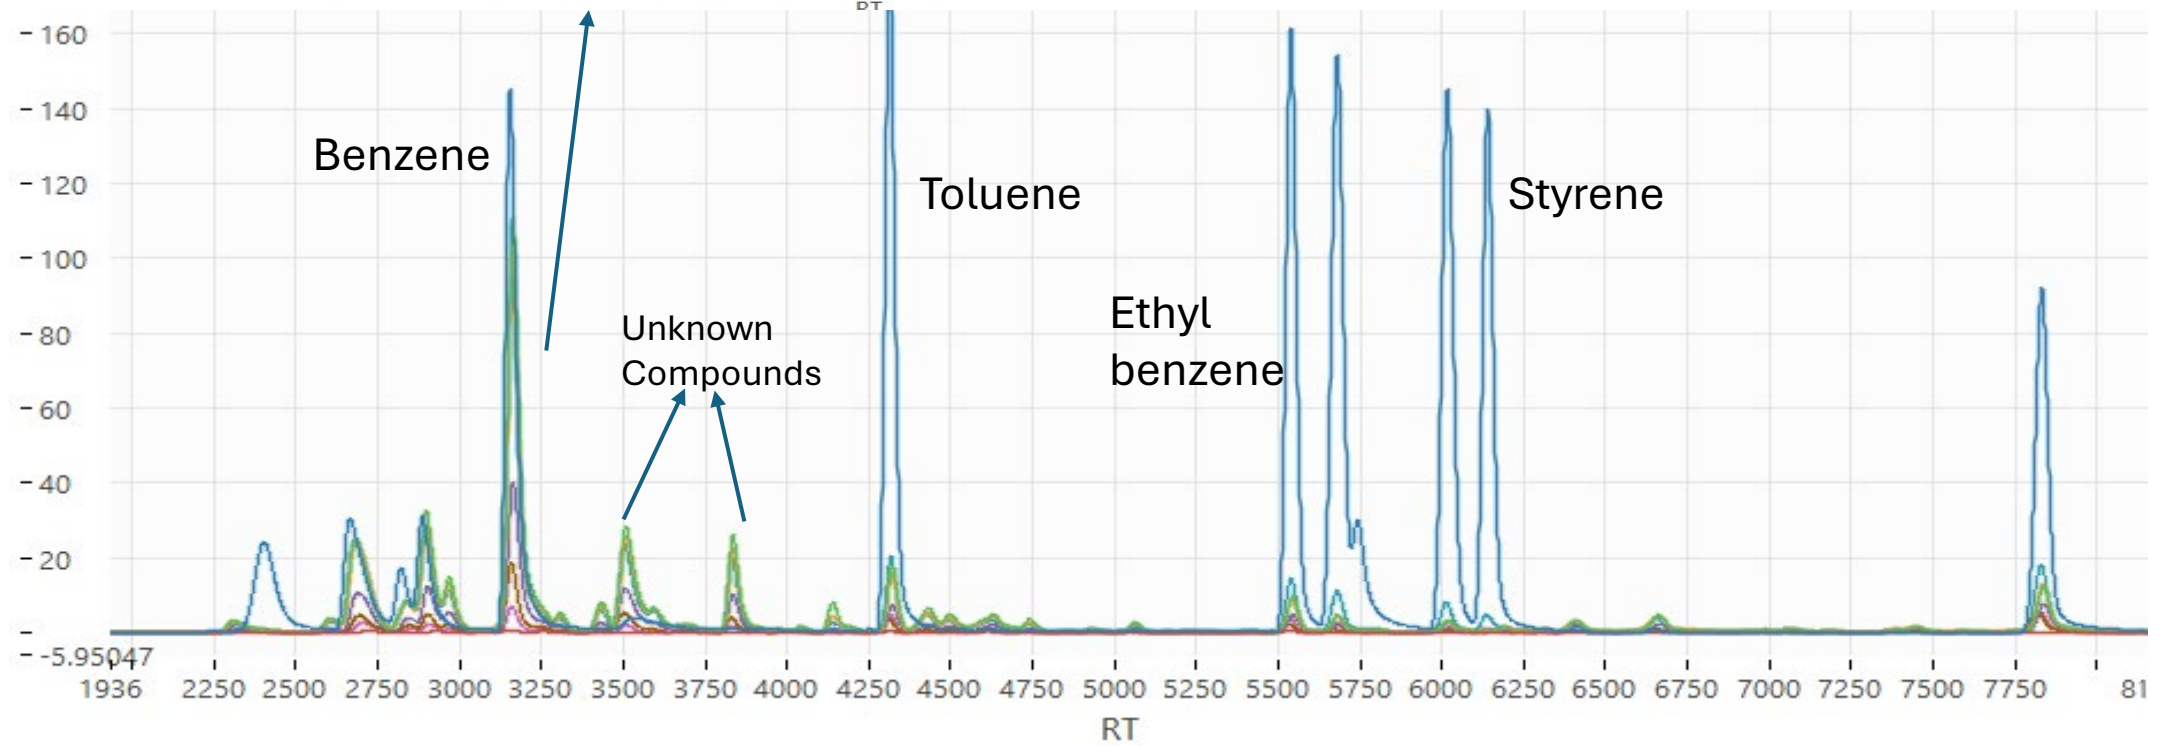
Sensor 1

Sampling Start Time	Benzene
12/22/2025 20:00	0.47 ppb
12/22/2025 21:00	11.14 ppb
12/22/2025 22:00	9.67 ppb
12/22/2025 23:00	4.23 ppb
12/23/2025 0:00	1.64 ppb
Calibration time	Calibration
12/23/2025 4:00	9.41 ppb

MS04 – Benzene Environmental sample signals

All benzene data recorded at MS04 are valid, reliable, and representative of environmental conditions, with no evidence of analytical or operational anomalies.

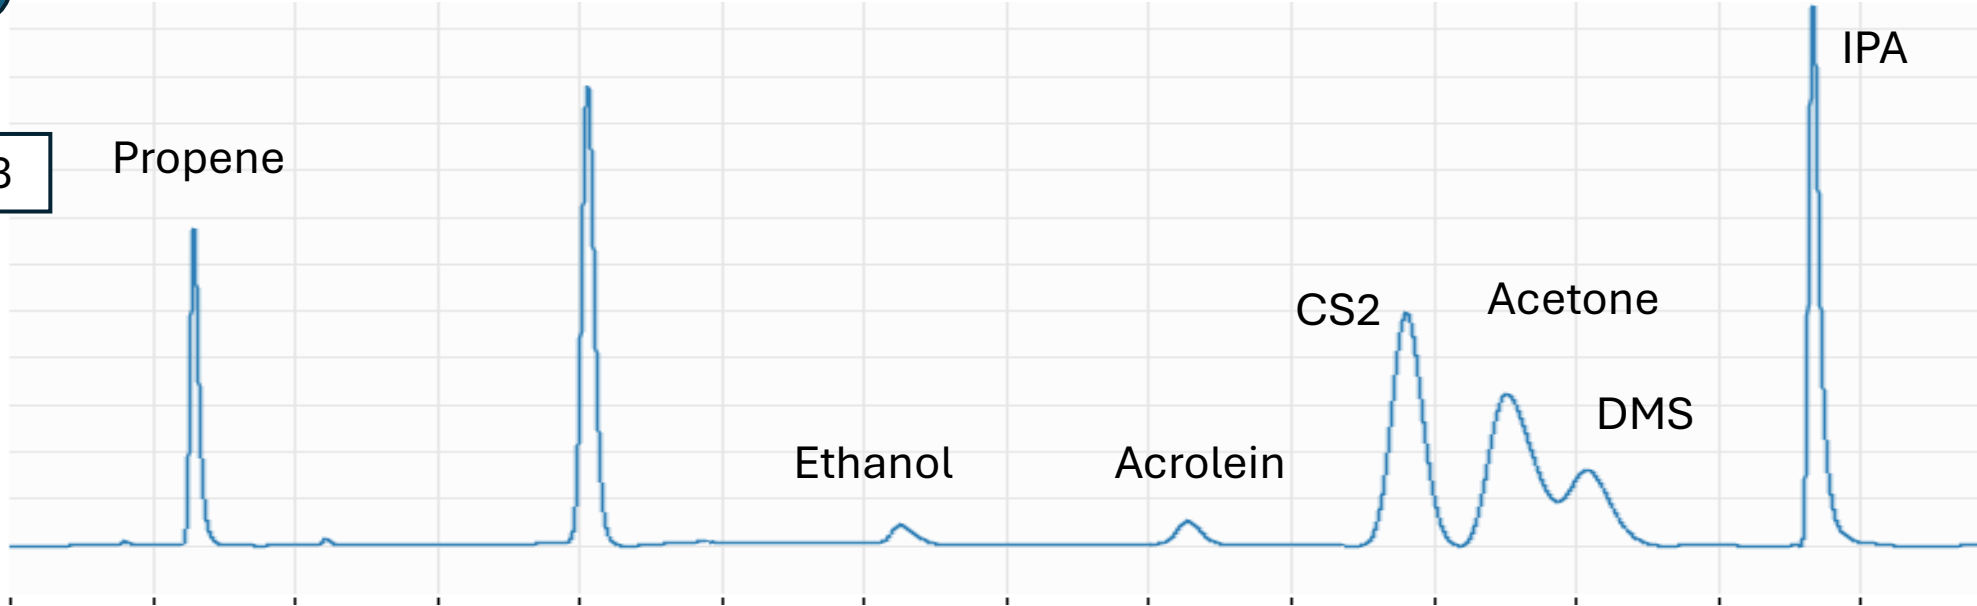
Sensor 3

Normal Calibration Peaks
