AQ-SPEC

Field Evaluation Report for

Strop de Aer PM-Ultimate

Report ID: F2025092.0

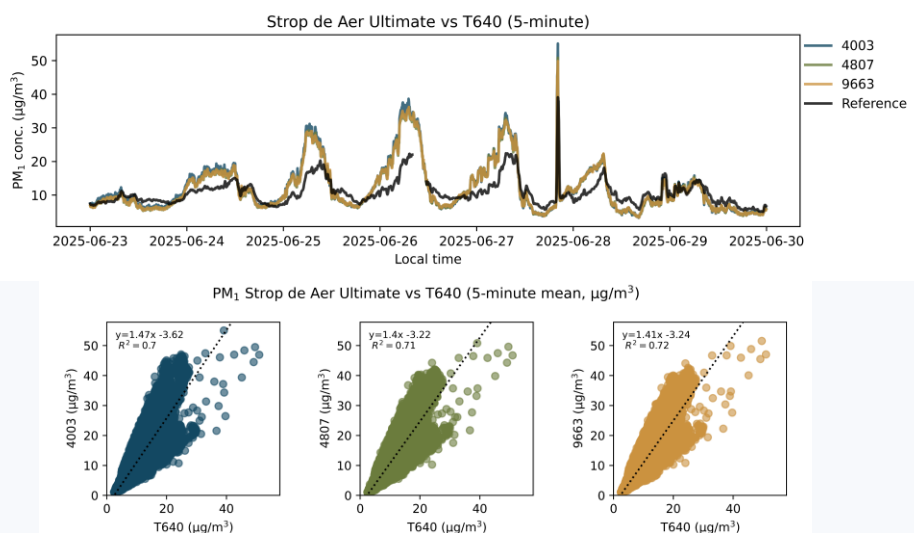
Interpretation: The Strop de Aer units showed strong correlation with the corresponding T640 data ($0.70 < R^2 < 0.72$) for 5-minute averaging.

Parameter	Time Resolution	T640 (mean ± SD)
PM ₁ (µg/m ³)	5-minutes	0.71 ± 0.01
	1-hour	0.71 ± 0.01
	24-hours	0.7 ± 0.01

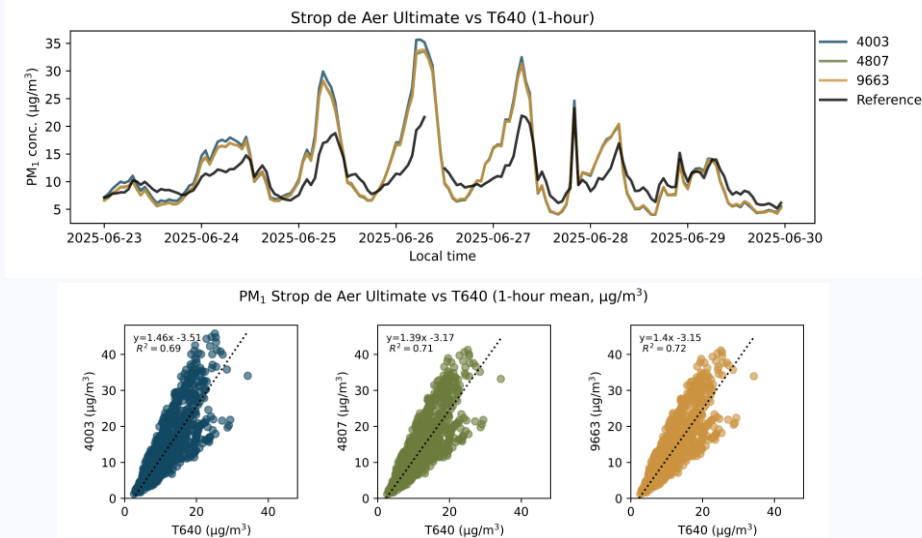
Interpretation: The Strop de Aer units showed moderate to strong correlation with the corresponding T640 data ($0.69 < R^2 < 0.72$) for 1-hour averaging.

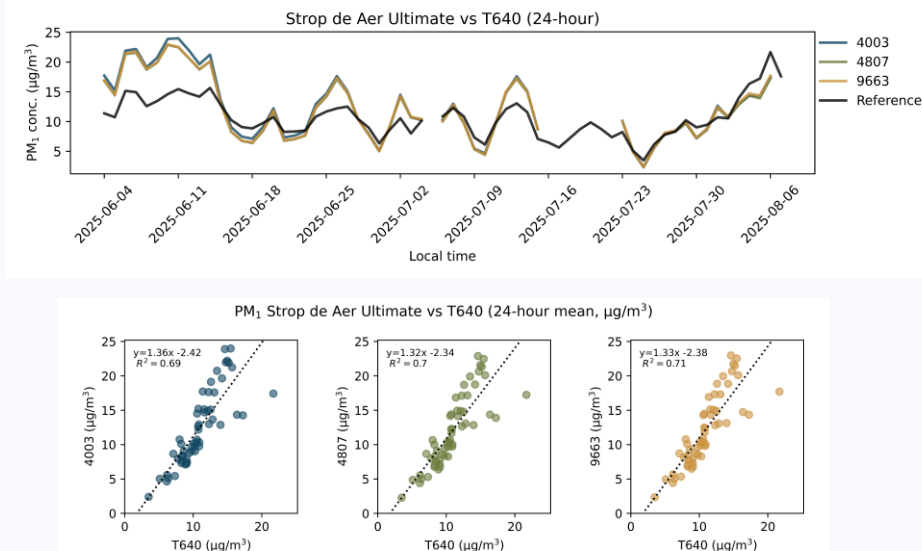
Interpretation: The Strop de Aer units showed moderate to strong correlation with the corresponding T640 data ($0.69 < R^2 < 0.71$) for 24-hour averaging.

*Large gap in 24-hour averaged sensor data due to laptop issues from 7/16/2025 to 7/22/2025.

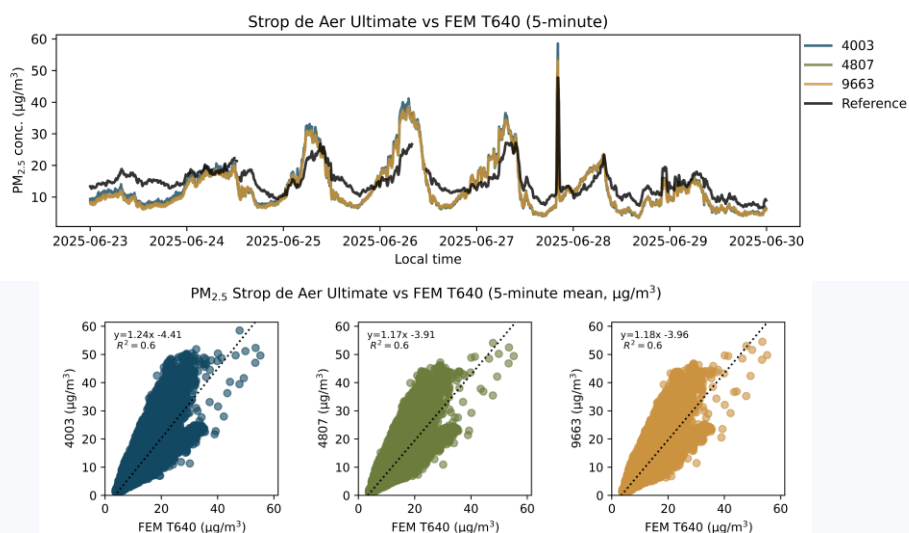
Interpretation: The Strop de Aer units showed moderate correlation with the corresponding FEM T640 data ($0.59 < R^2 < 0.60$) for 5-minute averaging.

Parameter	Time Resolution	FEM T640 (mean ± SD)
PM _{2.5} (µg/m ³)	5-minutes	0.6 ± 0.0
	1-hour	0.6 ± 0.0
	24-hours	0.48 ± 0.01

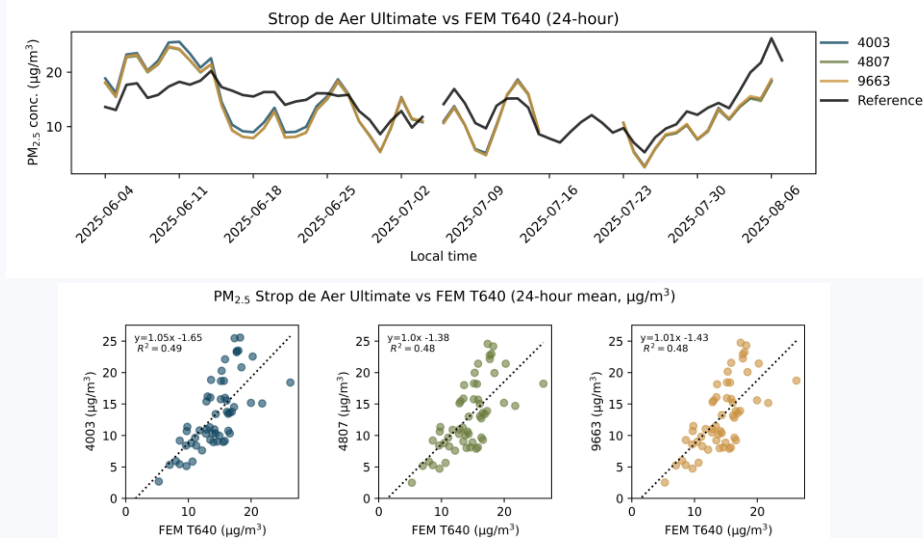
Interpretation: The Strop de Aer units showed weak correlation with the corresponding FEM T640 data ($0.48 < R^2 < 0.49$) for 24-hour averaging.

*Large gap in 24-hour averaged sensor data due to laptop issues from 7/16/2025 to 7/22/2025.

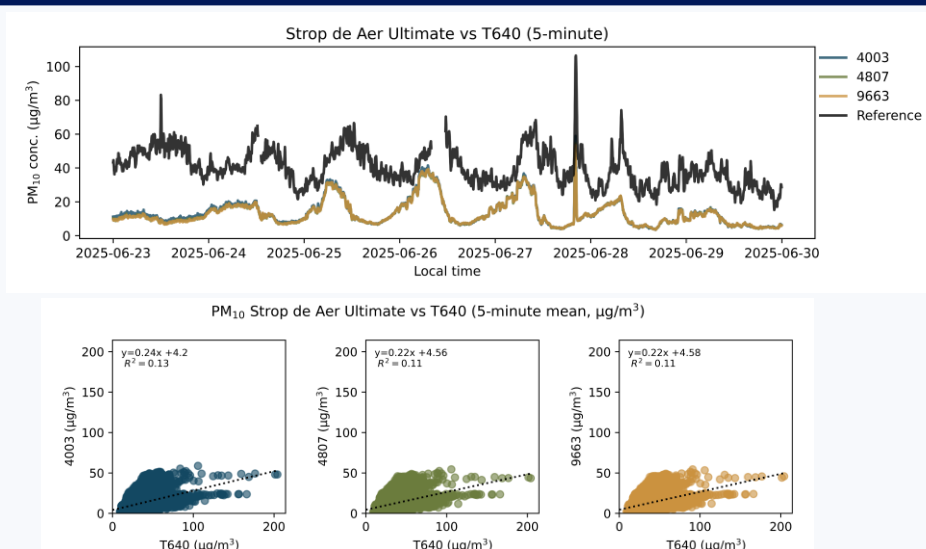
Interpretation: The Strop de Aer units showed very weak correlation with the corresponding T640 data ($0.11 < R^2 < 0.13$) for 5-minute averaging.

Parameter	Time Resolution	T640 (mean \pm SD)
PM ₁₀ ($\mu\text{g}/\text{m}^3$)	5-minutes	0.12 ± 0.01
	1-hour	0.13 ± 0.01
	24-hours	0.06 ± 0.01

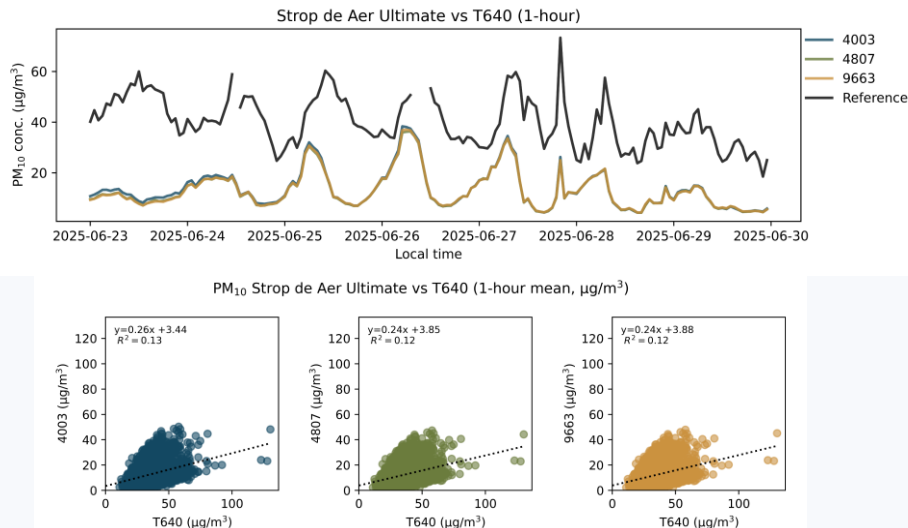
Interpretation: The Strop de Aer units showed very weak correlation with the corresponding T640 data ($0.12 < R^2 < 0.13$) for 1-hour averaging.

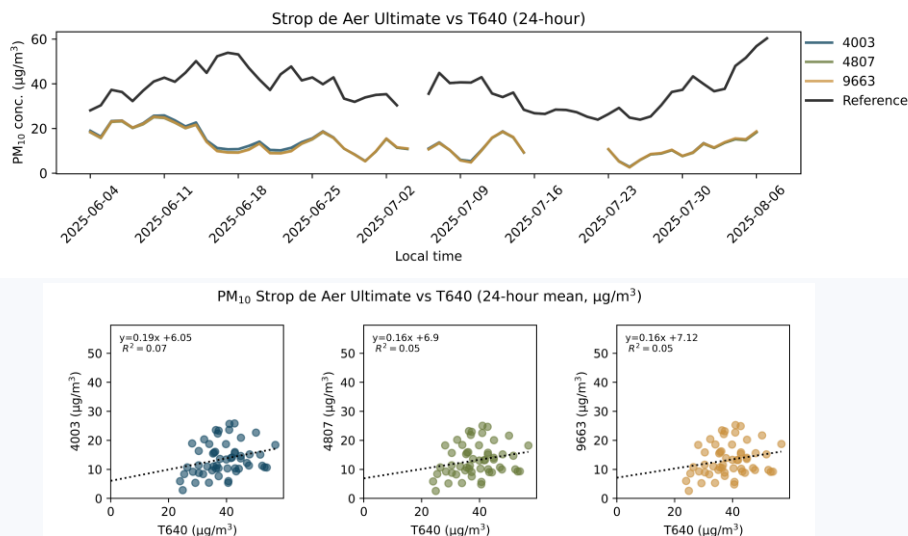
Interpretation: The Strop de Aer units showed no correlation with the corresponding T640 data ($0.05 < R^2 < 0.07$) for 24-hour averaging.

*Large gap in 24-hour averaged sensor data due to laptop issues from 7/16/2025 to 7/22/2025.
